PROPERTY INSPECTION REPORT

Property address: **123 For Sale Ln**

Walden, NY 12586

Inspection date: **Wednesday, January 7, 2009**

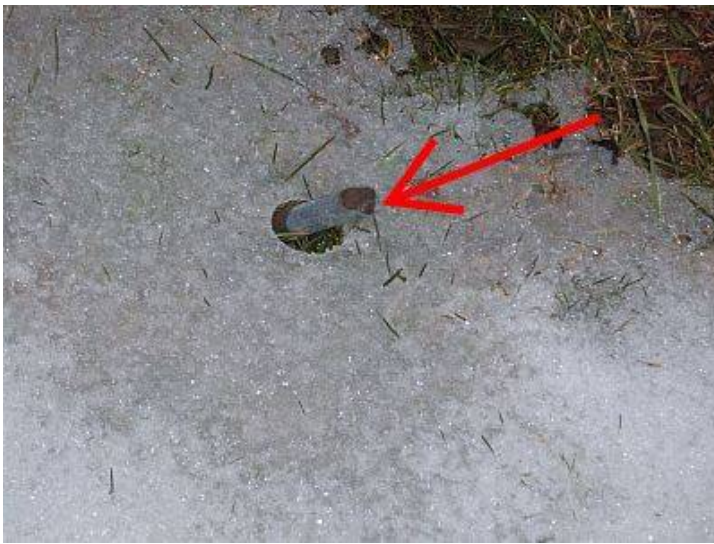
Trip hazards found on right side (south) of house from exposed metal grounding rods sticking out of ground. This poses safety hazards since they can cause impalement and serious injury if someone were to trip near and/or fall onto the exposed ground rod(s). A qualified contractor should evaluate and repair or cover ground rod to eliminate trip and safety hazards.

Photo 5
Metal rod sticking out of ground.

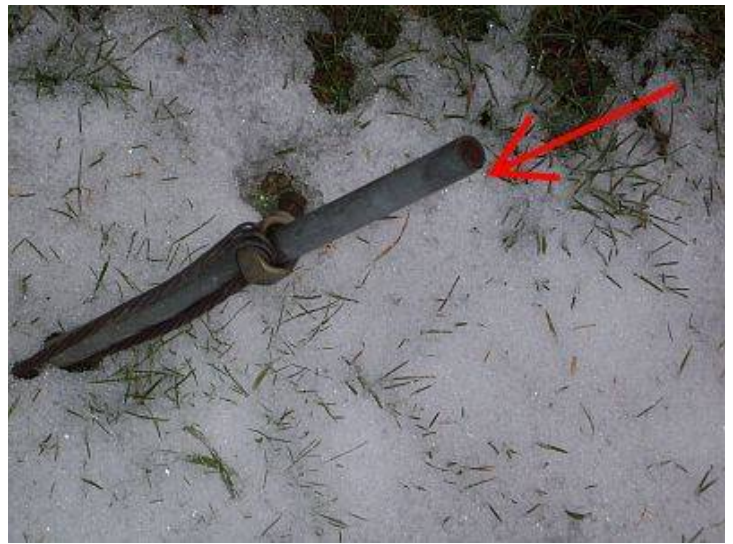
Photo 6
Exposed grounding rod extending ~ 1 ft out of ground.

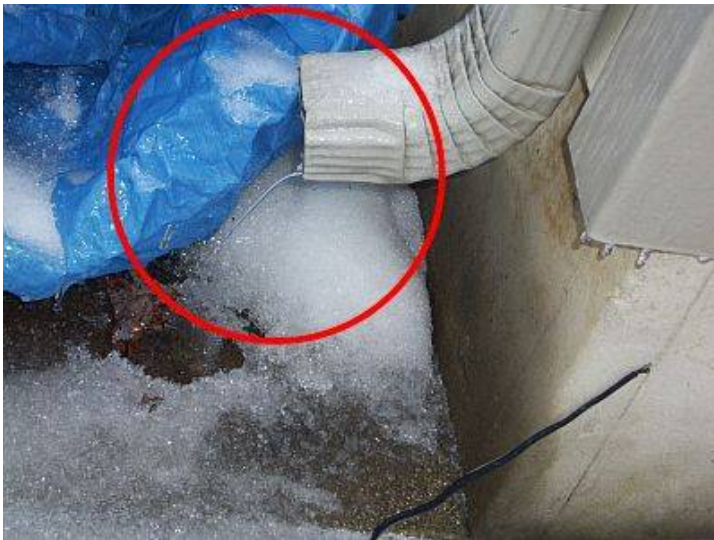
- 3) 🛠️💧 One or more downspouts have no extensions, or have extensions that are ineffective. This can result in water accumulating around the structure's foundation, or in basements and crawl spaces if they exist. In this particular case, the water is flowing toward the area of the stored fire wood and the air conditioner condensing unit. Accumulated water is a conducive condition to wood destroying insects and organisms, and may also cause the foundation to settle and possibly fail over time, in addition to corrosion of the air conditioning condensing unit. Repairs should be made as necessary, such as installing or repositioning splash blocks, extensions or installing and/or repairing tie-ins to underground drain lines, so rain water is carried at least several feet away from the structure to soil that slopes down and away from the structure.

Photo 3
Missing downspout extension.

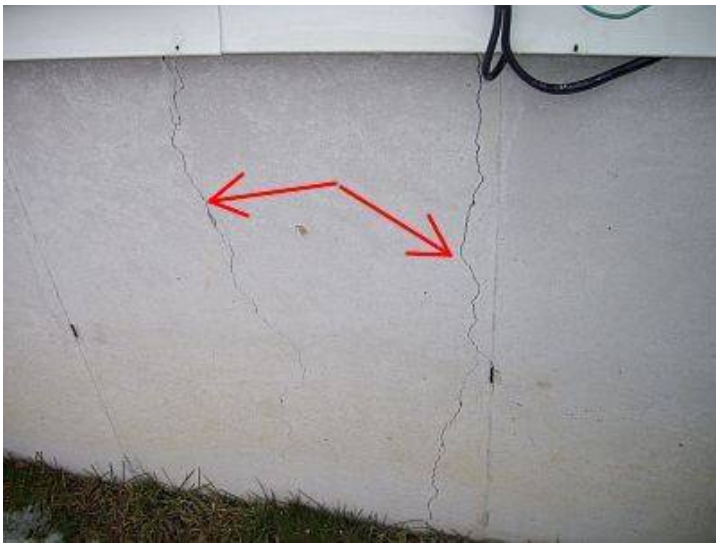
Photo 7

- 4) 🛠️🏠💧 One or more minor cracks (1/8 inch or less) were found in the foundation. These don't appear to be a structural concern, but recommend sealing them to prevent water infiltration and monitoring them in the future for increasing width/depth and/or displacement of foundation. Numerous products exist to seal such cracks including:
- Hydraulic cement. Requires chiseling a channel in the crack to apply. See <http://www.quickrete.com/catalog/HydraulicWater-StopCement.html> for an example.
 - Resilient caulks (easy to apply). See <http://www.quickrete.com/catalog/GrayConcreteRepair.html> for an example.
 - Epoxy sealants (both a waterproof and structural repair). See <http://www.mountaingrout.com/> for examples of these products.

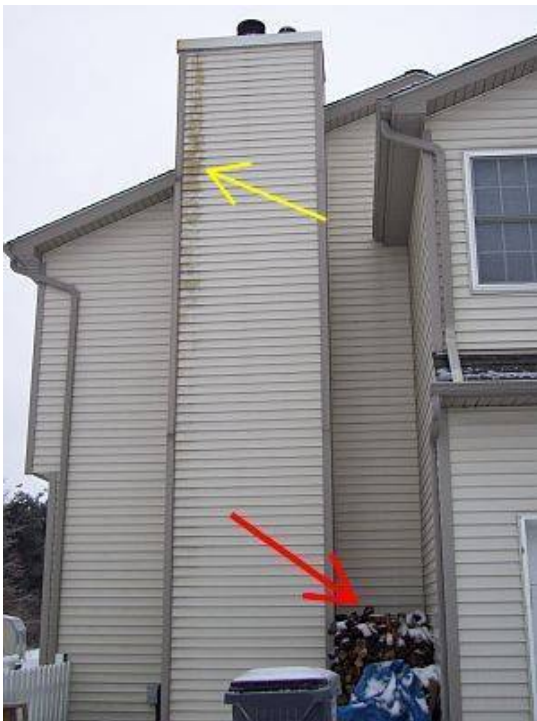
Photo 2

a. Firewood is stored so that it's either in contact with the structure or very close to it. This is a conducive condition for wood destroying insects. Recommend storing firewood outdoors in an open area, as far away from the house as practical, to keep away insects. For more information visit <http://ohioline.osu.edu/hyg-fact/2000/2065.html>

b. Stain/mold on vinyl siding (chimney area). This is the north side of the structure, which is conducive to higher moisture content because of the lack of sunlight.

a. (red arrow) Fire wood stored next to structure.

b. (yellow arrow) Stain, possibly mold on vinyl siding (chimney) area.

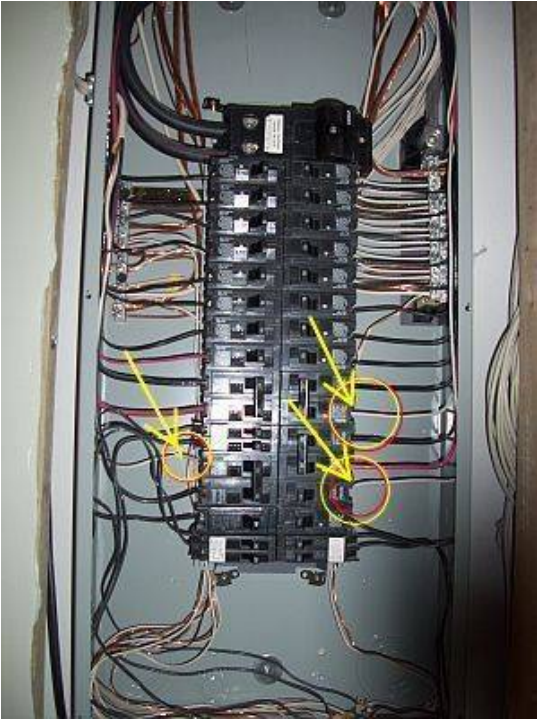
One or more white/neutral wires are being used as black/hot legs inside the panel without being marked as black or hot. This may be a potential safety hazard. A qualified electrician should evaluate and correct the situation as necessary.

Photo 13

White/neutral wires used as unmarked black/hot wires.

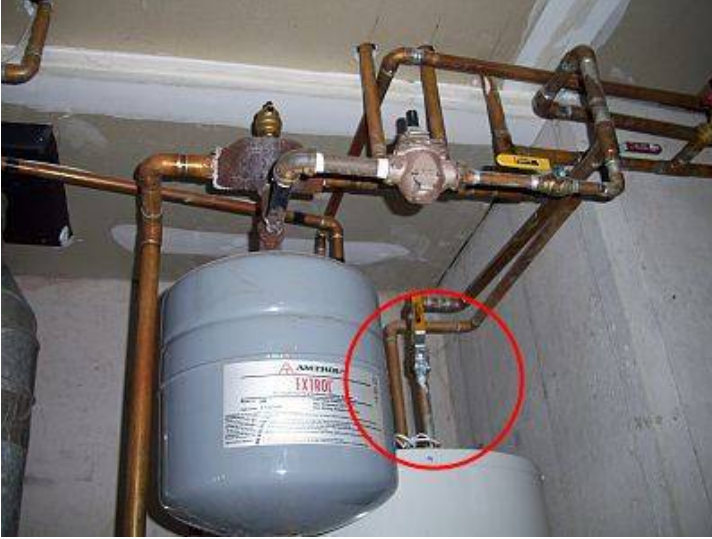
A water supply shut-off valve was leaking. A qualified plumbing contractor should evaluate and repair/replace this valve.

Photo 11
Leak at one or more shut off valves.

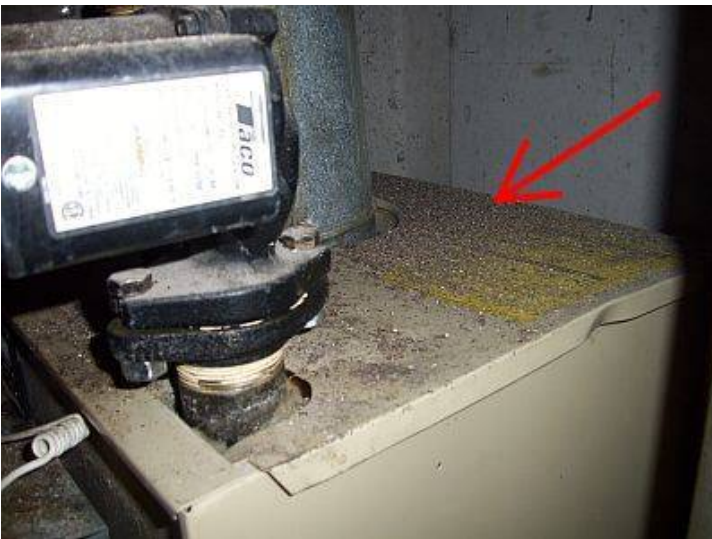
Ceiling above boiler has large opening/not finished. Ashes from fireplace above it on first floor found on top of boiler cabinet and immediate area. Section 16 recommended proper cleaning of fireplace and chimney by qualified professional at least annually. Also recommended is the evaluation and repair of the ceiling by a qualified contractor.

Photo 10
Ashes found from opening in ceiling; fireplace above it on first floor.

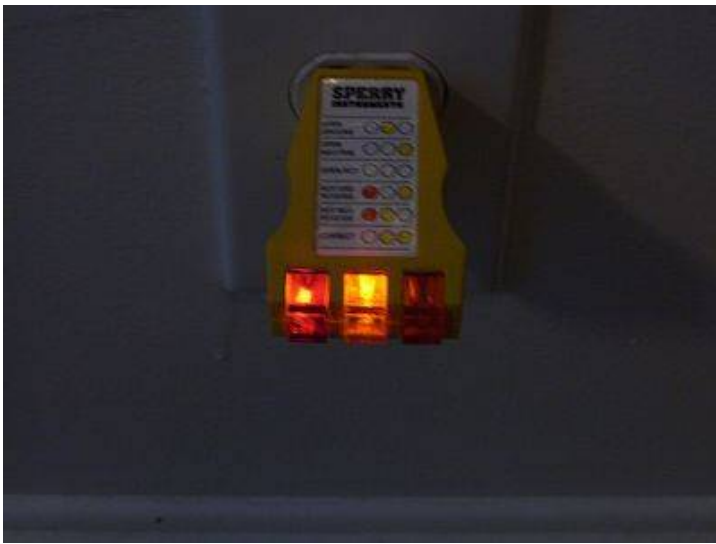
All the electric receptacles in the basement have reverse-polarity wiring, where the hot and neutral wires are reversed. This is a safety hazard due to the risk of shock. A qualified electrician should evaluate and make repairs as necessary.

Photo 9
Reversed polarity (hot/neutral).

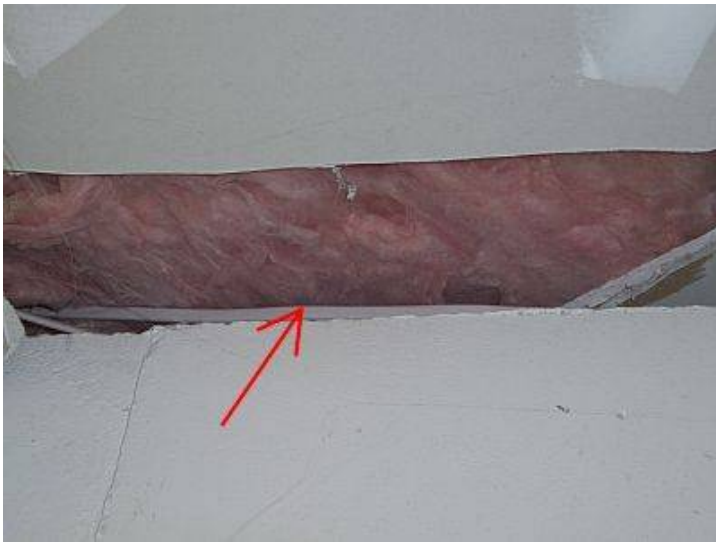
Areas of basement have exposed fiberglass insulation: boiler room ceiling, well equipment area ceiling, laundry water and drain/waste area and wall of storage room under steps. This is a potential safety hazard. Recommend a qualified contractor evaluate and repair/finish off the areas of exposed insulation.

Photo 8
Exposed fiberglass insulation.

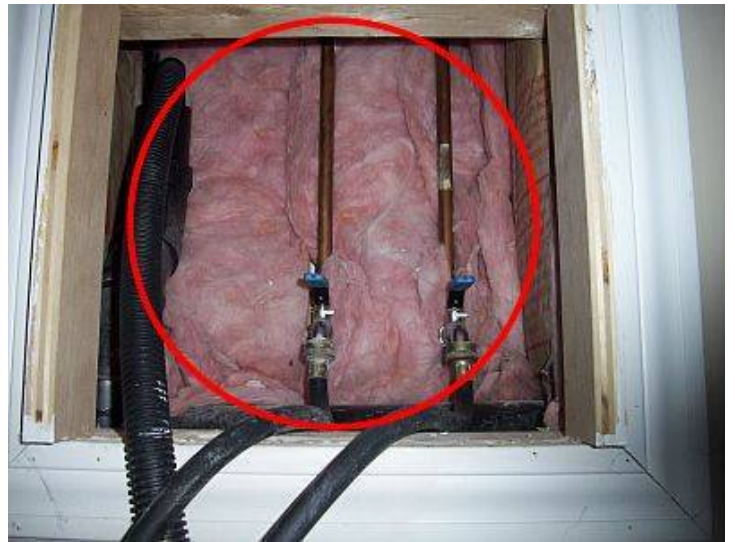
Photo 12
Exposed fiberglass insulation by laundry water supply and drain.

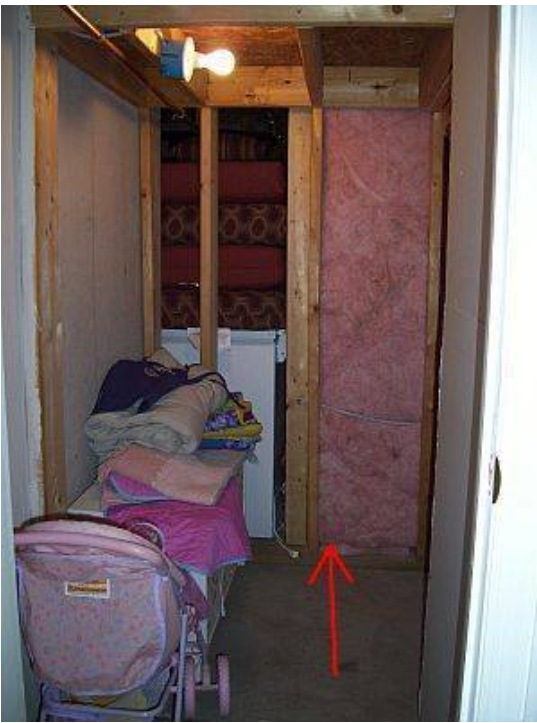
Photo 14
Exposed fiberglass insulation in storage area
beneath stairs. Walls and ceiling unfinished.

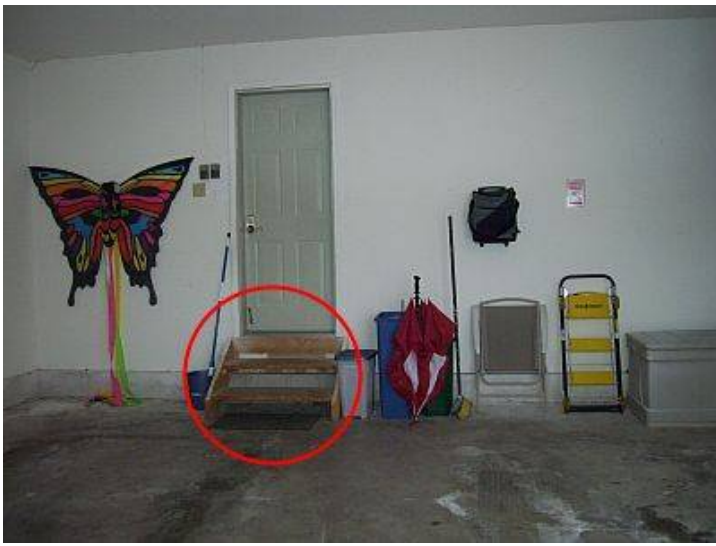
Photo 4

Stairs with more than two risers have no handrail installed. This is a safety hazard. A qualified contractor should install graspable handrails that your hand can completely encircle at stairs where missing, and as per standard building practices.
