# ALLISON CONSULTING GROUP, LLC

## Property Inspection Report

Property address: **3447 4th Street  
 Riverside, CA**

Inspection date: **Sunday, August 09, 2009**

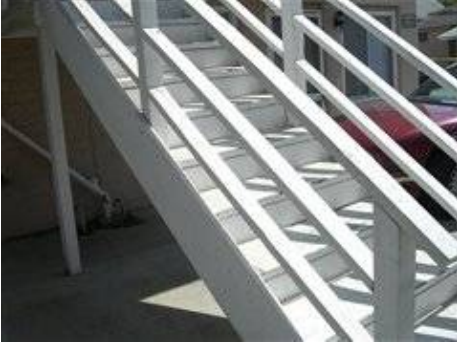
Photo 8  
Gaps in rail should not exceed 4-1/8" for child safety.

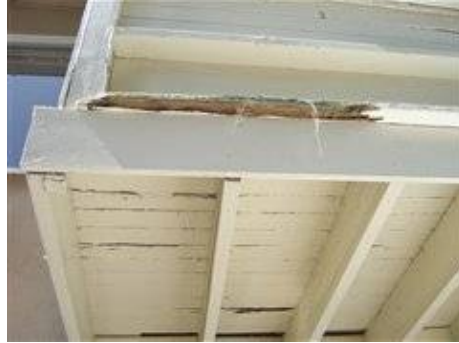
Photo 13  
Consult termite report.

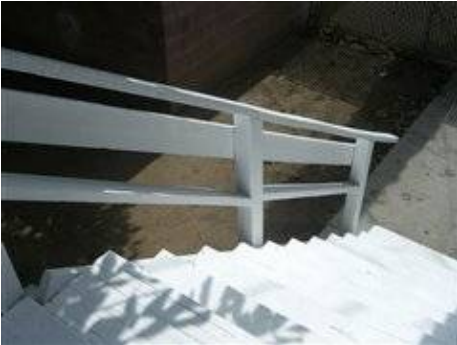
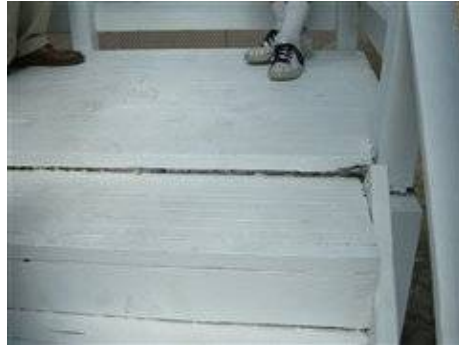
6) 🛠️🔪 Handrail(s) at some stairs are loose. This is a safety hazard. A qualified contractor should make repairs as necessary. For example, installing new fasteners and/or hardware so handrails are securely attached.

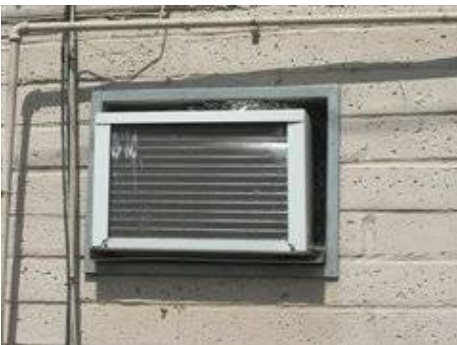
Photo 22

7) 🛠️🔪🔍💧 Flashing missing from A/C unit penetration.

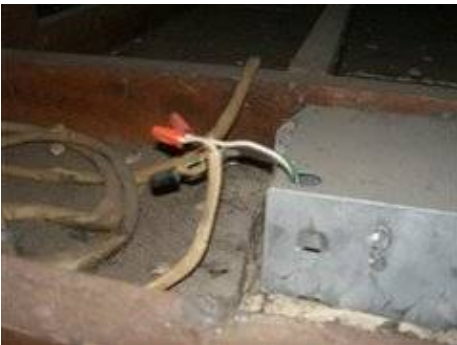
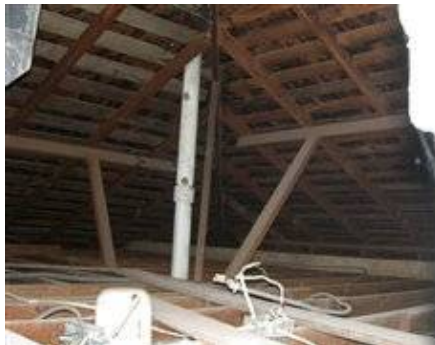
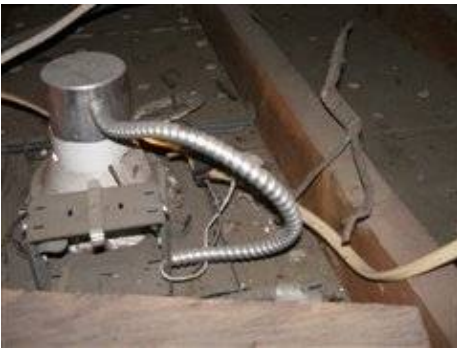
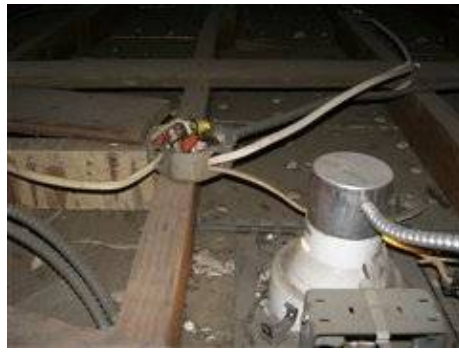
16) 🛠️🔍 Wire splices are exposed due to not being contained in a covered junction box. This is a safety hazard due to the risk of shock and fire. A qualified electrician should evaluate and make repairs as necessary. For example, install securely mounted junction boxes with cover plates where needed to contain wiring splices.

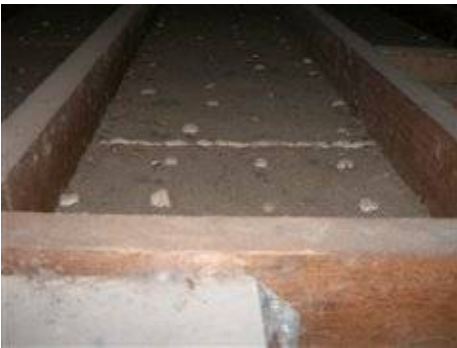
Photo 2

18) 🏠🔧 No ceiling insulation is installed in the attic. A qualified contractor should install insulation for better energy efficiency and as per standard building practices with an R rating recommended for this area.

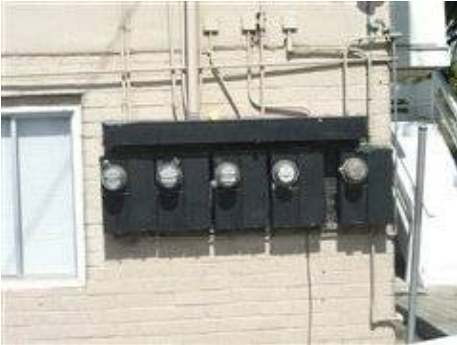
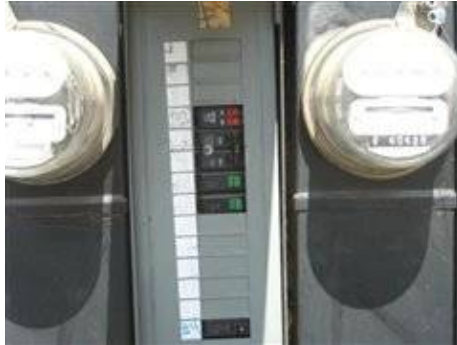
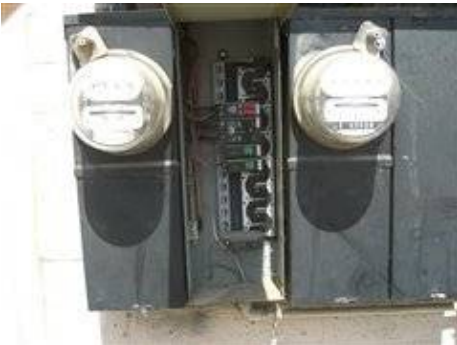
23) Electrical meters and panels functional.

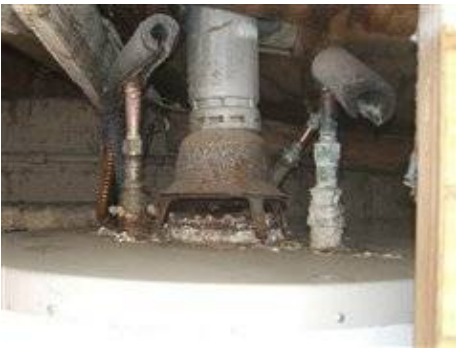
Photo 14

25) 🛠️🔥🚰💧 Corrosion present at water heater piping.

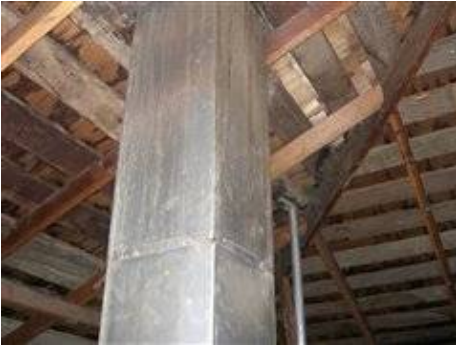
Photo 4

Abandoned supply/return air duct in attic. Registers capped.

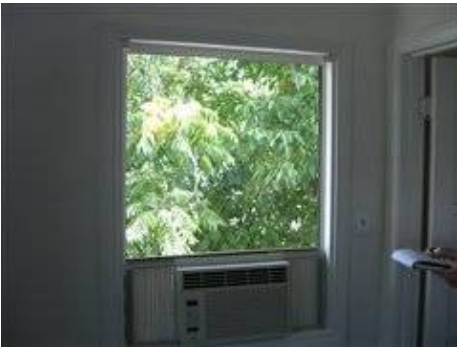
Photo 19

35) 🛠️ 🧑🔧 🔍 💧 Bedroom window missing.

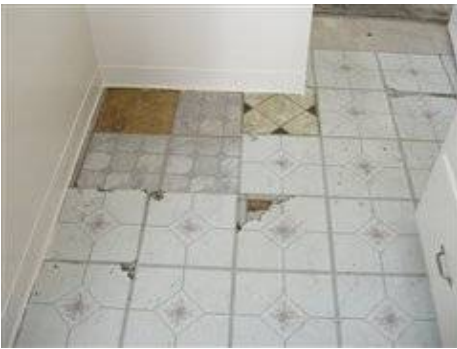
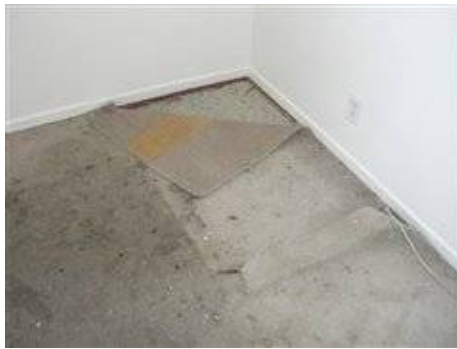
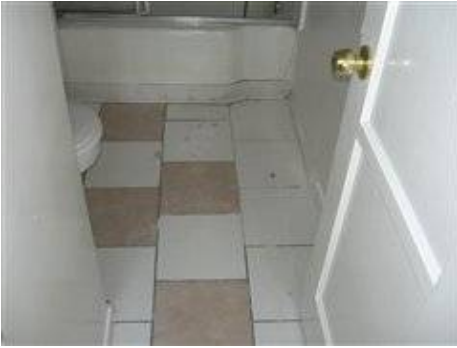
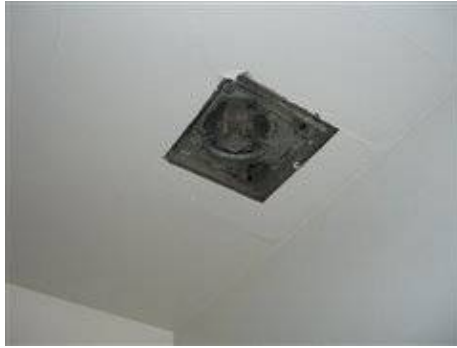
36) 🛠️ 🔑 🔍 ⓘ Unable to fully evaluate Apt 6, utilities turned off at time of inspection. Manager reports renovation in progress on this unit.

VCT tile and carpet at end of life.

Ceiling exhaust fan missing.
