# All Point Home Inspections

## Full General Home Inspection and Structural Pest Inspection WA State Dept. Agriculture ICN#00000000

Property address: **Anytown, USA**

Inspection date: **5/28/2012**

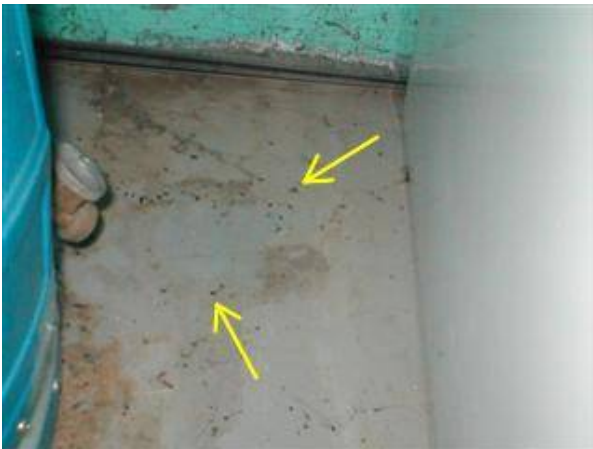
Photo 21

Evidence of rodent infestation was found in the form of feces in the garage. Consult with the property owner about this. A qualified person should make repairs to seal openings in the structure, set traps, and clean rodent waste as necessary. Recommend following guidelines in these Center for Disease Control articles:

Mouse feces in garage by water heater.

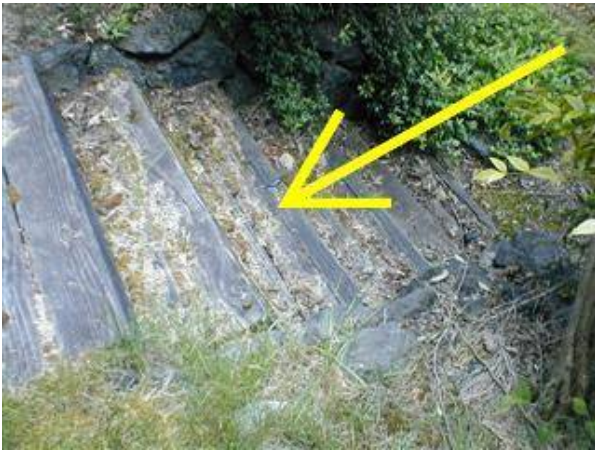
Photo 8

- 
- 4) 🚧 🪓 🪵 Stairs built from landscaping timbers were rotten. This is a potential fall hazard. Recommend replacing rotten timbers.

Rotten landscaping timbers used for back yard steps.

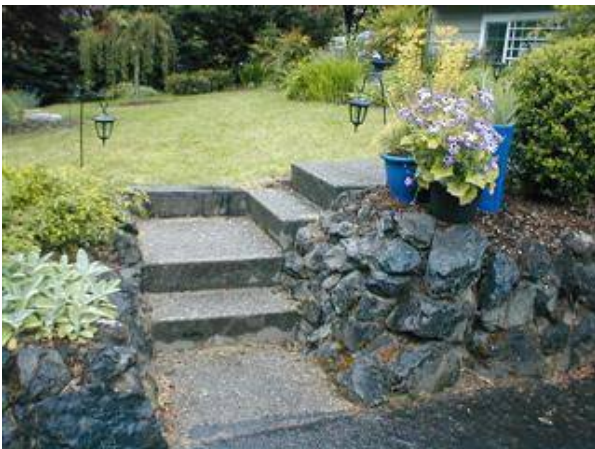
- 
- 5) 🚧 🪓 🪵 Handrails at one or more flights of stairs were missing. This is a potential fall hazard. Handrails should be installed at stairs with four or more risers or where stairs are greater than 30 inches high. Recommend that a qualified contractor install handrails where missing and per standard building practices.

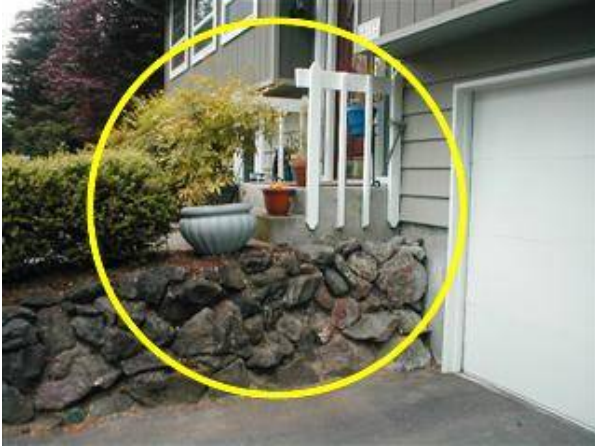
Photo 1

Guardrails at one or more locations with drop-offs higher than 30 inches were missing or had gaps wider than 4". This is a potential fall hazard. At a minimum, the client should be aware of this hazard. If concerned, have a qualified contractor install and/or repair guardrails per standard building practices where walking surfaces are more than 30 inches above the surrounding grade or surfaces below.

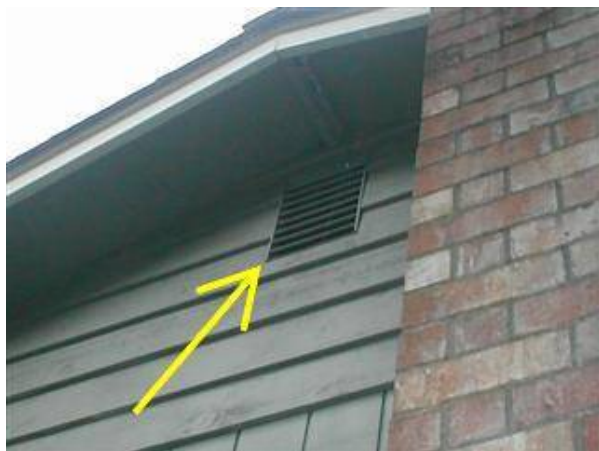
The roof structure had three types of ventilation openings; soffit, gable end, and ridge vents. Standard building practices call for venting to be installed at the lowest and highest points of a roof structure, with equal amounts of venting divided between them. This promotes airflow, drawing cool air in from below and exhausting warm and potentially moist air out through the top. Usually this is done with soffit vents, plus ridge OR gable end vents. When both ridge and gable end vents are installed, then cool air can be drawn in from the gable end vents instead of the soffit vents, leaving stagnant air at the lower sections of the attic or roof structure. Moisture from condensation can accumulate where the stagnant air is, and can be a conducive condition for wood-destroying organisms. Temperatures can also be elevated where the stagnant air is, and result in reduced life of roof surface materials and/or increased cooling costs. Consult with a qualified contractor who has a good understanding of roof ventilation systems, and that repairs be made per standard building practices. In some cases, the gable end vents simply need to be blocked off.

Photo 10  
Gable end vent.

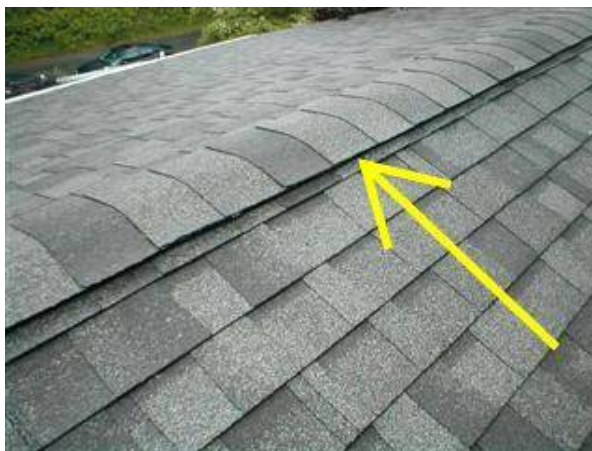
Photo 23  
Continuous ridge vent.

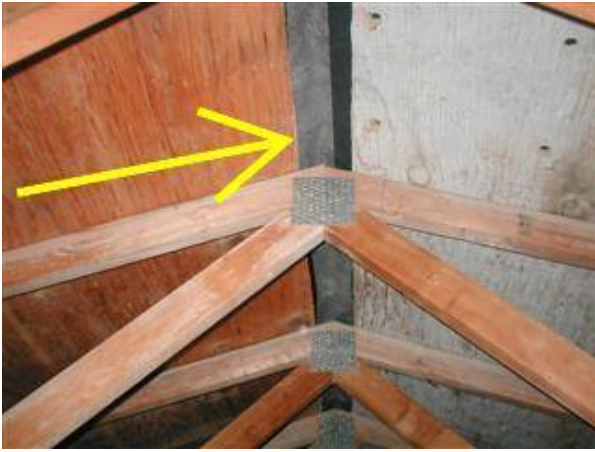
Photo 29  
Slot for continuous ridge vent, viewed from attic.

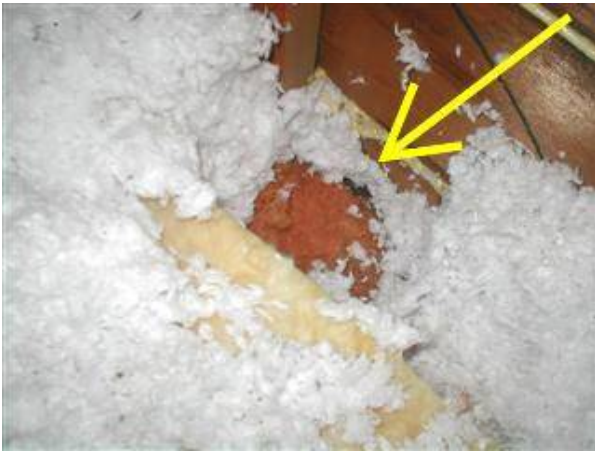
9) **i** The ceiling insulation appeared to be rated at approximately R-30, using loose fill fiberglass over a thin layer of silva wool. Today's standard for this area is R-38. Depending on future heating bills, the client may wish to upgrade to R-38.

Photo 30  
Silva wool insulation below newer loose fill fiberglass insulation in attic.

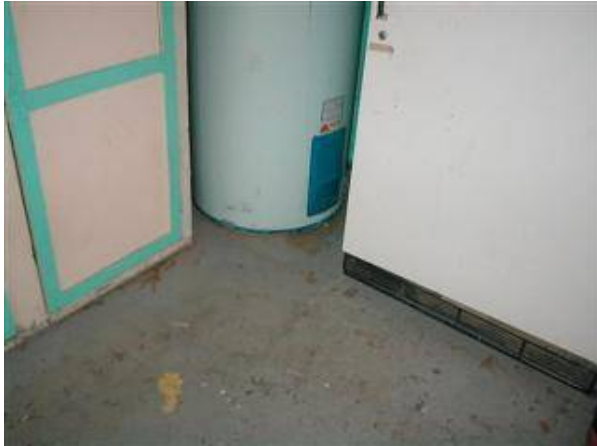
The water heater in the garage was installed so sources of spark were less than 18 inches above the floor. This is a potential fire or explosion hazard. Such appliances should be installed so that open flames or sources of spark are located at least 18 inches above the floor. This minimizes the chance of explosion or fire from fuel vapors from vehicles or storage containers. Recommend that a qualified contractor repair per standard building practices. For example, by installing a pedestal. If the water heater is replaced soon, installing one then would be a convenient time to do it.

Photo 20  
No 18" pedestal for water heater located in garage.

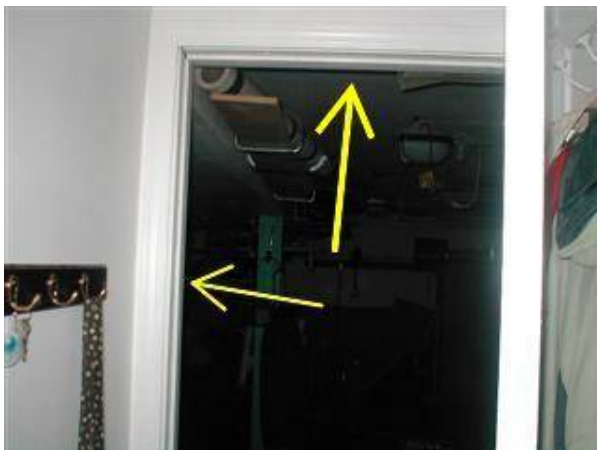
Weatherstripping around or at the base of the door between the garage and the house was missing. House to garage doors should prevent fire and fumes from spreading from the garage to the house. Weatherstripping should form a seal around this door. This is a potential safety hazard. Recommend that a qualified person replace or install weatherstripping as necessary.

Photo 12  
Weatherstrip missing from garage-house door.

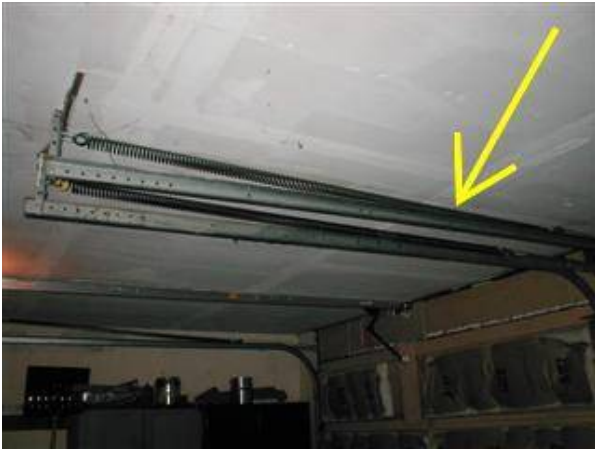
Photo 13

One or more extension springs supporting garage vehicle door springs had no safety containment cables installed. These cables prevent injury to people located nearby when springs eventually break. This is a potential safety hazard. Recommend that a qualified contractor install cables where missing per standard building practices. For more information, visit:

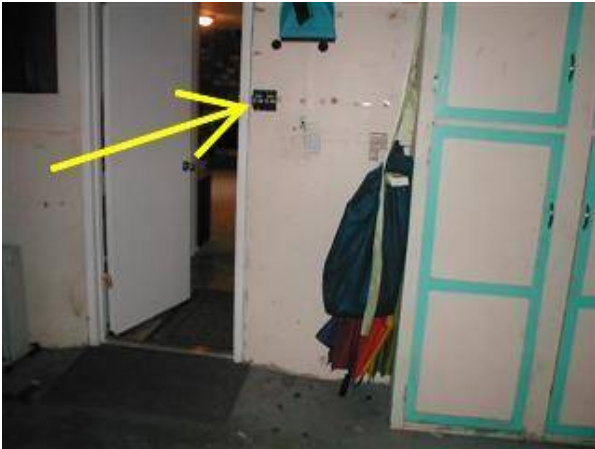
Photo 15

The wall-mounted control for one or more automatic garage vehicle door openers was less than 5 feet off the floor, or within reach of children. This is a safety hazard. Children should not be able to operate automatic garage vehicle door openers. A qualified person should relocate controls for door openers so they are at least 5 feet above floors and/or out of reach of children. For more information on garage door safety issues, visit: <http://www.cpsc.gov/cpscpub/pubs/523.html>

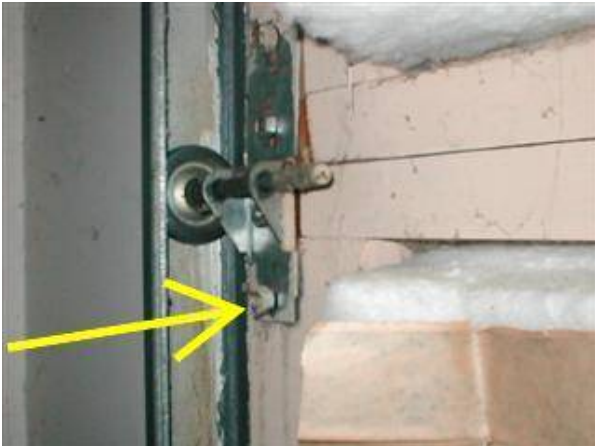
Photo 16

Hardware such as brackets, hangers, rollers and/or fasteners on one or more garage vehicle doors was loose. A qualified person should repair as necessary.

Nuts loose on vehicle door hinges.

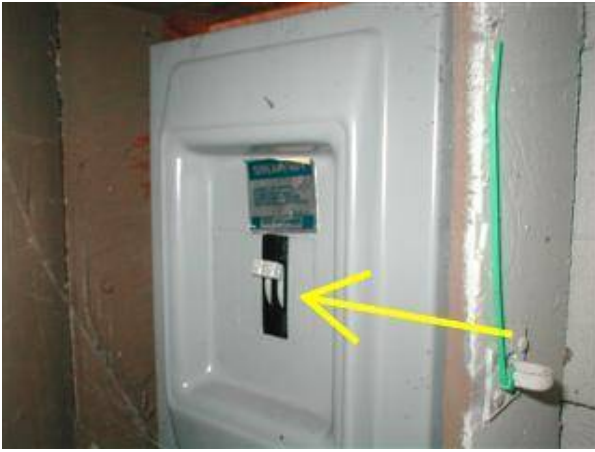
Panel(s) #B had circuit breakers manufactured by the Zinsco company. These circuit breakers have a history of problems including not tripping under normal overload conditions and appearing to be tripped when they're not. This is a potential safety hazard for shock and/or fire. Recommend that a qualified electrician carefully evaluate all panels with Zinsco brand circuit breakers and make repairs as necessary. Consider replacing panels with Zinsco brand circuit breakers with modern panels that offer more flexibility for new, safer protective technologies like arc fault circuit interrupters (AFCIs). For more information, visit:

Photo 4  
Zinsco breakers used at heat pump disconnect panel.

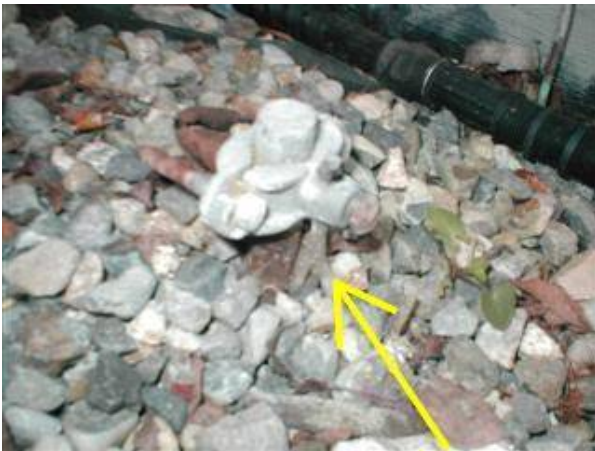
One or more clamps that secure the electric service's grounding electrode conductor(s) to a grounding rod were loose. Grounding may be substandard as a result and may be a safety hazard for shock. Recommend that a qualified electrician repair as necessary. For example, by tightening clamps.

Photo 9  
Loose clamp on ground rod.

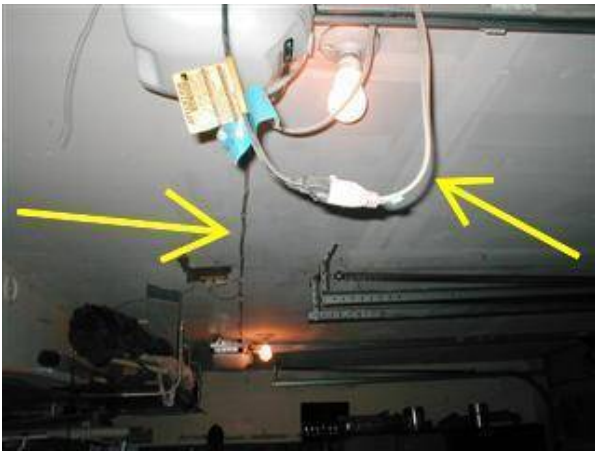
Extension cords were being used as permanent wiring at one or more locations. They should only be used for portable equipment on a temporary basis. Using extension cords as permanent wiring is a potential fire and shock hazard, and indicates that wiring is inadequate and needs updating. Extension cords may be undersized. Connections may not be secure resulting in power fluctuations, damage to equipment, overheating and sparks that could start a fire. Recommend that a qualified electrician repair per standard building practices and eliminate extension cords for permanently installed equipment.

Photo 14  
Extension cords used for vehicle door automatic openers.

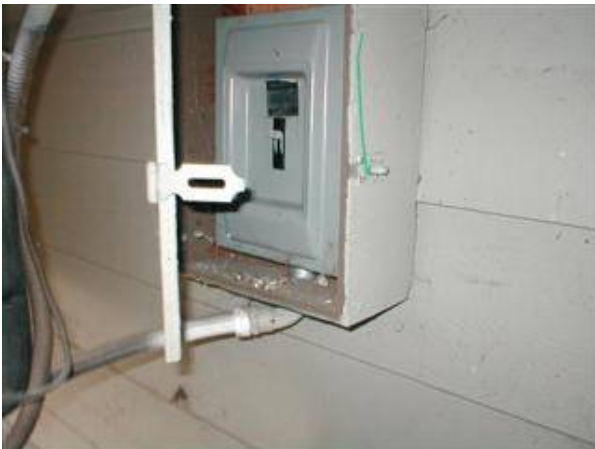
The inspector was unable to open and evaluate panel(s) #B because the wooden enclosure prohibited removal of the screw that secured the cover. These panel(s) are excluded from this inspection. Recommend that repairs, modifications and/or cleanup should be made as necessary so panels can be opened and fully evaluated.

Photo 5  
Wooden enclosure prohibited removal of subpanel cover.

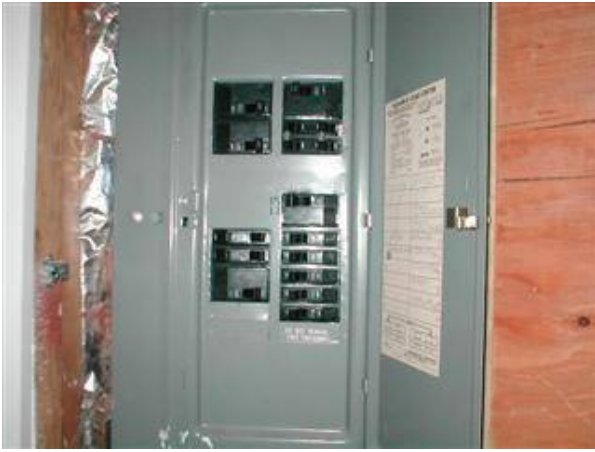
A "split bus" panel was installed as a main service panel. On such panels there is no single main disconnect switch to turn the power off. Instead, all breakers labeled "main" or "sub-main" (usually those on the upper half of the panel) must be turned off to turn all power off. These panels are common, but are no longer installed. The client should familiarize themselves with the operation of this panel and the procedure for turning all the power off in the event of an emergency. Consult with an electrician if necessary. Please see any other comments in this report related to the panel's legend.

Photo 24  
Split bus main service panel.

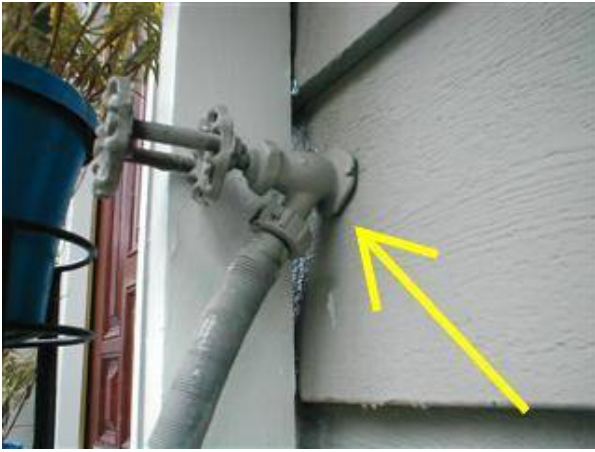
Photo 3

20) 🚰 One or more hose bibs (outside faucets) were missing backflow prevention devices. These devices reduce the likelihood of gray water entering the potable water supply. Recommend installing backflow prevention devices on all hose bibs where missing. They are available at most home improvement stores and are easily installed. For more information, visit:

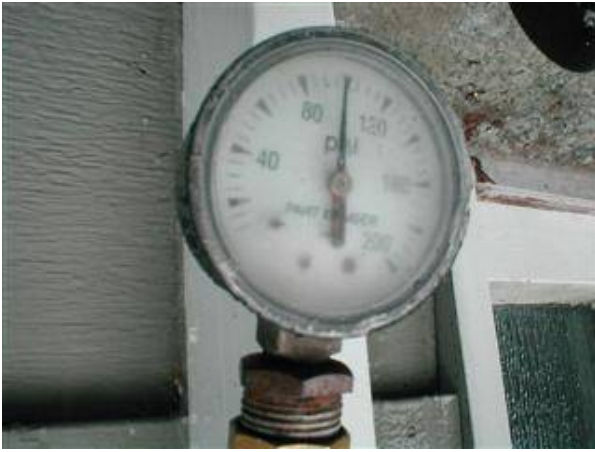
Photo 2

The water supply pressure was greater than 80 pounds per square inch (PSI). Pressures above 80 PSI may void warranties for some appliances such as water heaters or washing machines. Flexible supply lines to washing machines are likely to burst with higher pressures. 40-80 PSI is considered the normal range for water pressure in a home, and most plumbers recommend 50-60 PSI. Typically, the pressure cannot be regulated at the water meter. Recommend that a qualified plumber evaluate and make modifications to reduce the pressure to below 80 PSI. Installing a pressure reducing valve on the main service pipe is a common solution to this problem. If one exists, then it should be adjusted, repaired or replaced as necessary to maintain lower pressures. Note that installing a pressure reducing valve creates a "closed system," which may require installing an expansion tank at the water heater if one is not already installed.

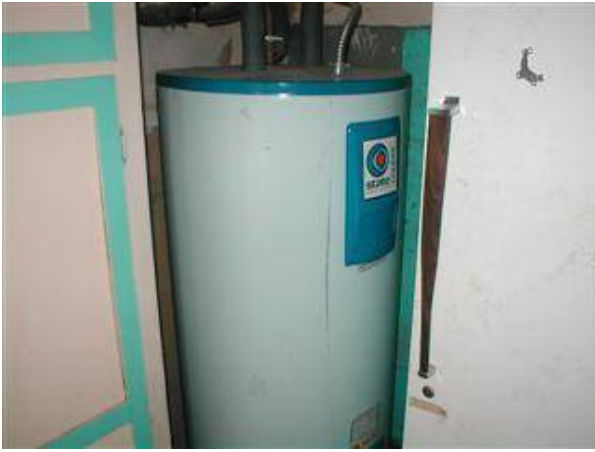
The water heater did not have earthquake straps or struts installed. This is a potential safety hazard in the event of an earthquake due to the risk of the water heater tipping over, gas lines breaking if it's gas-fired, or electric wiring being damaged if powered by electricity. Leaks can also occur in water-supply pipes. Recommend that a qualified person install earthquake straps or struts as necessary and per standard building practices.

Photo 18  
No seismic straps.

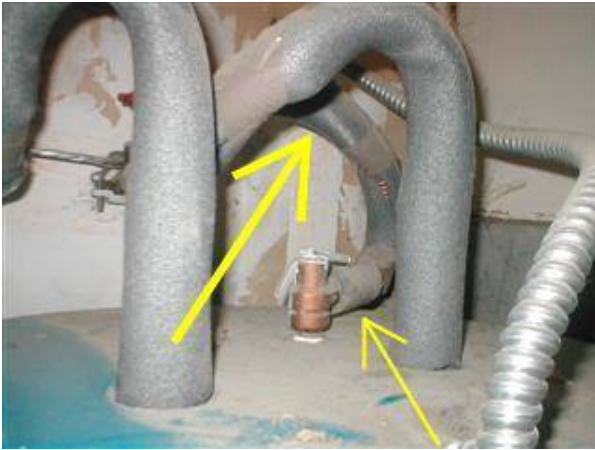
One or more sections of the temperature-pressure relief valve drain line were sloped upwards. This is a potential safety hazard due to the risk of explosion. Water and/or minerals can accumulate in the drain line after periodic discharges and impair the operation of the valve. Also, mineral deposits from accumulated water can accumulate on the valve and impair its operation. A qualified plumber should repair per standard building practices, and so the drain line doesn't slope upwards. For more information, visit:

Photo 17  
T/P valve drain line routed upwards.

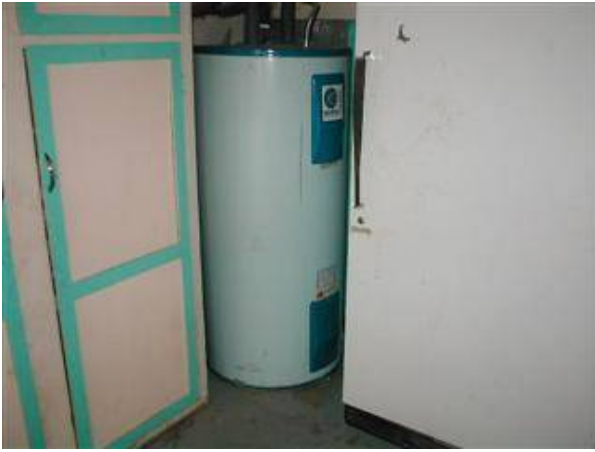
The estimated useful life for most water heaters is 8-12 years. This water heater appeared to be beyond this age and/or its useful lifespan and may need replacing at any time. Recommend budgeting for a replacement in the near future, or considering replacement now before any leaks occur. The client should be aware that significant flooding can occur if the water heater fails. If not replaced now, consider having a qualified person install a catch pan and drain or a water alarm to help prevent damage if water does leak.

Photo 19  
Older water heater.

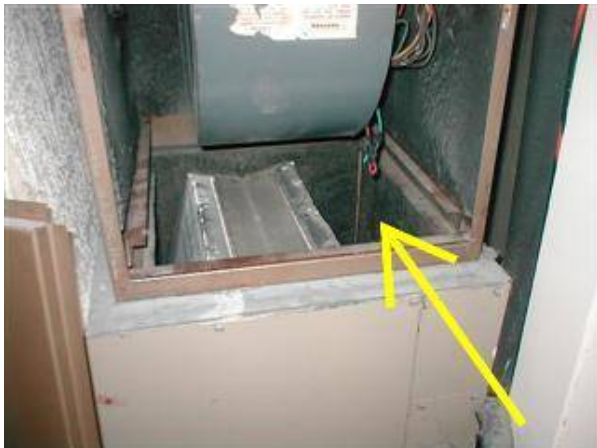
Air filters for the heating and/or cooling system were missing at one or more locations where they should have been installed. Indoor air quality will be reduced as a result. Recommend installing good quality filters at intended locations (e.g. in or at the air handler, behind return air grills). Filters should be sized correctly to minimize

Photo 26  
No filter at base of furnace.

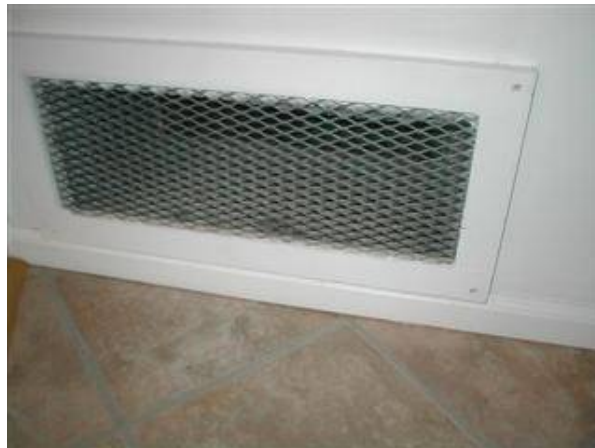
Photo 28  
No filter at downstairs return air grill.

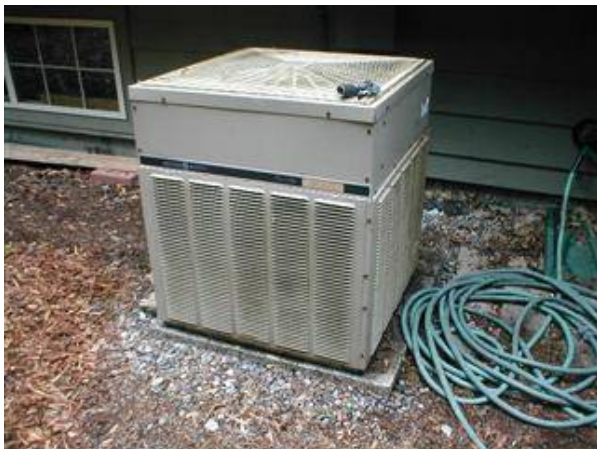
The estimated useful life for most heat pumps and air conditioning condensing units is 10-15 years. The inspector was unable to determine the age of this unit. Be aware that it may be near, at, or beyond its useful life and may need replacing or significant repairs at any time. Recommend attempting to determine the age (ask property owner or service technician), and budgeting for a replacement if necessary.

Photo 6  
Older heat pump.

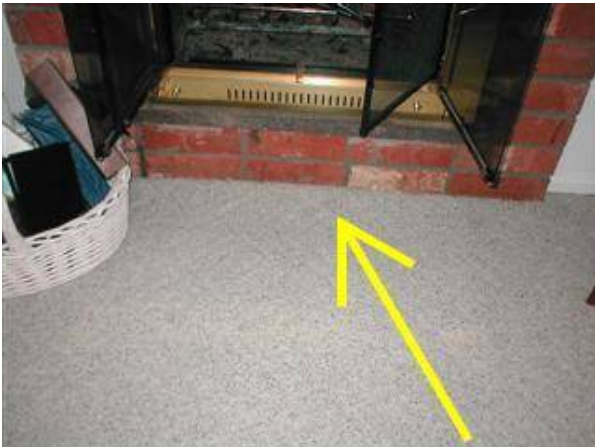
Photo 37

No hearth was installed for the downstairs fireplace. Embers may ignite combustible surfaces nearby. This is a fire hazard. For fireplaces with a firebox less than 6 square feet in size, hearths should be at least 16 inches deep in front and extend at least 8 inches to the sides. For fireboxes more than 6 square feet in size, hearths should be at least 20 inches deep and extend 12 inches to each side. Recommend that a qualified person make repairs or modifications per standard building practices if necessary. For example, by installing a non-flammable hearth pad, or by extending the existing hearth with non-flammable materials.

No hearth at downstairs fireplace.

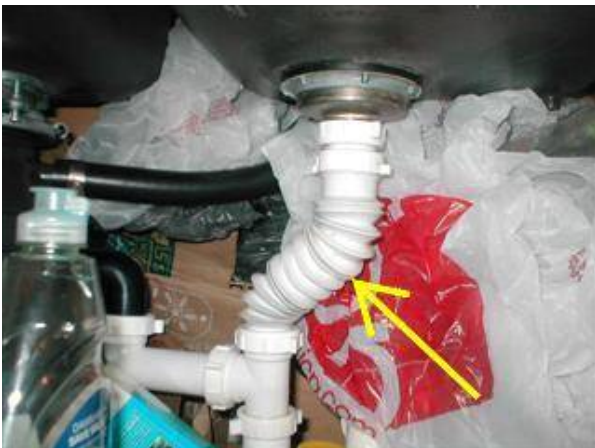
Photo 31

Ribbed, flexible drain pipe was used at the sink. This type of drain pipe accumulates debris more easily than smooth wall pipe and is more likely to clog. Recommend that a qualified plumber replace flexible piping with standard plumbing components (smooth wall pipe) to prevent clogged drains.

Flex pipe used for kitchen sink drain.

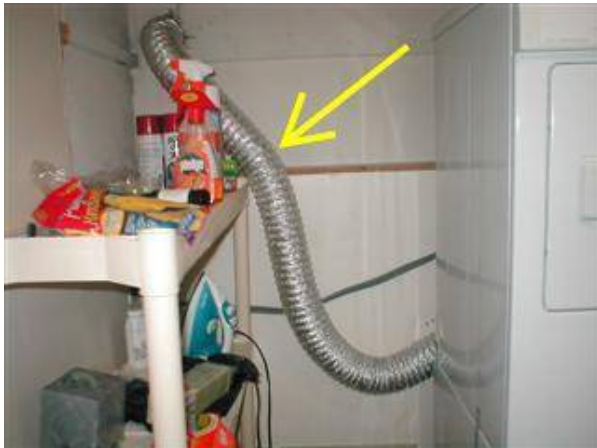
Photo 25

The clothes dryer was equipped with a vinyl or mylar, accordion-type, flexible exhaust duct. The U.S. Consumer Product Safety Commission considers these types of ducts to be unsafe, and a fire hazard. They can trap lint and are susceptible to kinks or crushing, which can greatly reduce the air flow and cause overheating. Recommend that such ducts be replaced with a rigid or corrugated semi-rigid metal duct, and by a qualified contractor if necessary. For more information, visit:

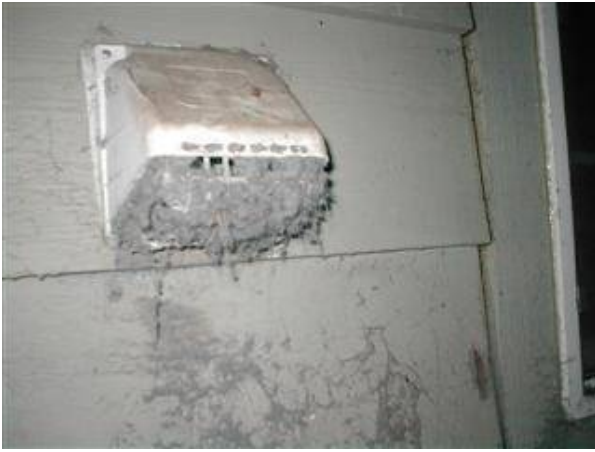
Photo 7

The clothes dryer exhaust duct appeared to need cleaning. Significant amounts of lint build-up were visible and may reduce air flow. This is a fire hazard. Recommend that a qualified person clean this duct now and as necessary in the future. Some chimney sweeps or heating/cooling duct cleaners perform this service. For more information, visit:

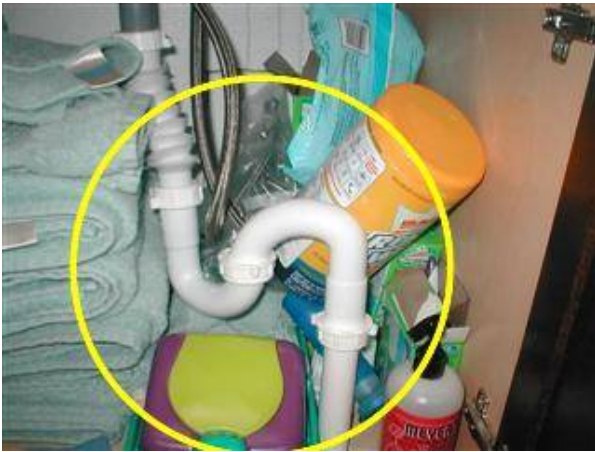
38) 🛠️ The sink drain pipe at location(s) #A used an S-trap rather than a P-trap, or no P-trap was visible. Siphons and sudden flows of water in S-Traps can drain all the water out of the trap, leaving it dry. Sewer gases can then enter living areas. Recommend that a qualified plumber repair per standard building practices.

Photo 36  
S-trap at upstairs bathroom sink drain.

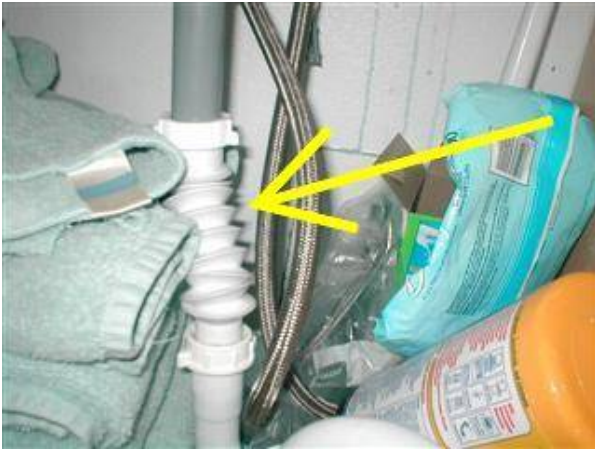
39) 🛠️ Ribbed, flexible drain pipe was used at the sink at location(s) #A. This type of drain pipe accumulates debris more easily than smooth wall pipe and is likely to clog. Recommend that a qualified plumber replace flexible piping with standard plumbing components (smooth wall pipe) to prevent clogged drains.

Photo 35  
Flex pipe used for upstairs bathroom sink drain.

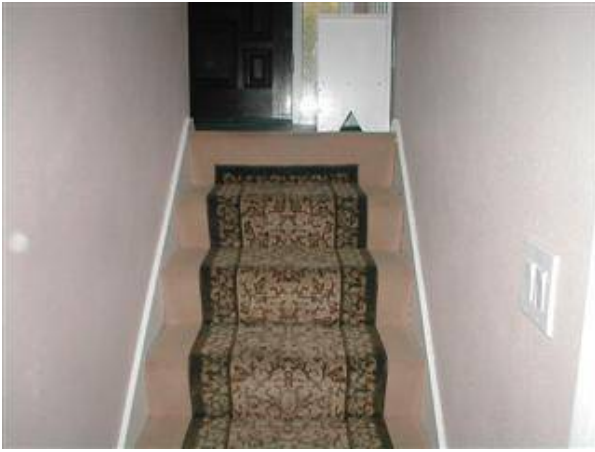
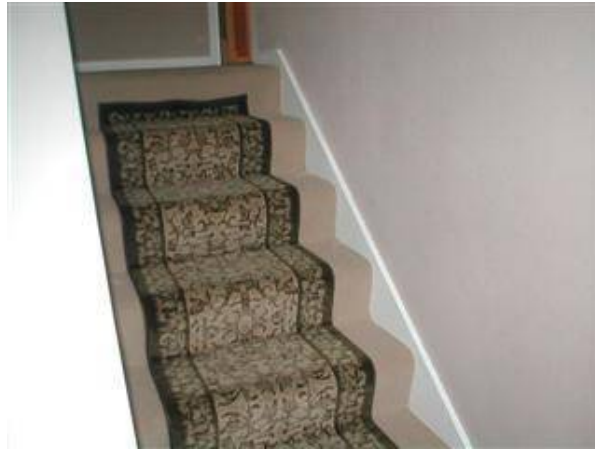
Handrails at one or more flights of stairs were missing. This is a potential fall hazard. Handrails should be installed at stairs with four or more risers or where stairs are greater than 30 inches high. Recommend that a qualified contractor install handrails where missing and per standard building practices.

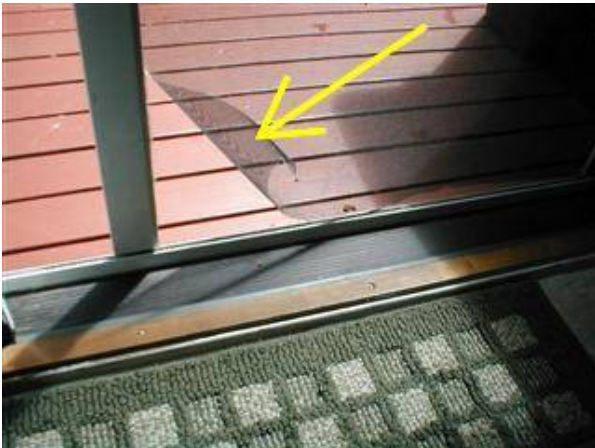
One or more screen doors were damaged, difficult to open or close. Recommend that a qualified person evaluate and repair or replace as necessary.

Photo 32  
Torn screen in kitchen entry door.

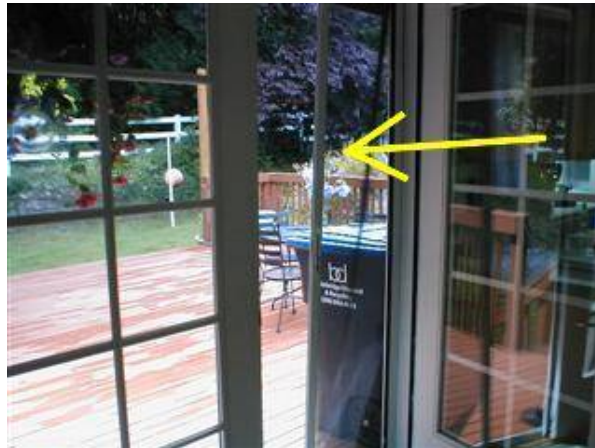
Photo 33  
Screen door at kitchen difficult to open and close.
