All Point Home Inspections

Full General Home Inspection and Structural Pest Inspection WA State Dept. Agriculture ICN#00000000

Property address: **Anytown, USA**

Inspection date: **5/28/2012**

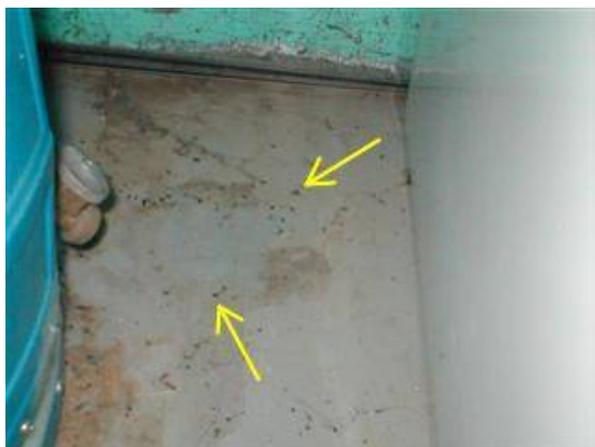
Photo 21

Evidence of rodent infestation was found in the form of feces in the garage. Consult with the property owner about this. A qualified person should make repairs to seal openings in the structure, set traps, and clean rodent waste as necessary. Recommend following guidelines in these Center for Disease Control articles:

Mouse feces in garage by water heater.

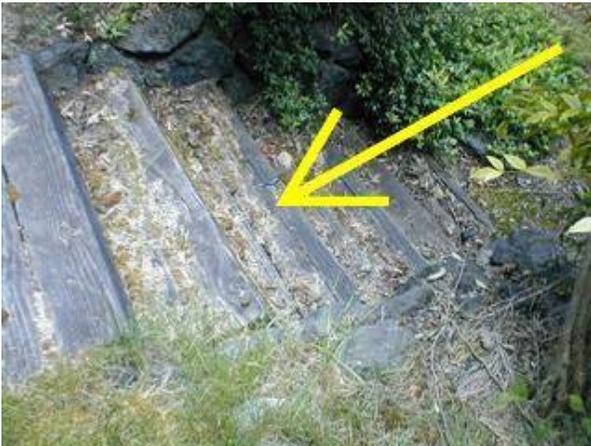
Photo 8

-
- 4) 🚧 🪓 🪵 Stairs built from landscaping timbers were rotten. This is a potential fall hazard. Recommend replacing rotten timbers.

Rotten landscaping timbers used for back yard steps.

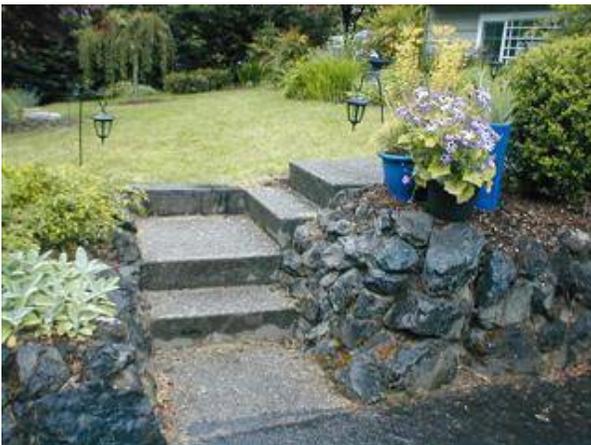
-
- 5) 🚧 🪓 Handrails at one or more flights of stairs were missing. This is a potential fall hazard. Handrails should be installed at stairs with four or more risers or where stairs are greater than 30 inches high. Recommend that a qualified contractor install handrails where missing and per standard building practices.

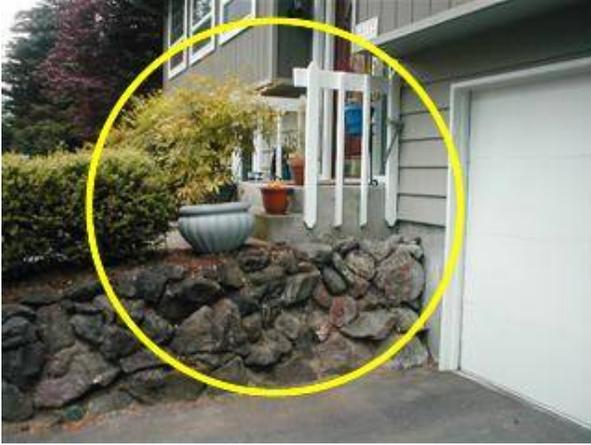
Photo 1

Guardrails at one or more locations with drop-offs higher than 30 inches were missing or had gaps wider than 4". This is a potential fall hazard. At a minimum, the client should be aware of this hazard. If concerned, have a qualified contractor install and/or repair guardrails per standard building practices where walking surfaces are more than 30 inches above the surrounding grade or surfaces below.

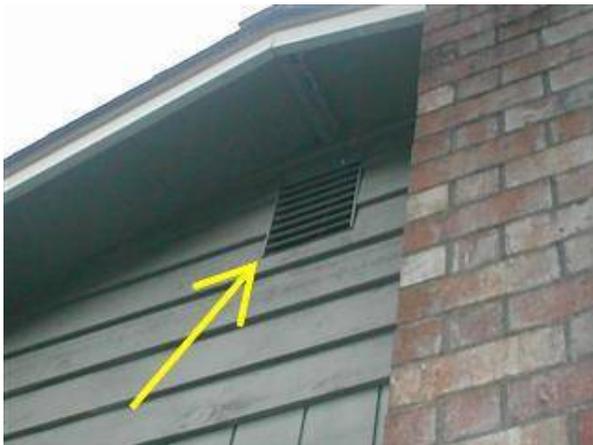
The roof structure had three types of ventilation openings; soffit, gable end, and ridge vents. Standard building practices call for venting to be installed at the lowest and highest points of a roof structure, with equal amounts of venting divided between them. This promotes airflow, drawing cool air in from below and exhausting warm and potentially moist air out through the top. Usually this is done with soffit vents, plus ridge OR gable end vents. When both ridge and gable end vents are installed, then cool air can be drawn in from the gable end vents instead of the soffit vents, leaving stagnant air at the lower sections of the attic or roof structure. Moisture from condensation can accumulate where the stagnant air is, and can be a conducive condition for wood-destroying organisms. Temperatures can also be elevated where the stagnant air is, and result in reduced life of roof surface materials and/or increased cooling costs. Consult with a qualified contractor who has a good understanding of roof ventilation systems, and that repairs be made per standard building practices. In some cases, the gable end vents simply need to be blocked off.

Photo 10
Gable end vent.

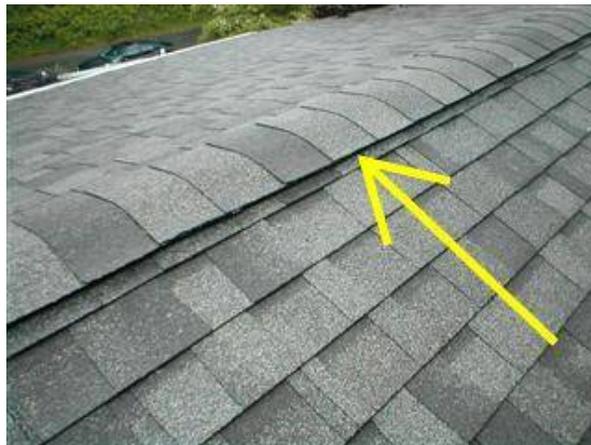
Photo 23
Continuous ridge vent.

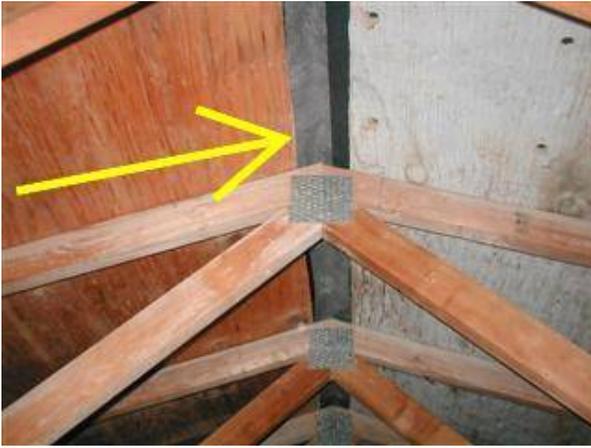
Photo 29
Slot for continuous ridge vent, viewed from attic.

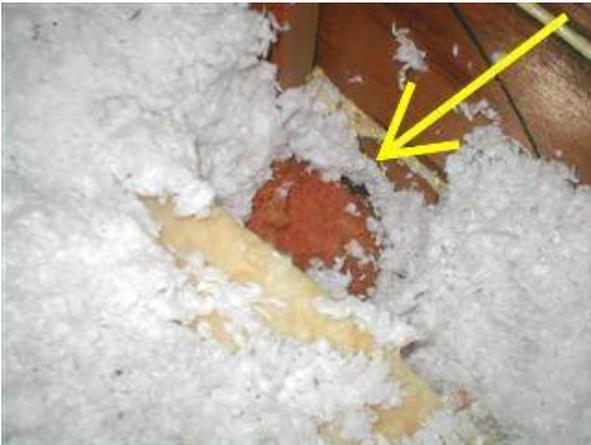
9) **i** The ceiling insulation appeared to be rated at approximately R-30, using loose fill fiberglass over a thin layer of silva wool. Today's standard for this area is R-38. Depending on future heating bills, the client may wish to upgrade to R-38.

Photo 30
Silva wool insulation below newer loose fill fiberglass insulation in attic.

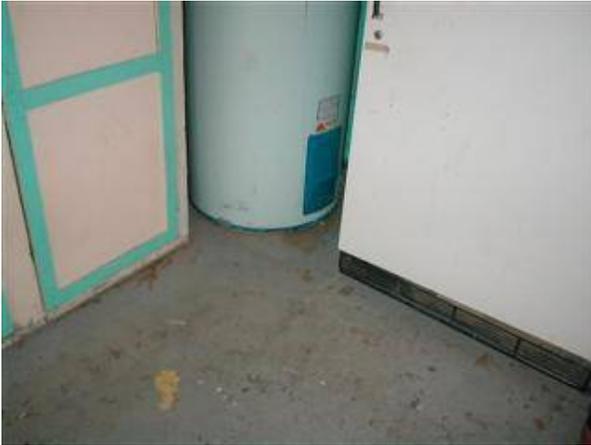
The water heater in the garage was installed so sources of spark were less than 18 inches above the floor. This is a potential fire or explosion hazard. Such appliances should be installed so that open flames or sources of spark are located at least 18 inches above the floor. This minimizes the chance of explosion or fire from fuel vapors from vehicles or storage containers. Recommend that a qualified contractor repair per standard building practices. For example, by installing a pedestal. If the water heater is replaced soon, installing one then would be a convenient time to do it.

Photo 20
No 18" pedestal for water heater located in garage.

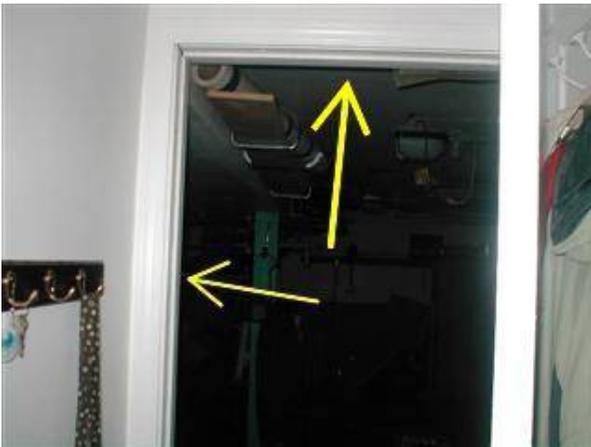
Weatherstripping around or at the base of the door between the garage and the house was missing. House to garage doors should prevent fire and fumes from spreading from the garage to the house. Weatherstripping should form a seal around this door. This is a potential safety hazard. Recommend that a qualified person replace or install weatherstripping as necessary.

Photo 12
Weatherstrip missing from garage-house door.

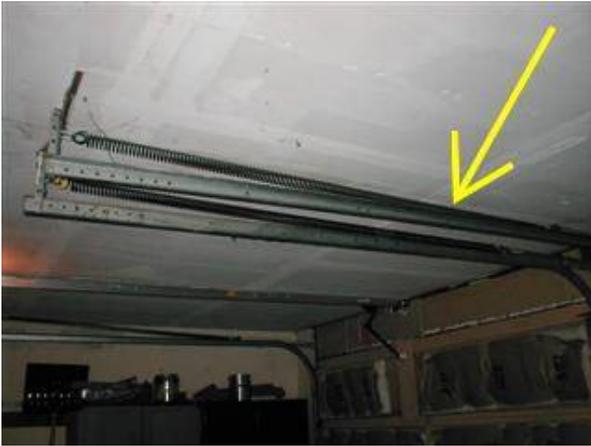
Photo 13

One or more extension springs supporting garage vehicle door springs had no safety containment cables installed. These cables prevent injury to people located nearby when springs eventually break. This is a potential safety hazard. Recommend that a qualified contractor install cables where missing per standard building practices. For more information, visit:

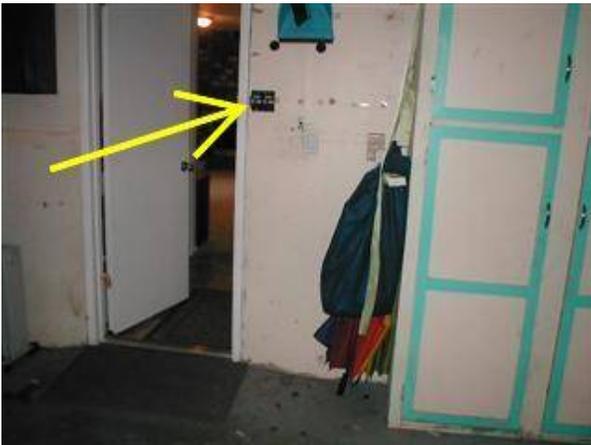
Photo 15

The wall-mounted control for one or more automatic garage vehicle door openers was less than 5 feet off the floor, or within reach of children. This is a safety hazard. Children should not be able to operate automatic garage vehicle door openers. A qualified person should relocate controls for door openers so they are at least 5 feet above floors and/or out of reach of children. For more information on garage door safety issues, visit: <http://www.cpsc.gov/cpscpub/pubs/523.html>

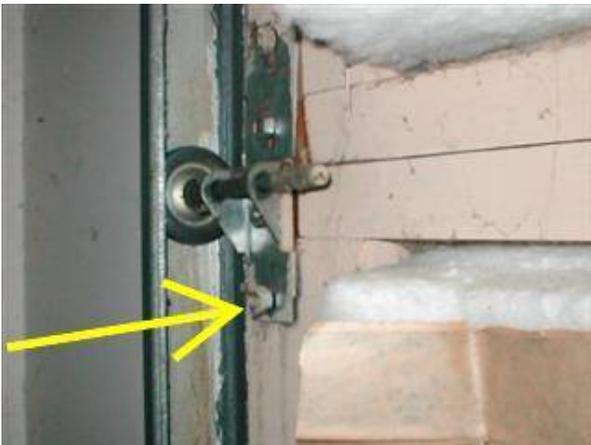
Photo 16

Hardware such as brackets, hangers, rollers and/or fasteners on one or more garage vehicle doors was loose. A qualified person should repair as necessary.

Nuts loose on vehicle door hinges.

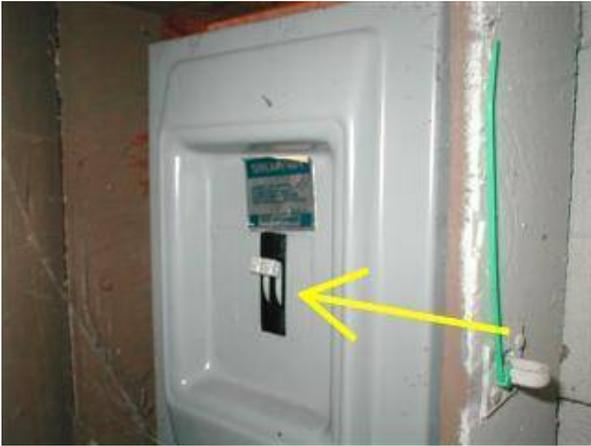
Panel(s) #B had circuit breakers manufactured by the Zinsco company. These circuit breakers have a history of problems including not tripping under normal overload conditions and appearing to be tripped when they're not. This is a potential safety hazard for shock and/or fire. Recommend that a qualified electrician carefully evaluate all panels with Zinsco brand circuit breakers and make repairs as necessary. Consider replacing panels with Zinsco brand circuit breakers with modern panels that offer more flexibility for new, safer protective technologies like arc fault circuit interrupters (AFCIs). For more information, visit:

Photo 4
Zinsco breakers used at heat pump disconnect panel.

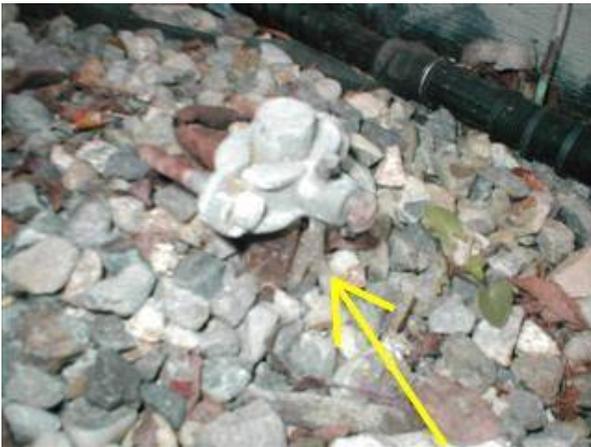
One or more clamps that secure the electric service's grounding electrode conductor(s) to a grounding rod were loose. Grounding may be substandard as a result and may be a safety hazard for shock. Recommend that a qualified electrician repair as necessary. For example, by tightening clamps.

Photo 9
Loose clamp on ground rod.

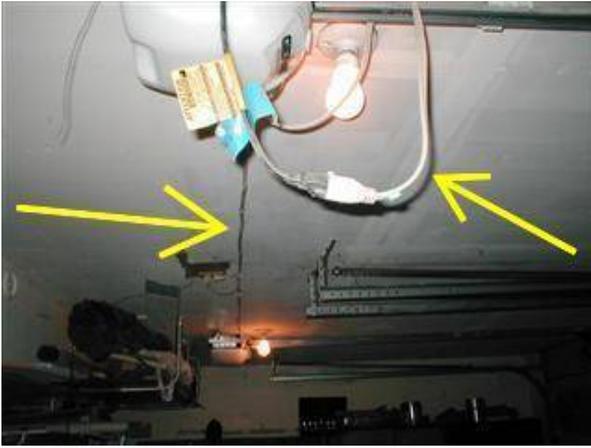
Extension cords were being used as permanent wiring at one or more locations. They should only be used for portable equipment on a temporary basis. Using extension cords as permanent wiring is a potential fire and shock hazard, and indicates that wiring is inadequate and needs updating. Extension cords may be undersized. Connections may not be secure resulting in power fluctuations, damage to equipment, overheating and sparks that could start a fire. Recommend that a qualified electrician repair per standard building practices and eliminate extension cords for permanently installed equipment.

Photo 14
Extension cords used for vehicle door automatic openers.

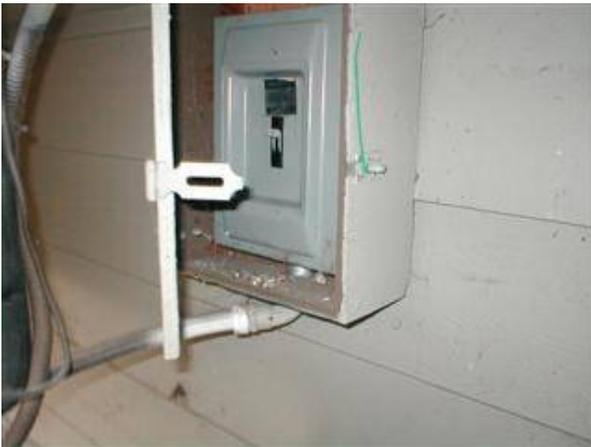
The inspector was unable to open and evaluate panel(s) #B because the wooden enclosure prohibited removal of the screw that secured the cover. These panel(s) are excluded from this inspection. Recommend that repairs, modifications and/or cleanup should be made as necessary so panels can be opened and fully evaluated.

Photo 5
Wooden enclosure prohibited removal of subpanel cover.

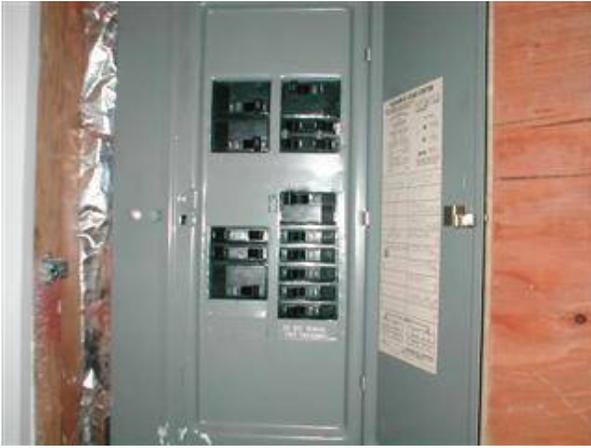
A "split bus" panel was installed as a main service panel. On such panels there is no single main disconnect switch to turn the power off. Instead, all breakers labeled "main" or "sub-main" (usually those on the upper half of the panel) must be turned off to turn all power off. These panels are common, but are no longer installed. The client should familiarize themselves with the operation of this panel and the procedure for turning all the power off in the event of an emergency. Consult with an electrician if necessary. Please see any other comments in this report related to the panel's legend.

Photo 24
Split bus main service panel.

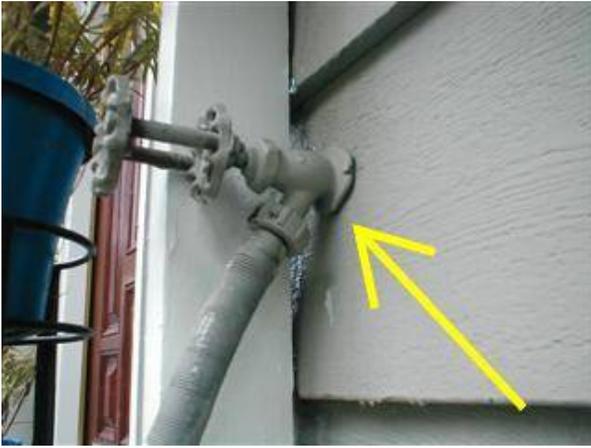
Photo 3

20) 🚰 One or more hose bibs (outside faucets) were missing backflow prevention devices. These devices reduce the likelihood of gray water entering the potable water supply. Recommend installing backflow prevention devices on all hose bibs where missing. They are available at most home improvement stores and are easily installed. For more information, visit:

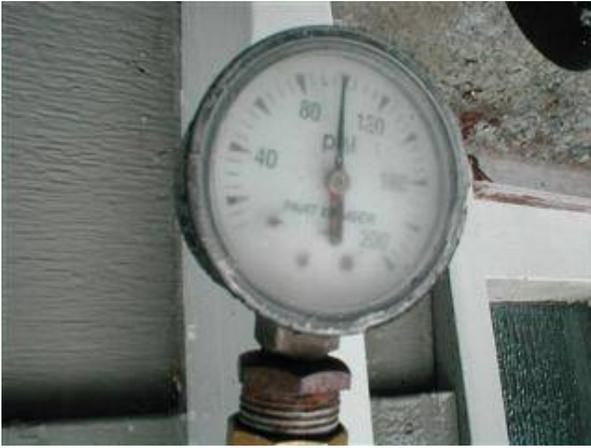
Photo 2

The water supply pressure was greater than 80 pounds per square inch (PSI). Pressures above 80 PSI may void warranties for some appliances such as water heaters or washing machines. Flexible supply lines to washing machines are likely to burst with higher pressures. 40-80 PSI is considered the normal range for water pressure in a home, and most plumbers recommend 50-60 PSI . Typically, the pressure cannot be regulated at the water meter. Recommend that a qualified plumber evaluate and make modifications to reduce the pressure to below 80 PSI . Installing a pressure reducing valve on the main service pipe is a common solution to this problem. If one exists, then it should be adjusted, repaired or replaced as necessary to maintain lower pressures. Note that installing a pressure reducing valve creates a "closed system," which may require installing an expansion tank at the water heater if one is not already installed.

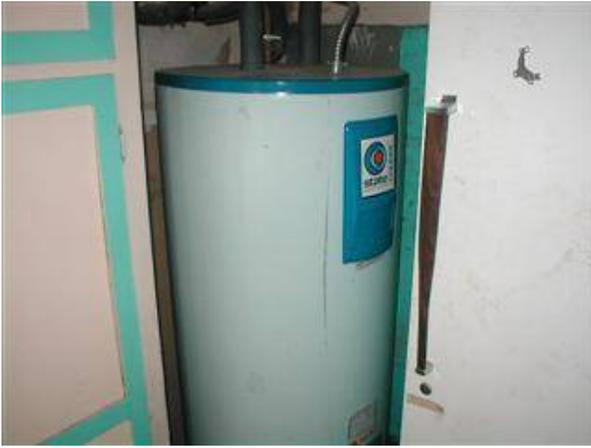
The water heater did not have earthquake straps or struts installed. This is a potential safety hazard in the event of an earthquake due to the risk of the water heater tipping over, gas lines breaking if it's gas-fired, or electric wiring being damaged if powered by electricity. Leaks can also occur in water-supply pipes. Recommend that a qualified person install earthquake straps or struts as necessary and per standard building practices.

Photo 18
No seismic straps.

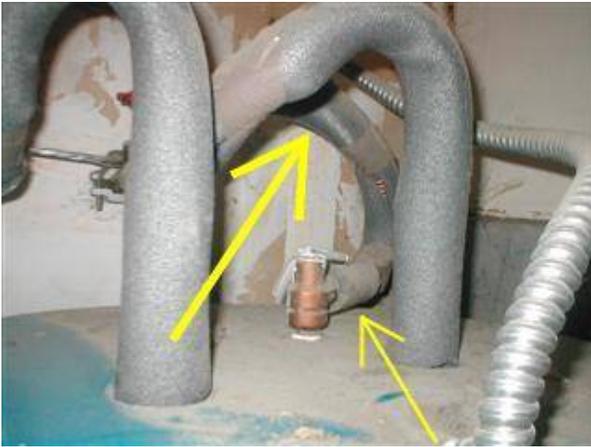
One or more sections of the temperature-pressure relief valve drain line were sloped upwards. This is a potential safety hazard due to the risk of explosion. Water and/or minerals can accumulate in the drain line after periodic discharges and impair the operation of the valve. Also, mineral deposits from accumulated water can accumulate on the valve and impair its operation. A qualified plumber should repair per standard building practices, and so the drain line doesn't slope upwards. For more information, visit:

Photo 17
T/P valve drain line routed upwards.

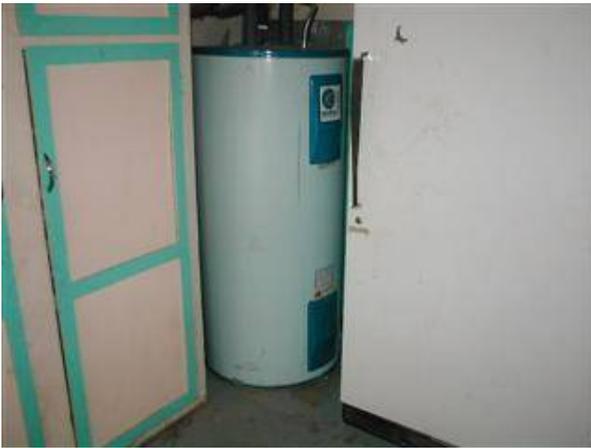
The estimated useful life for most water heaters is 8-12 years. This water heater appeared to be beyond this age and/or its useful lifespan and may need replacing at any time. Recommend budgeting for a replacement in the near future, or considering replacement now before any leaks occur. The client should be aware that significant flooding can occur if the water heater fails. If not replaced now, consider having a qualified person install a catch pan and drain or a water alarm to help prevent damage if water does leak.

Photo 19
Older water heater.

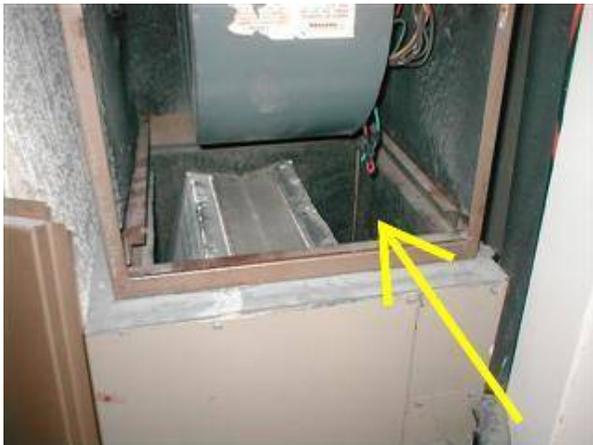
Air filters for the heating and/or cooling system were missing at one or more locations where they should have been installed. Indoor air quality will be reduced as a result. Recommend installing good quality filters at intended locations (e.g. in or at the air handler, behind return air grills). Filters should be sized correctly to minimize

Photo 26
No filter at base of furnace.

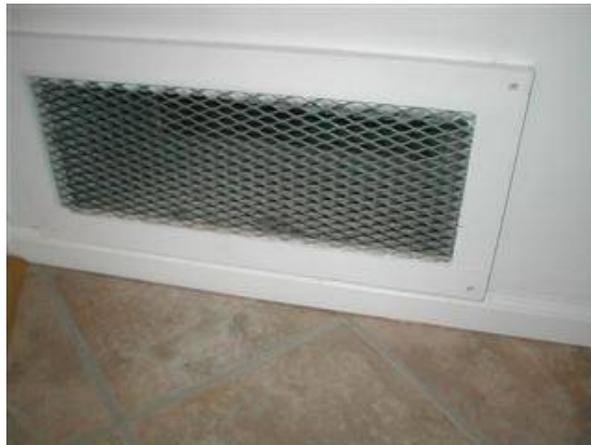
Photo 28
No filter at downstairs return air grill.

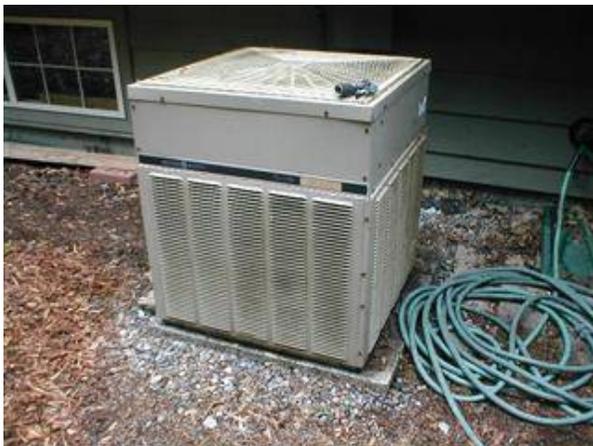
The estimated useful life for most heat pumps and air conditioning condensing units is 10-15 years. The inspector was unable to determine the age of this unit. Be aware that it may be near, at, or beyond its useful life and may need replacing or significant repairs at any time. Recommend attempting to determine the age (ask property owner or service technician), and budgeting for a replacement if necessary.

Photo 6
Older heat pump.

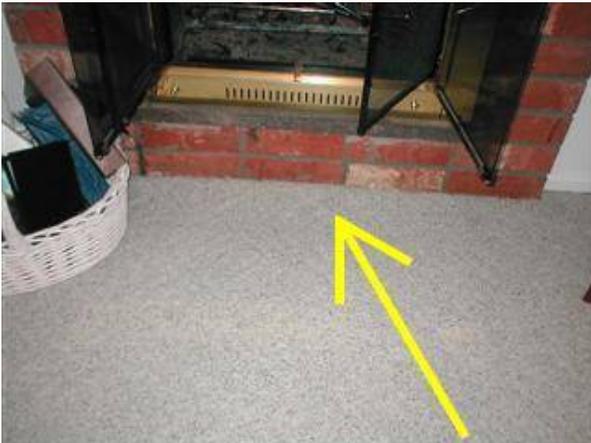
Photo 37

No hearth was installed for the downstairs fireplace. Embers may ignite combustible surfaces nearby. This is a fire hazard. For fireplaces with a firebox less than 6 square feet in size, hearths should be at least 16 inches deep in front and extend at least 8 inches to the sides. For fireboxes more than 6 square feet in size, hearths should be at least 20 inches deep and extend 12 inches to each side. Recommend that a qualified person make repairs or modifications per standard building practices if necessary. For example, by installing a non-flammable hearth pad, or by extending the existing hearth with non-flammable materials.

No hearth at downstairs fireplace.

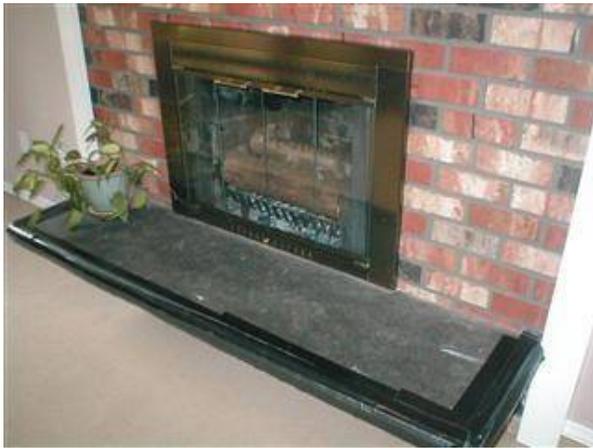
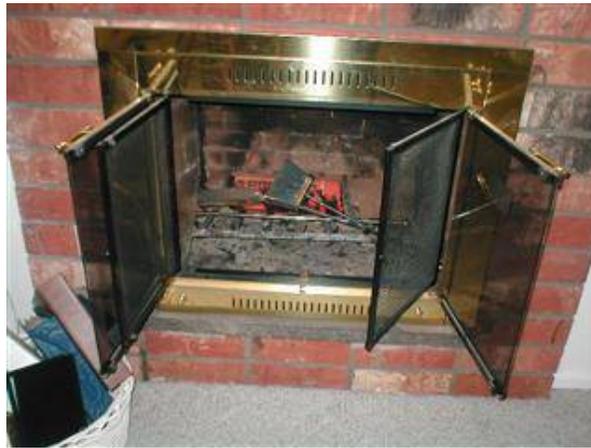
One or more wood-burning fireplaces or stoves were found at the property. When such devices are used, they should be professionally inspected and cleaned annually to prevent creosote build-up and to determine if repairs are needed. The National Fire Protection Association states that a "Level 2" chimney inspection should be performed with every sale or transfer of property with a wood-burning device. Recommend consulting with the property owner about recent and past servicing and repairs to all wood-burning devices and chimneys or flues at this property. Recommend that a qualified specialist evaluate all wood-burning devices and chimneys, and clean and repair as necessary. Note that if a wood stove insert is installed, it may need to be removed for such an evaluation. For more information, search for "chimney inspection" at:

Photo 34
Upstairs fireplace.

Photo 38
Downstairs fireplace.

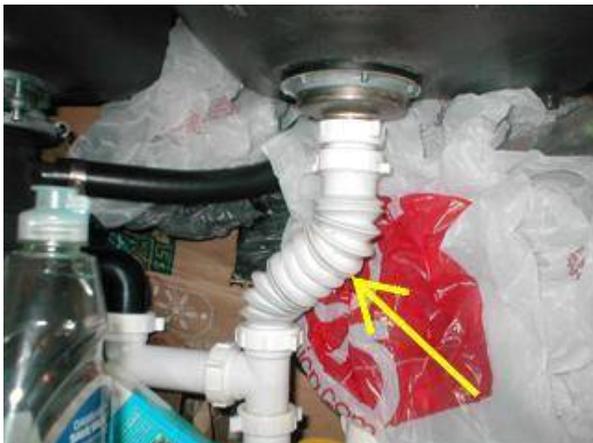
Photo 31

Ribbed, flexible drain pipe was used at the sink. This type of drain pipe accumulates debris more easily than smooth wall pipe and is more likely to clog. Recommend that a qualified plumber replace flexible piping with standard plumbing components (smooth wall pipe) to prevent clogged drains.

Flex pipe used for kitchen sink drain.

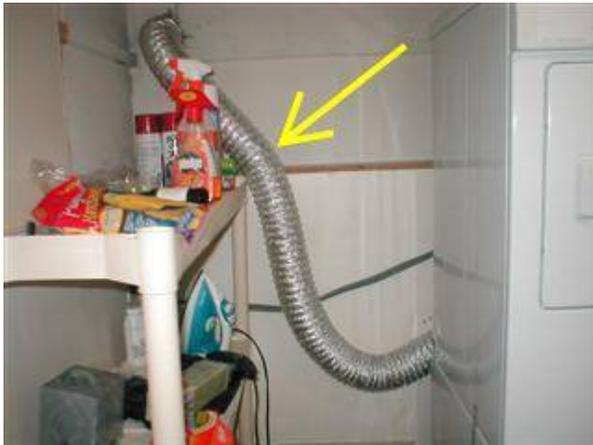
Photo 25

The clothes dryer was equipped with a vinyl or mylar, accordion-type, flexible exhaust duct. The U.S. Consumer Product Safety Commission considers these types of ducts to be unsafe, and a fire hazard. They can trap lint and are susceptible to kinks or crushing, which can greatly reduce the air flow and cause overheating. Recommend that such ducts be replaced with a rigid or corrugated semi-rigid metal duct, and by a qualified contractor if necessary. For more information, visit:

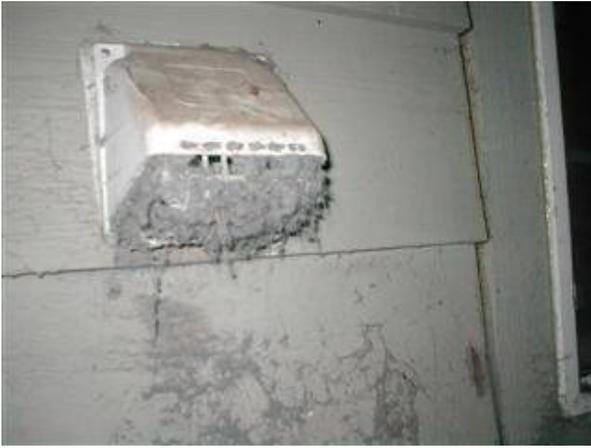
Photo 7

The clothes dryer exhaust duct appeared to need cleaning. Significant amounts of lint build-up were visible and may reduce air flow. This is a fire hazard. Recommend that a qualified person clean this duct now and as necessary in the future. Some chimney sweeps or heating/cooling duct cleaners perform this service. For more information, visit:

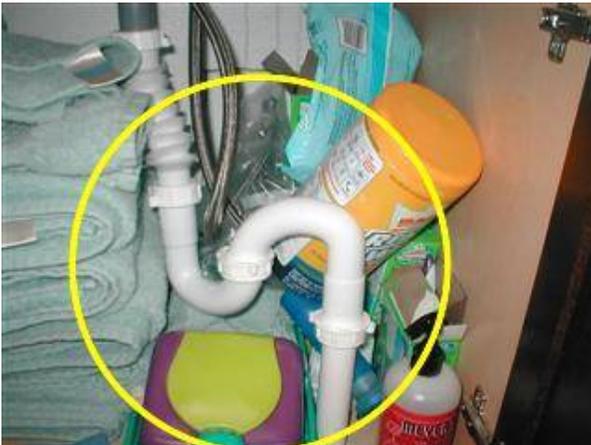
38) 🛠️ The sink drain pipe at location(s) #A used an S-trap rather than a P-trap, or no P-trap was visible. Siphons and sudden flows of water in S-Traps can drain all the water out of the trap, leaving it dry. Sewer gases can then enter living areas. Recommend that a qualified plumber repair per standard building practices.

Photo 36
S-trap at upstairs bathroom sink drain.

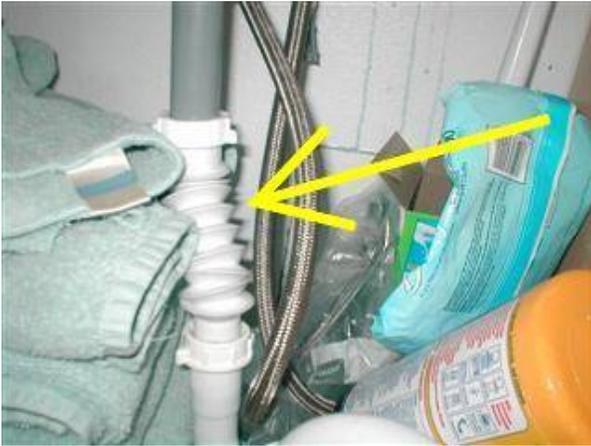
39) 🛠️ Ribbed, flexible drain pipe was used at the sink at location(s) #A. This type of drain pipe accumulates debris more easily than smooth wall pipe and is likely to clog. Recommend that a qualified plumber replace flexible piping with standard plumbing components (smooth wall pipe) to prevent clogged drains.

Photo 35
Flex pipe used for upstairs bathroom sink drain.

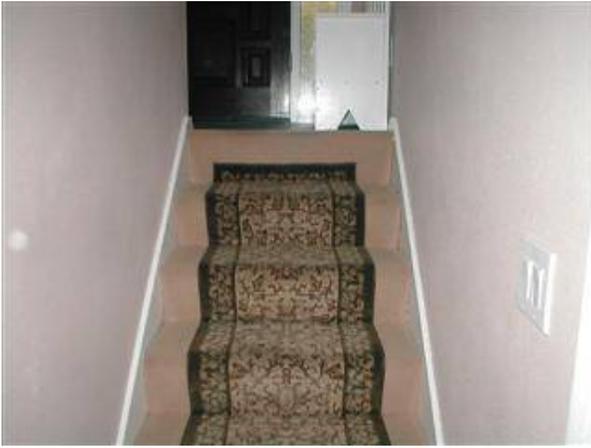
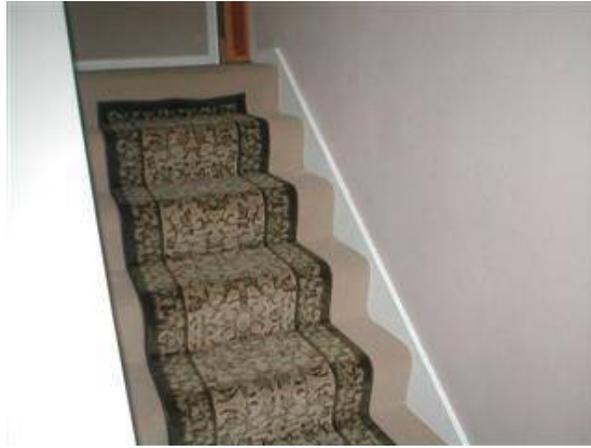
Handrails at one or more flights of stairs were missing. This is a potential fall hazard. Handrails should be installed at stairs with four or more risers or where stairs are greater than 30 inches high. Recommend that a qualified contractor install handrails where missing and per standard building practices.

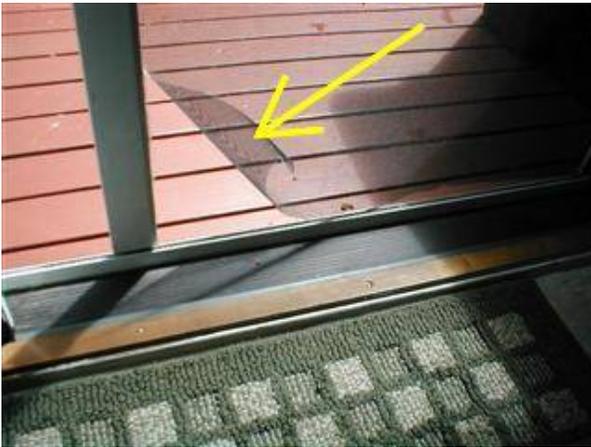
One or more screen doors were damaged, difficult to open or close. Recommend that a qualified person evaluate and repair or replace as necessary.

Photo 32
Torn screen in kitchen entry door.

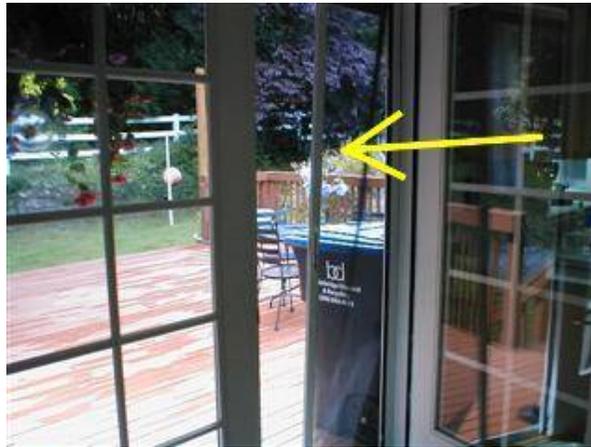
Photo 33
Screen door at kitchen difficult to open and close.
