# All Point Home Inspections

## Full General Home Inspection and Structural Pest Inspection WA State Dept. Agriculture ICN#00000000

Property address: **Anytown, USA**

Inspection date: **5/28/2012**

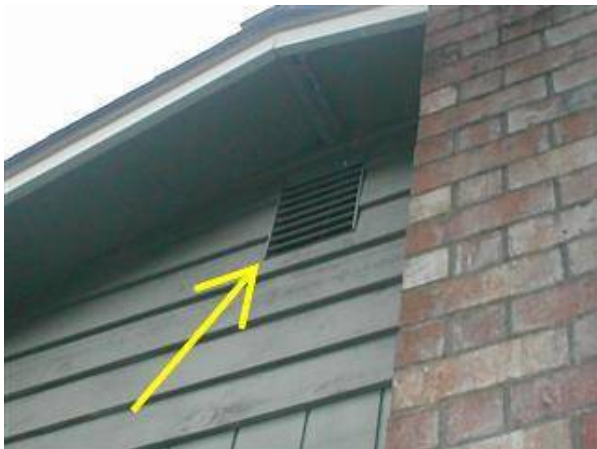
The roof structure had three types of ventilation openings; soffit, gable end, and ridge vents. Standard building practices call for venting to be installed at the lowest and highest points of a roof structure, with equal amounts of venting divided between them. This promotes airflow, drawing cool air in from below and exhausting warm and potentially moist air out through the top. Usually this is done with soffit vents, plus ridge OR gable end vents. When both ridge and gable end vents are installed, then cool air can be drawn in from the gable end vents instead of the soffit vents, leaving stagnant air at the lower sections of the attic or roof structure. Moisture from condensation can accumulate where the stagnant air is, and can be a conducive condition for wood-destroying organisms. Temperatures can also be elevated where the stagnant air is, and result in reduced life of roof surface materials and/or increased cooling costs. Consult with a qualified contractor who has a good understanding of roof ventilation systems, and that repairs be made per standard building practices. In some cases, the gable end vents simply need to be blocked off.

Photo 10  
Gable end vent.

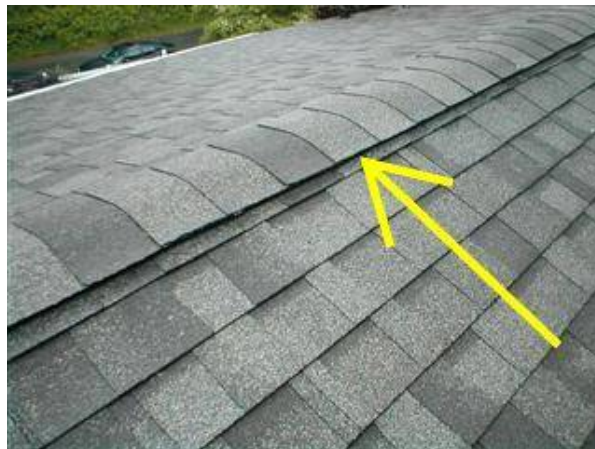
Photo 23  
Continuous ridge vent.

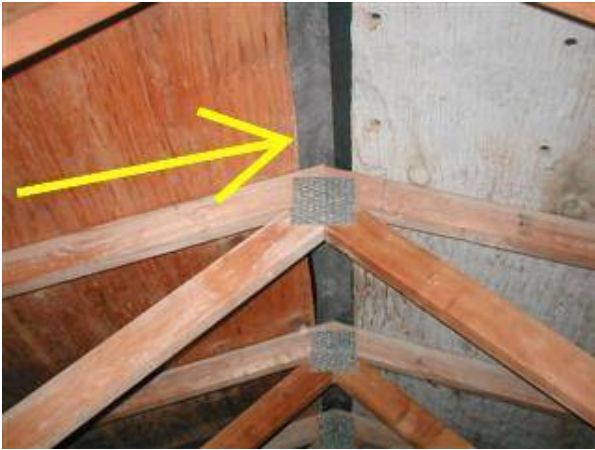
Photo 29  
Slot for continuous ridge vent, viewed from  
attic.

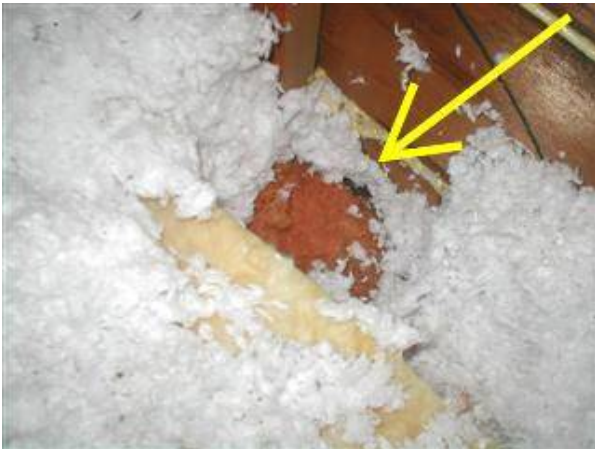
9) **i** The ceiling insulation appeared to be rated at approximately R-30, using loose fill fiberglass over a thin layer of silva wool. Today's standard for this area is R-38. Depending on future heating bills, the client may wish to upgrade to R-38.

Photo 30  
Silva wool insulation below newer loose fill  
fiberglass insulation in attic.

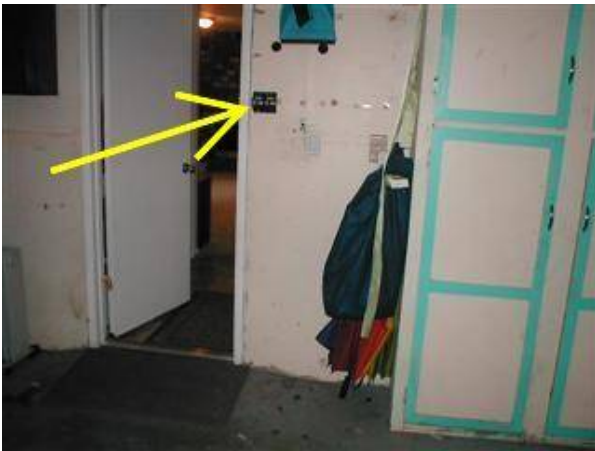
Photo 15

The wall-mounted control for one or more automatic garage vehicle door openers was less than 5 feet off the floor, or within reach of children. This is a safety hazard. Children should not be able to operate automatic garage vehicle door openers. A qualified person should relocate controls for door openers so they are at least 5 feet above floors and/or out of reach of children. For more information on garage door safety issues, visit: <http://www.cpsc.gov/cpscpub/pubs/523.html>

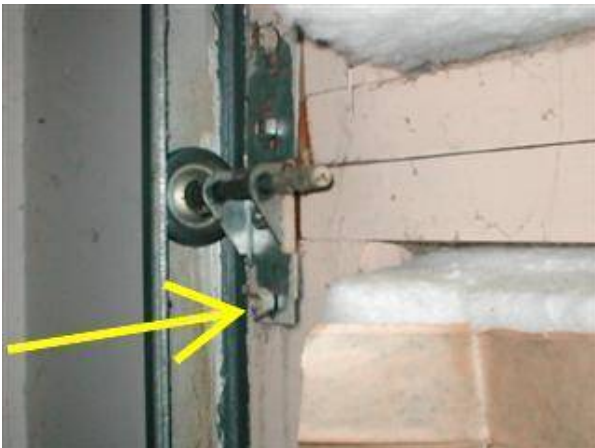
Photo 16

Hardware such as brackets, hangers, rollers and/or fasteners on one or more garage vehicle doors was loose. A qualified person should repair as necessary.

Nuts loose on vehicle door hinges.

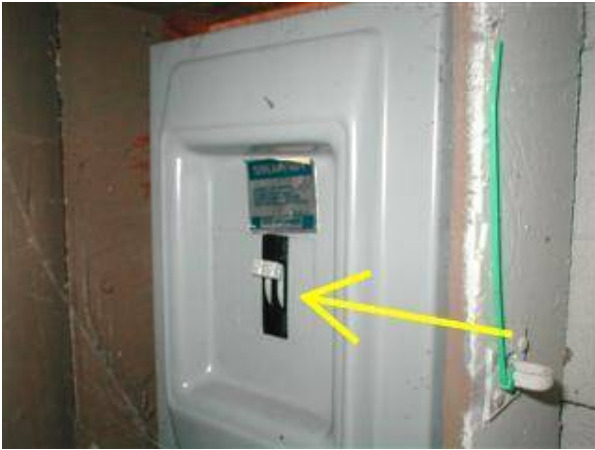
Panel(s) #B had circuit breakers manufactured by the Zinsco company. These circuit breakers have a history of problems including not tripping under normal overload conditions and appearing to be tripped when they're not. This is a potential safety hazard for shock and/or fire. Recommend that a qualified electrician carefully evaluate all panels with Zinsco brand circuit breakers and make repairs as necessary. Consider replacing panels with Zinsco brand circuit breakers with modern panels that offer more flexibility for new, safer protective technologies like arc fault circuit interrupters (AFCIs). For more information, visit:

Photo 4  
Zinsco breakers used at heat pump disconnect panel.

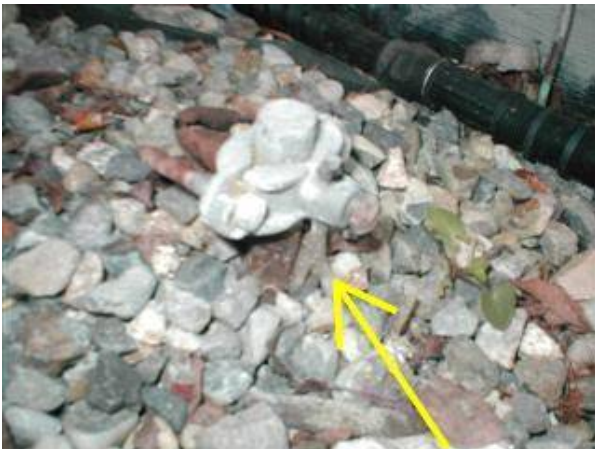
One or more clamps that secure the electric service's grounding electrode conductor(s) to a grounding rod were loose. Grounding may be substandard as a result and may be a safety hazard for shock. Recommend that a qualified electrician repair as necessary. For example, by tightening clamps.

Photo 9  
Loose clamp on ground rod.

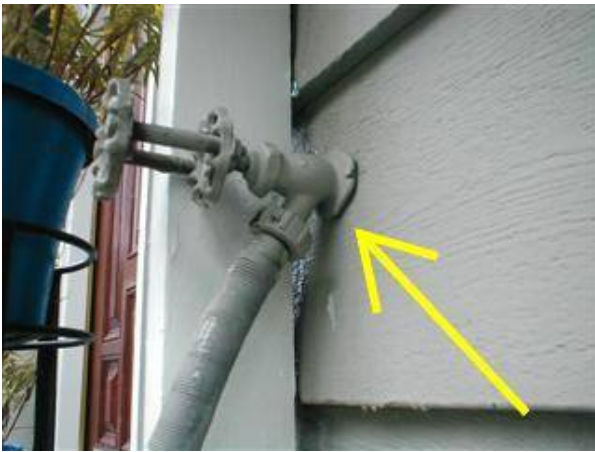
Photo 3

20) 🚰 🛠️ One or more hose bibs (outside faucets) were missing backflow prevention devices. These devices reduce the likelihood of gray water entering the potable water supply. Recommend installing backflow prevention devices on all hose bibs where missing. They are available at most home improvement stores and are easily installed. For more information, visit:

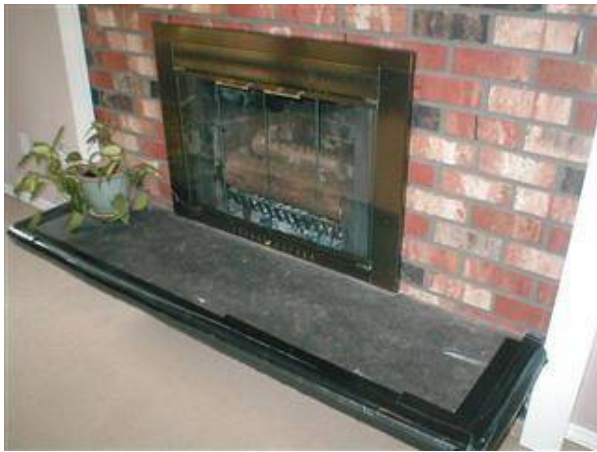
One or more wood-burning fireplaces or stoves were found at the property. When such devices are used, they should be professionally inspected and cleaned annually to prevent creosote build-up and to determine if repairs are needed. The National Fire Protection Association states that a "Level 2" chimney inspection should be performed with every sale or transfer of property with a wood-burning device. Recommend consulting with the property owner about recent and past servicing and repairs to all wood-burning devices and chimneys or flues at this property. Recommend that a qualified specialist evaluate all wood-burning devices and chimneys, and clean and repair as necessary. Note that if a wood stove insert is installed, it may need to be removed for such an evaluation. For more information, search for "chimney inspection" at:

Photo 34  
Upstairs fireplace.

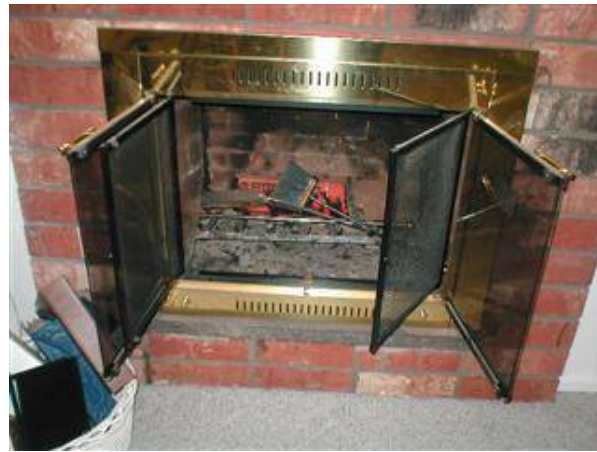
Photo 38  
Downstairs fireplace.

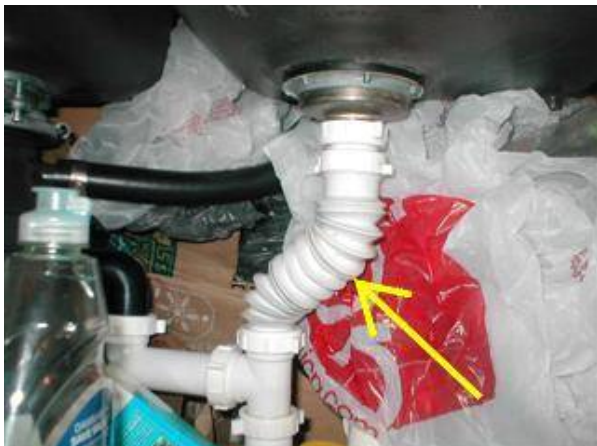
Photo 31

Ribbed, flexible drain pipe was used at the sink. This type of drain pipe accumulates debris more easily than smooth wall pipe and is more likely to clog. Recommend that a qualified plumber replace flexible piping with standard plumbing components (smooth wall pipe) to prevent clogged drains.

Flex pipe used for kitchen sink drain.
