All Point Home Inspections

Full General Home Inspection and Structural Pest Inspection WA State Dept. Agriculture ICN# 00000000

Property address: **Anytown, USA**

Inspection date: **3/29/2012**

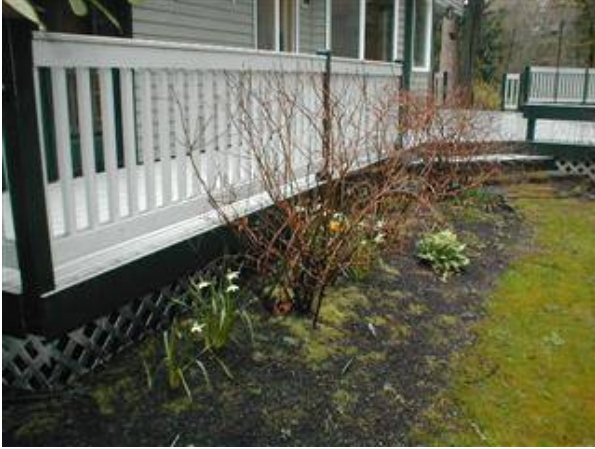
Photo 4

Most areas of the deck substructure were inaccessible due to limited space below, permanently installed

skirting. These areas couldn't be evaluated and are excluded from the inspection.

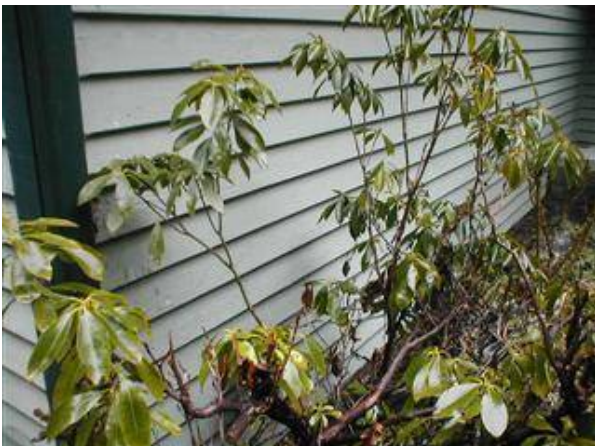
Photo 1

Vegetation such as trees, shrubs and/or vines was in contact with or close to the building exterior. Vegetation can serve as a pathway for wood-destroying insects and can retain moisture against the exterior after it rains. This is a conducive condition for wood-destroying organisms. Recommend pruning, moving or removing vegetation as necessary to maintain at least 6 inches of space between it and the building exterior. A 1-foot clearance is better.

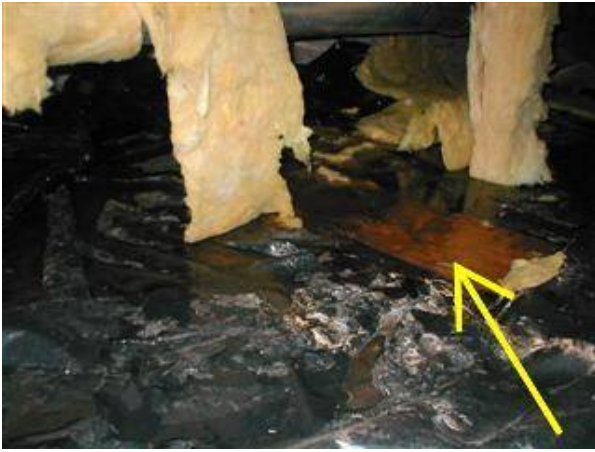
Standing water was found at one or more locations in the crawl space. Water from crawl spaces can evaporate and enter the structure above causing high levels of moisture in the structure. This is a conducive condition for wood-destroying organisms. While a minor amount of seasonal water is commonly found in crawl spaces, significant amounts should not be present.

Photo 54
Standing water in crawl space.

Rain runoff is the most common cause of wet crawl spaces, but water can come from other sources such as groundwater or underground springs. Recommend that a qualified person correct any issues related to outside perimeter grading and/or roof drainage (see any other comments about this in this report). If standing water persists, then recommend that a qualified contractor who specializes in drainage issues evaluate and repair as necessary. Typically such repairs include:

- Repairing, installing or improving underground footing and/or curtain drains
- Applying waterproof coatings to foundation walls
- Digging trenches in the crawl space to collect or divert water
- Installing sump pumps

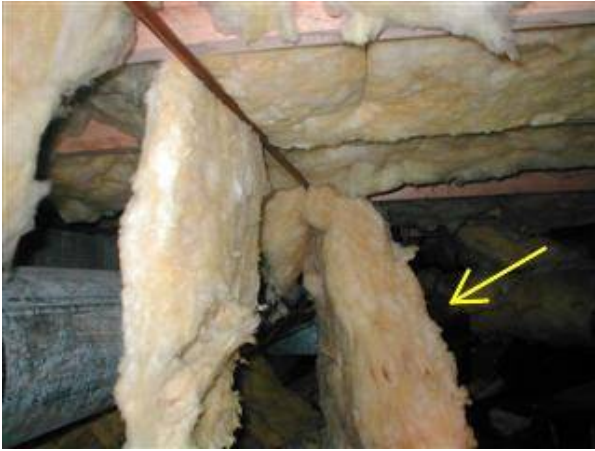
Some sections of under-floor insulation above the crawl space have fallen down, were damaged or deteriorated. This may result in reduced energy efficiency. Recommend that a qualified person install or replace insulation as necessary.

Photo 56
Fallen down under-floor insulation in crawl space.

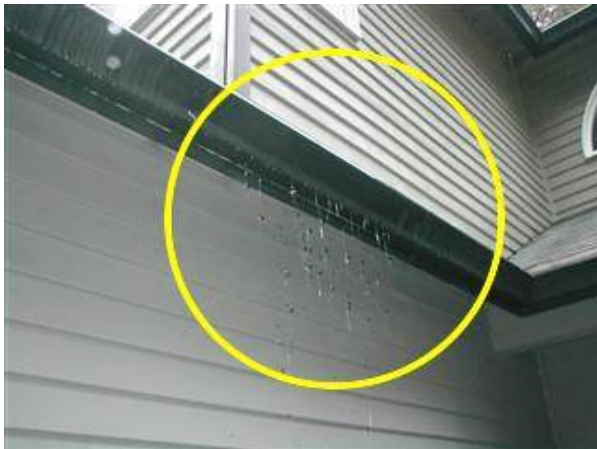
7) 🛠️💧 Significant amounts of debris have accumulated in one or more gutters. Gutters can overflow and cause water to come in contact with the building exterior or water can accumulate around the foundation. This is a conducive condition for wood-destroying organisms. Recommend cleaning gutters now and as necessary in the future.

Photo 2
Overflowing gutters.

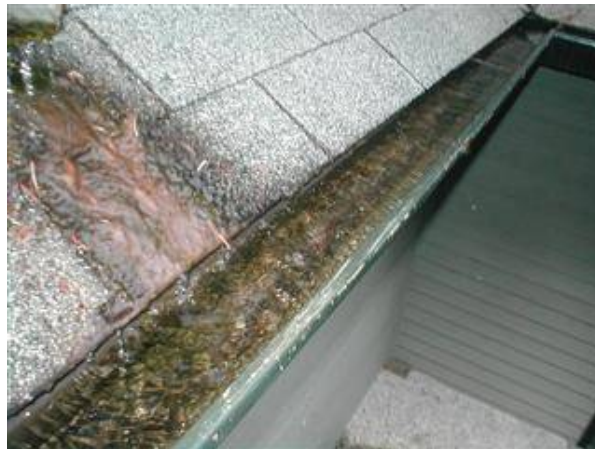
Photo 5
Overflowing gutter.

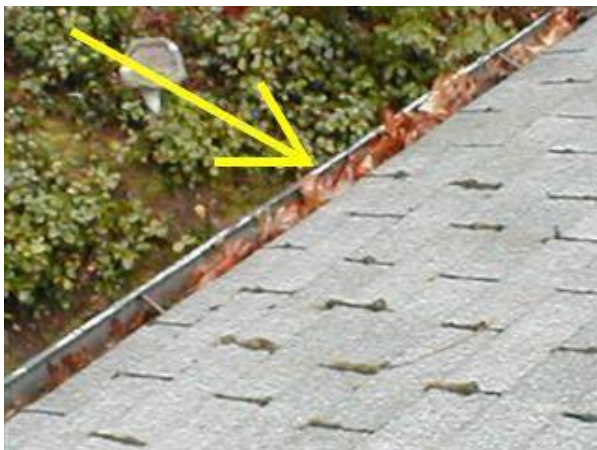
Photo 8
Debris in gutters.

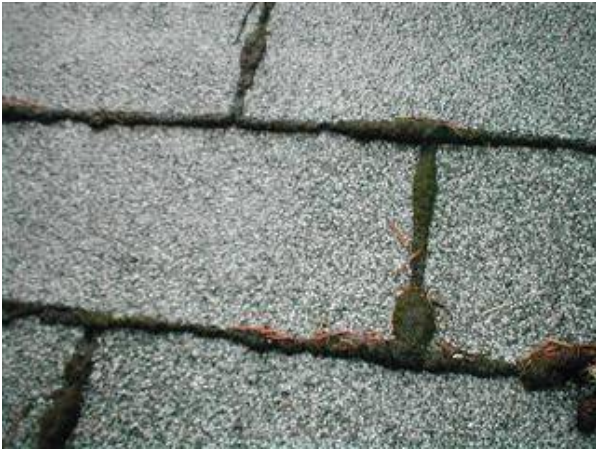
Photo 6

8) 🛠️ Moss was growing on the roof. As a result, shingles can lift or be damaged. Leaks can result and/or the roof surface can fail prematurely. Efforts should be made to kill the moss during its growing season (wet months). Typically, zinc or phosphate-based chemicals are used for this and must be applied periodically. For information on various moss treatment products and their pros and cons, visit:

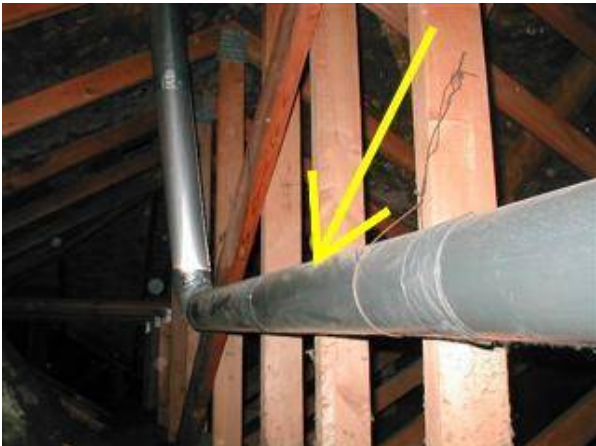
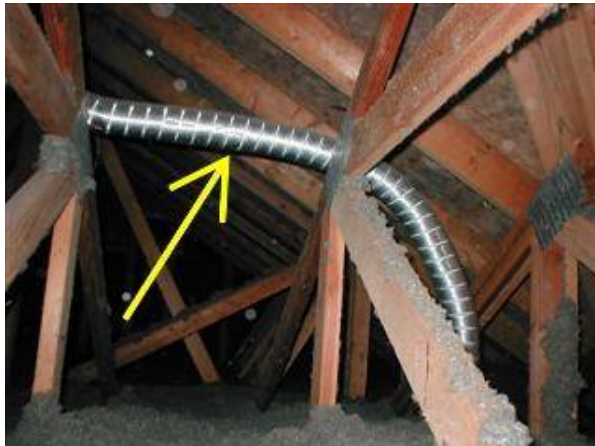
One or more exhaust ducts (e.g. bathroom fan, clothes dryer) in the attic were not insulated. This can result in moisture forming inside the duct or "sweating" on the outside of the duct depending on the surrounding air temperature and the exhaust air temperature. Recommend that a qualified person install insulation on exhaust ducts per standard building practices (typically R-4 rating), or replace uninsulated ducts with insulated ducts.

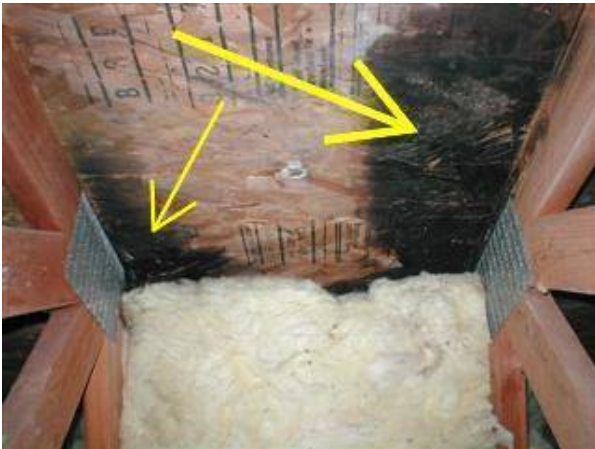
11) 🔍 Oriented strand board (OSB) roof sheathing was dark in some areas inside the attic. This may be due to mold growth from substandard ventilation. Mold is not a wood destroying organism like fungal rot. The inspector probed dark areas of sheathing where accessible and found the OSB sheathing to be serviceable. However, recommend consulting with a qualified contractor to determine what repairs may be needed to prevent further deterioration. Note that standard building practices require one free square foot of ventilation for every 150 square feet of attic space, and that vents be evenly distributed between the lowest points of the roof structure and the highest points to promote air circulation. Additional venting may be needed.

Photo 21
Blackened roof sheathing by skylight chase.

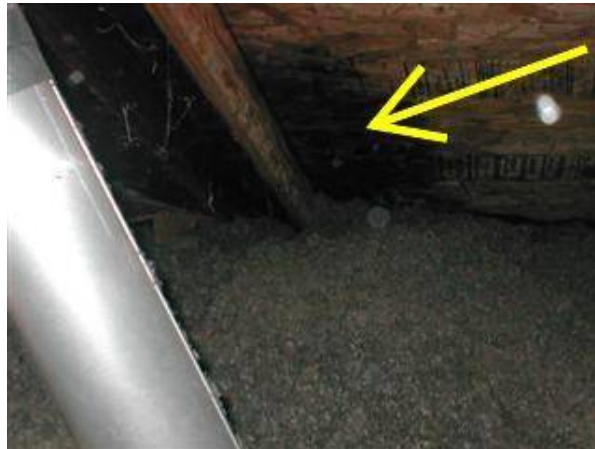
Photo 22
Blackened sheathing by wooden chimney enclosure.

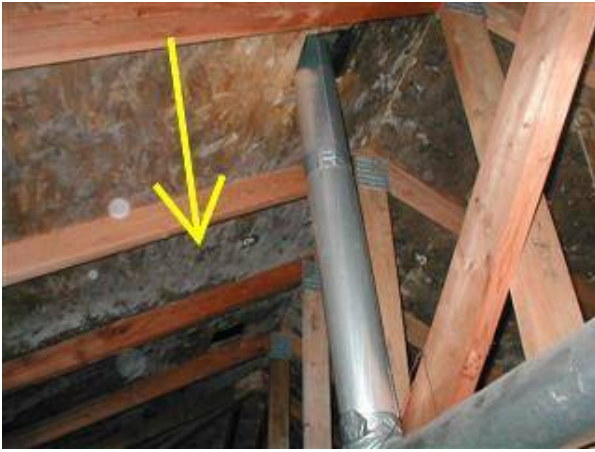
Photo 23
Discolored roof sheathing.

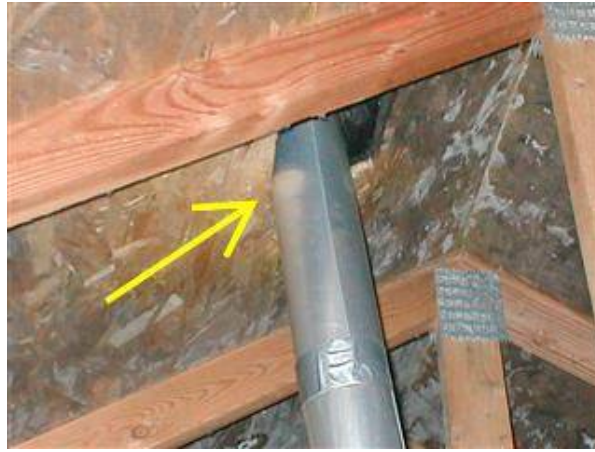
Photo 26
Exhaust fan duct blocking roof vent. Should have a dedicated vent cap.

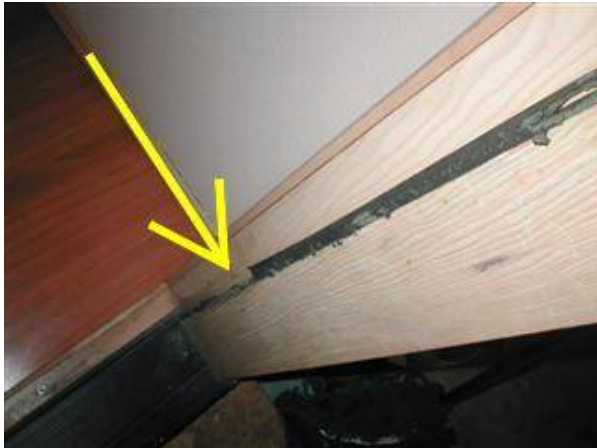
Photo 9

Weatherstripping around or at the base of the door between the garage and the house was damaged. House to garage doors are prevent fire and fumes from spreading from the garage to the house. Weatherstripping should form a seal around this door. This is a potential safety hazard. Recommend that a qualified person replace or install weatherstripping as necessary.

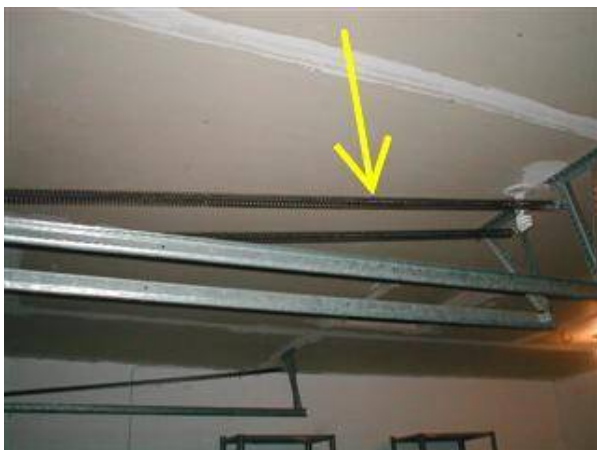
Photo 10

One or more extension springs supporting garage vehicle door springs had no safety containment cables installed. These cables prevent injury to people located nearby when springs eventually break. This is a potential safety hazard. Recommend that a qualified contractor install cables where missing per standard building practices. For more information, visit:

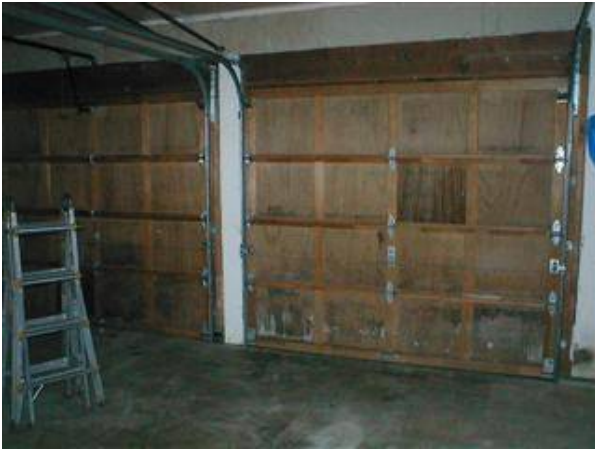
Photo 11

One or more garage vehicle doors weren't balanced. The door(s) wouldn't stay in place when opened half-way, and fell to the ground instead. This is a potential safety hazard since the door(s) can fall when open and cause injury. A qualified contractor should repair as necessary. For more information on garage door safety issues, visit:

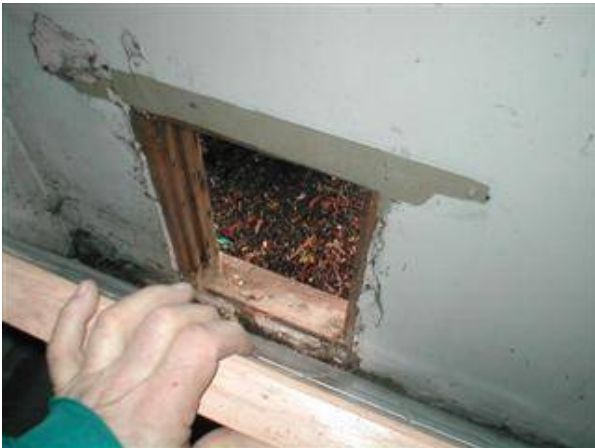
Photo 15

A large hole (for a pet door?) had been cut into the garage exterior wall. Recommend that a qualified contractor repair as necessary.

Hole in garage exterior wall (pet door?).

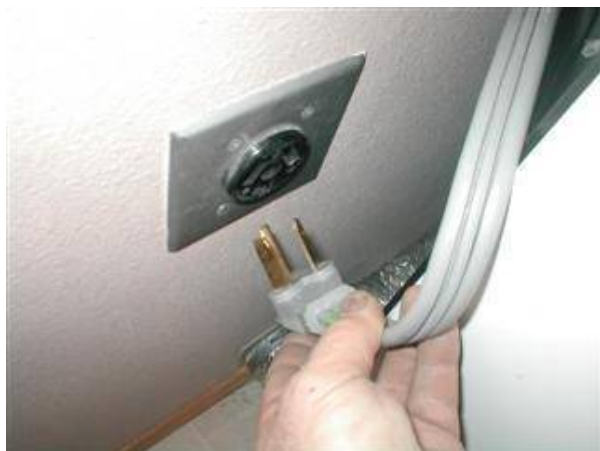
Photo 34

A 3-slot receptacle (outlet) was installed for the clothes dryer. Most modern clothes dryers use both 120 and 240 volts (120 for timers and motors, and 240 for heating elements) and either require or are more safely installed with a 4-slot receptacle. With 3-conductor wiring, the ground wire rather than a neutral wire is used to carry the return current back for the 120 volt leg. The clothes dryer's metal frame can become energized if the neutral wire becomes loose at the receptacle or panel. While 3-wire clothes dryer circuits were allowed prior to 1996 and are commonly found, they are considered unsafe due to the risk of shock. Recommend that a qualified electrician convert this to a 4-wire circuit. Note that this may require installing a new circuit wire from the panel to the clothes dryer location.

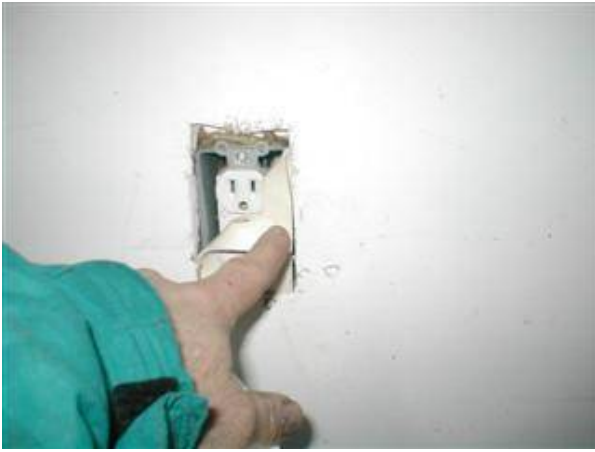
One or more cover plates for switches, receptacles (outlets) or junction boxes were missing or broken. These plates are intended to contain fire and prevent electric shock from occurring due to exposed wires. Recommend that a qualified person install cover plates where necessary.

Photo 12
Garage receptacle.

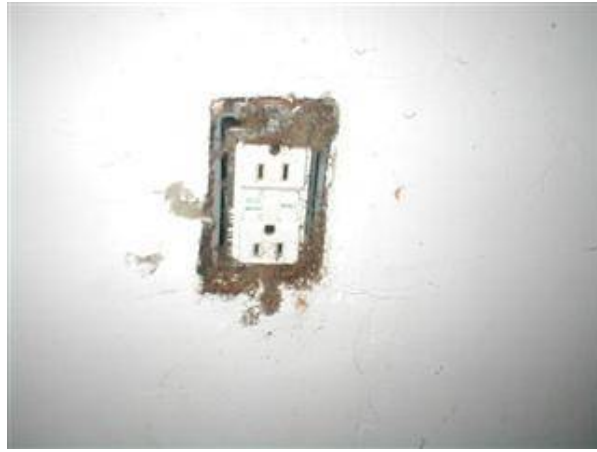
Photo 13
Garage receptacle.

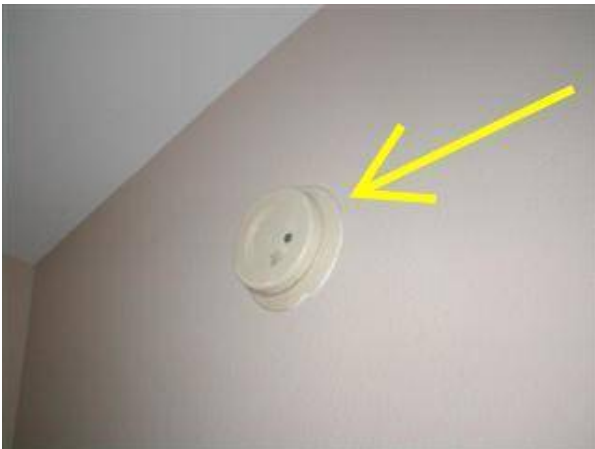
Based on the age of this structure and the appearance of existing smoke alarms, the alarms may have been installed more than 10 years ago. According to [National Fire Protection Association](http://www.nfpa.org), aging smoke alarms don't operate as efficiently and often are the source for nuisance alarms. Older smoke alarms are estimated to have a 30% probability of failure within the first 10 years. Newer smoke alarms do better, but should be replaced after 10 years. Unless you know that the smoke alarms are new, replacing them when moving into a new residence is also recommended by NFPA. For more information, visit: <http://www.google.com/search?q=old+smoke+alarms>

Photo 19
Possible older smoke detector.

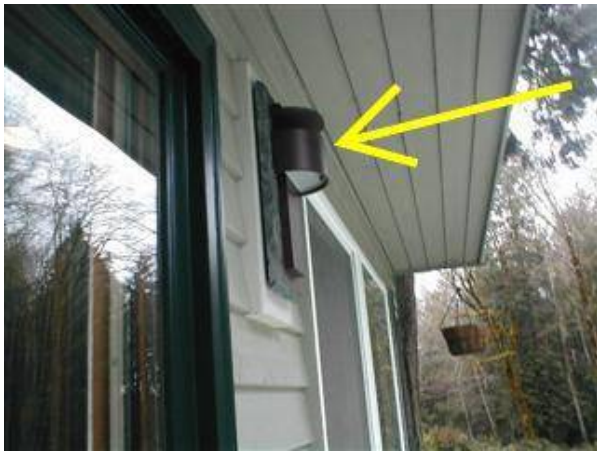
Photo 30

25) 🔍 One or more light fixtures were inoperable (didn't turn on when nearby switches were operated). Recommend further evaluation by replacing bulbs and/or consulting with the property owner. If replacing bulbs doesn't work and/or no other switch(es) can be found, then recommend that a qualified electrician evaluate and repair or replace light fixtures as necessary.

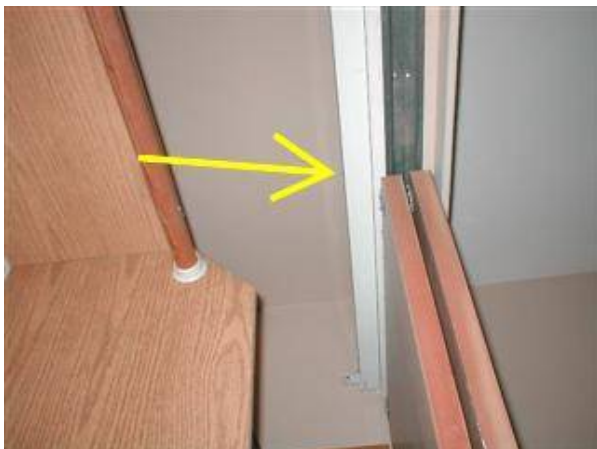
26) 🔍 Bulbs in one or more light fixtures were missing, inoperable or broken. These light fixtures couldn't be fully evaluated. If replacement bulbs are inoperable, then recommend that a qualified electrician evaluate and repair or replace light fixtures as necessary.

Photo 41
Fluorescent light fixture in closet.

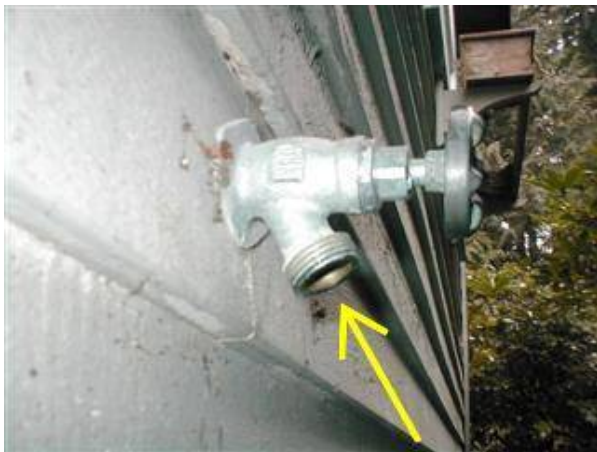
Photo 3

27) 🚰🔧 One or more hose bibs (outside faucets) were missing backflow prevention devices. These devices reduce the likelihood of gray water entering the potable water supply. Recommend installing backflow prevention devices on all hose bibs where missing. They are available at most home improvement stores and are easily installed. For more information, visit:

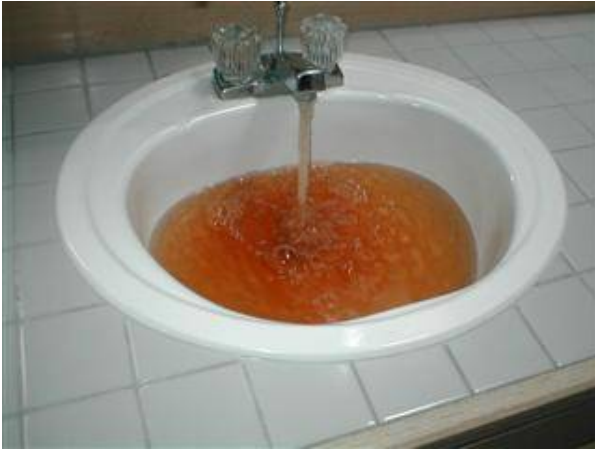
Photo 43

28) 🔧🔍 Water was discolored when bathtubs or sinks were filled, or when showers were operated. This can be caused by water stagnating in water supply pipes, rust accumulating in pipes or in the water heater, or sediment being present in the water supply. Recommend flushing the water supply piping and the water heater. If that fails to

resolve the issue, then have a qualified plumber evaluate and repair as necessary.

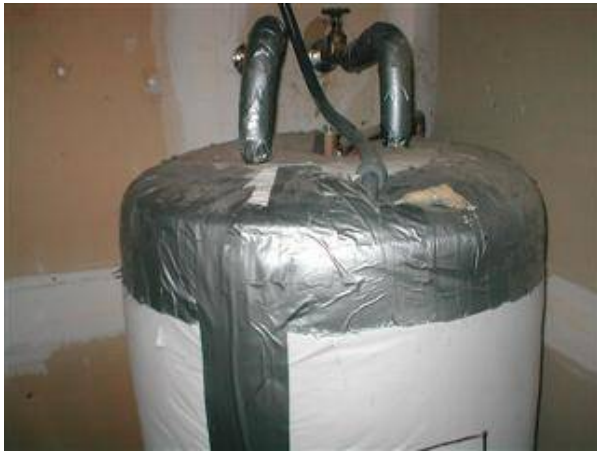
Photo 18

The water heater did not have earthquake straps or struts installed. This is a potential safety hazard in the event of an earthquake due to the risk of the water heater tipping over, gas lines breaking if it's gas-fired, or electric wiring being damaged if powered by electricity. Leaks can also occur in water-supply pipes. Recommend that a qualified person install earthquake straps or struts as necessary and per standard building practices.

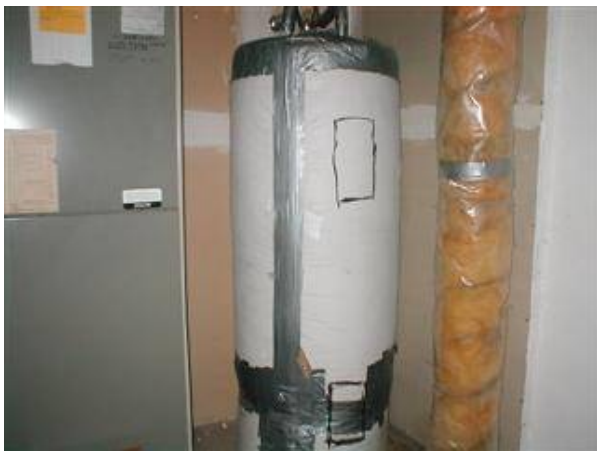
Photo 17

A permanently installed insulated jacket was installed on the water heater. It obscured the manufacturer's information label and/or most of the water heater. The inspector was unable to fully evaluate the water heater.

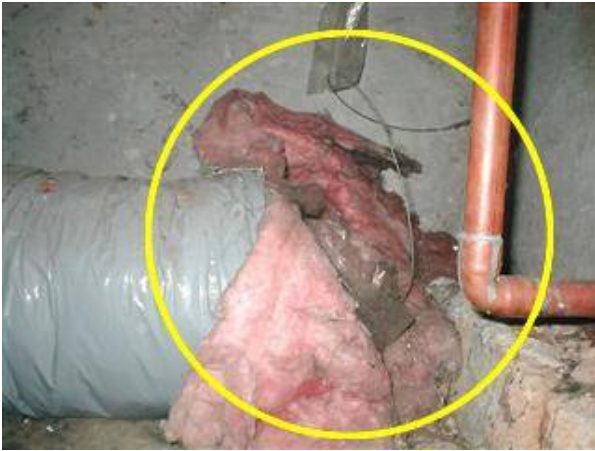
One or more heating or cooling ducts in an unconditioned space (e.g. crawl space, attic or basement) have come apart, or have significant gaps at junctions. This will result in reduced energy efficiency, and possibly increased moisture in surrounding spaces. A qualified contractor should make permanent repair as necessary. For example, by securely supporting ducts and installing approved tape or mastic at seams.

Photo 49
Broken duct in crawl space.

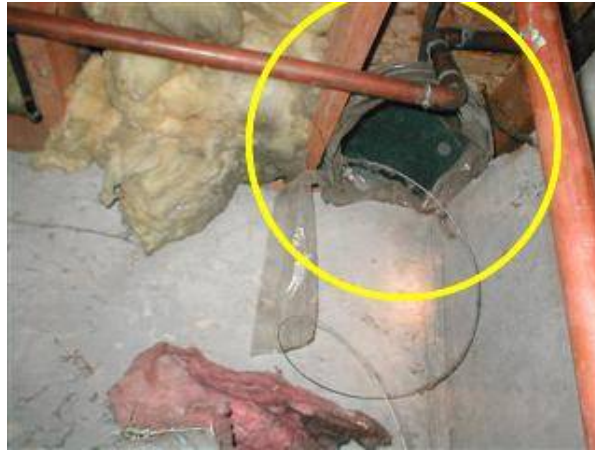
Photo 50
Other end of broken duct.

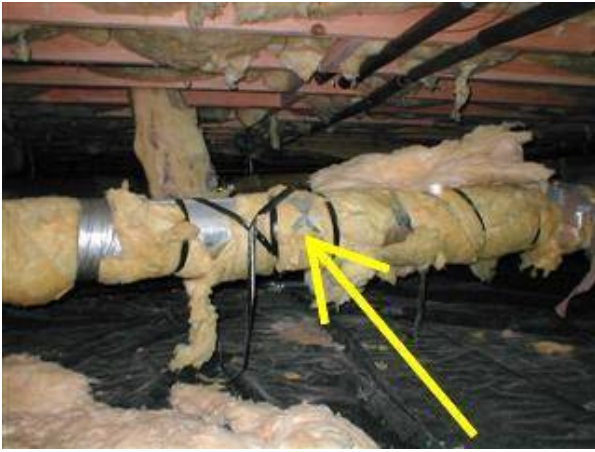
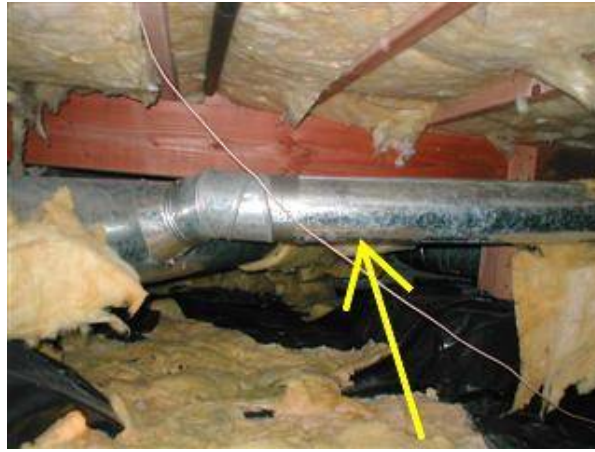
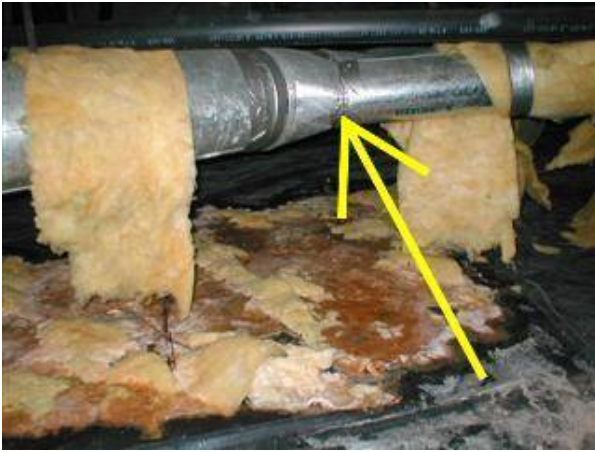
One or more heating or cooling ducts in an unconditioned space (e.g. crawl space, attic or basement) were not insulated, or the insulation was damaged or deteriorated. This can result in reduced energy efficiency, moisture inside heating ducts, and/or "sweating" on cooling ducts". Recommend that a qualified person repair as per standard building practices. For example, by wrapping ducts in insulation with an R-value of R-8.

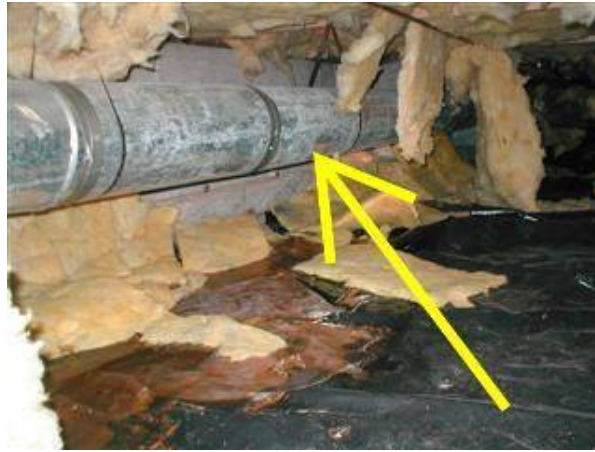
Photo 55
Ductwork insulation lying in water in crawl space.

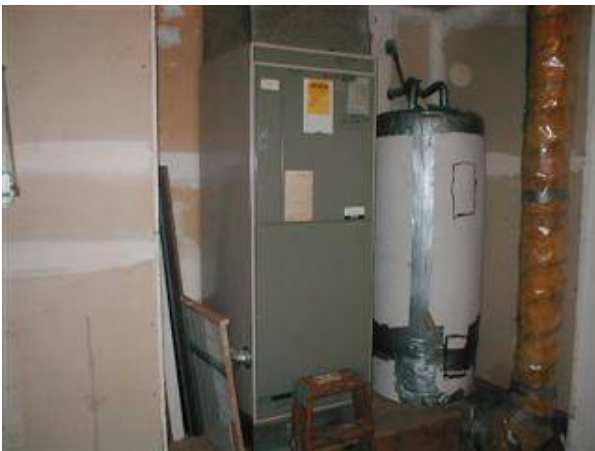
Photo 16

36) 🔧🔍 The last service date of this system appeared to be more than two years ago, or the inspector was unable to determine the last service date. The client should ask the property owner when it was last serviced. If unable to determine the last service date, or if this system was serviced more than two years ago, a qualified heating and cooling contractor should inspect, clean, and service this system, and make repairs if necessary. This servicing should be performed every few years in the future, or per the contractor's recommendations.

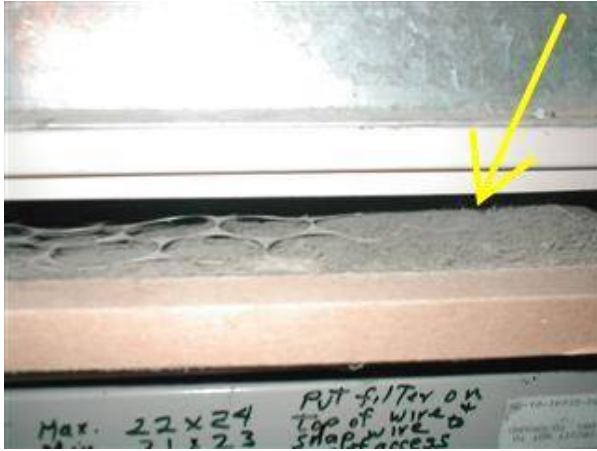
37) 🔑 One or more air filters were dirty. A qualified person should replace filter(s) as necessary. Filters should be

Photo 44
Dirty furnace filter.

checked monthly and maintained as necessary in the future.

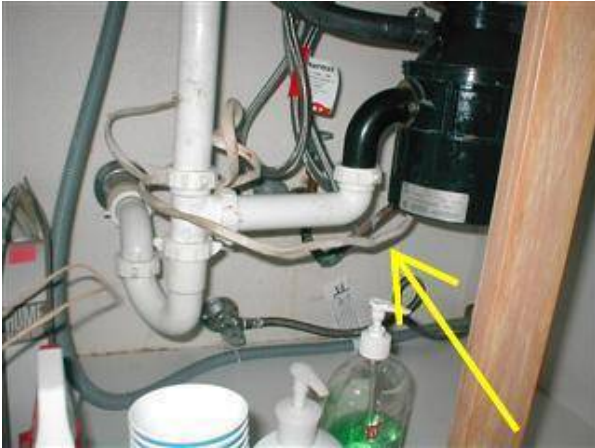
Photo 27

BX-armored conduit should be installed to protect wiring, or a flexible appliance cable should be installed. This is a potential shock hazard. Recommend that a qualified contractor repair per standard building practices.

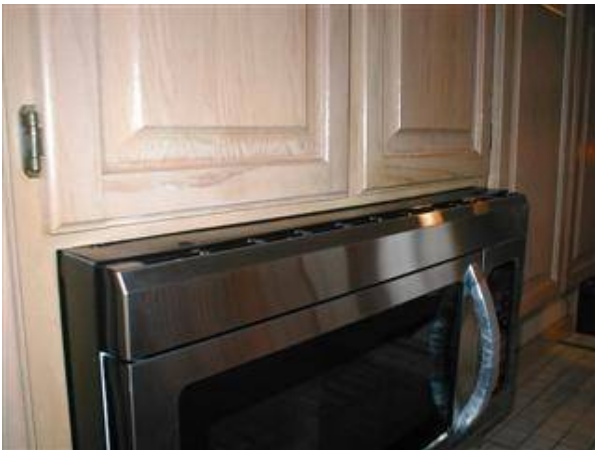
Photo 29

An exhaust hood was installed over the cook top or range, but the fan recirculated the exhaust air back into the kitchen. This may be due to no duct being installed, baffles at the front of the hood not being installed, or a problem with the duct. This can be a nuisance for odor and grease accumulation. Where a gas-fired range or cook top is installed, carbon monoxide and excessive levels of moisture can accumulate in living spaces. Recommend that a qualified contractor evaluate and repair as necessary so exhaust air is ducted outdoors.

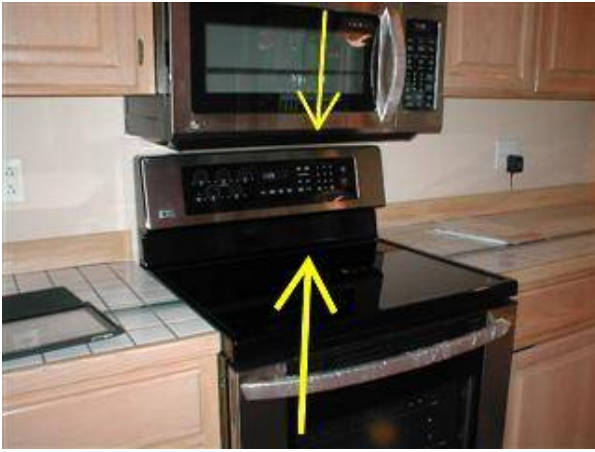
Photo 28

The clearance between the stove top and the base of the exhaust hood above was too low. While the recommended height varies per the hood manufacturer, standards usually call for a minimum of 24 inches of clearance. A low hood height can restrict visibility of the stove top. Recommend that a qualified contractor repair per standard building practices.

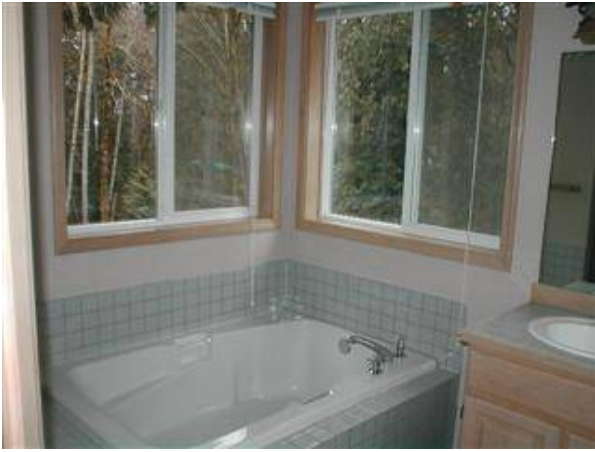
Photo 20

The inspector was unable to verify that the glass used in one or more windows by the bathtub at location(s) #C was approved safety glass. Glazing that is not approved safety glass located in areas subject to human impact is a potential safety hazard. Standard building practices require that approved safety glass be used in enclosures for bathtubs, showers, spas, saunas and steam rooms, and in windows where the bottom edge of the window is less than 60 inches above the drain inlet or standing surface. Wire-reinforced glass is not acceptable. Recommend that a qualified contractor evaluate and replace glass if necessary, and per standard building practices.

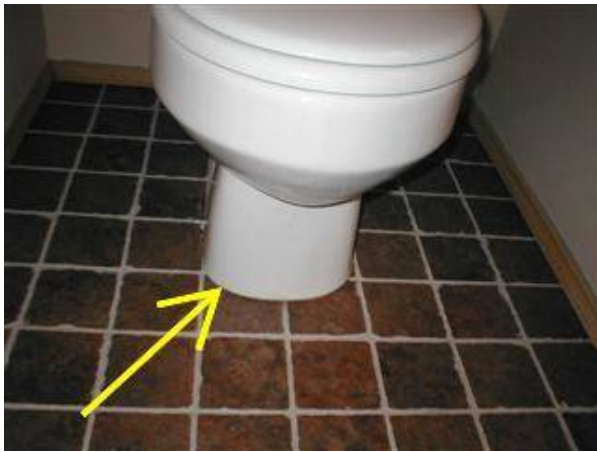
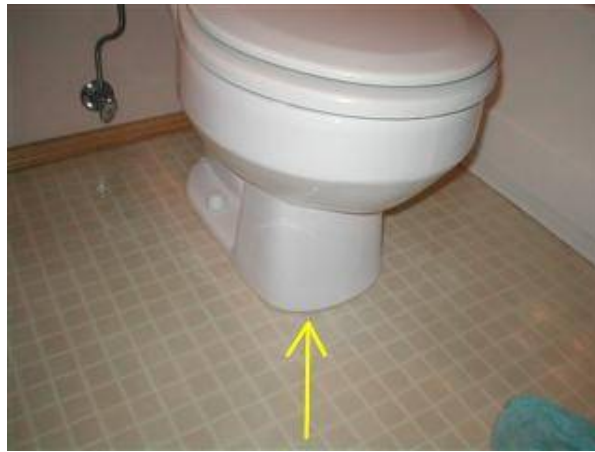
No caulk was installed around the base of the toilet at location(s) #A, B where fastened to the floor. Caulk should be applied approximately 3/4 of the way around the toilet base at the front for sanitary purposes and to prevent water intrusion. The back should be left uncaulked so water can escape if a leak ever occurs. Recommend that a qualified person caulk around the toilet base(s) per standard building practices.

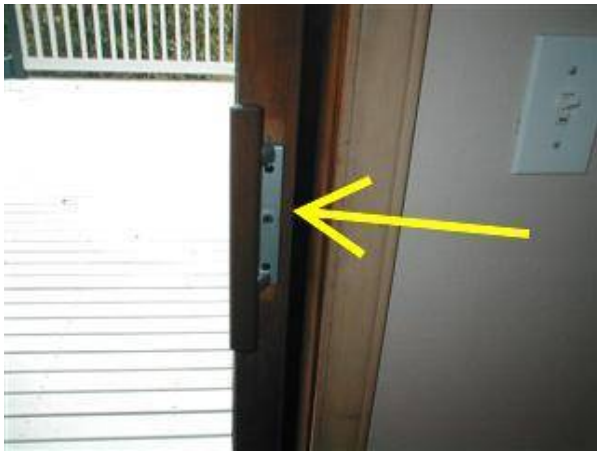
Photo 31

The lock mechanisms on one or more sliding glass doors were inoperable. A qualified person should repair as necessary.

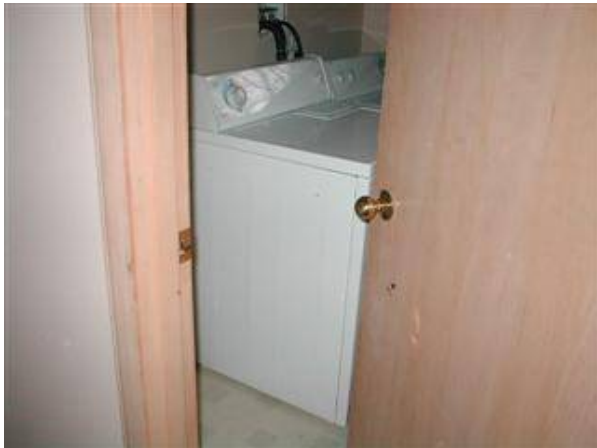
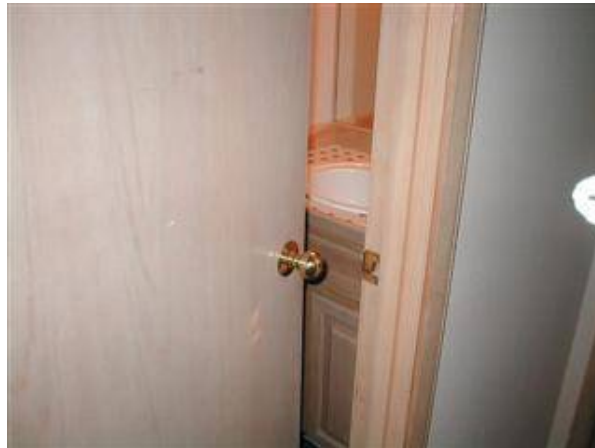
One or more interior doors wouldn't latch or were difficult to latch. Recommend that a qualified person repair as necessary. For example, by adjusting latch plates or locksets.
