All Point Home Inspections

Full General Home Inspection and Structural Pest Inspection WA State Dept. Agriculture ICN# 00000000

Property address: **Anytown, USA**

Inspection date: **3/29/2012**

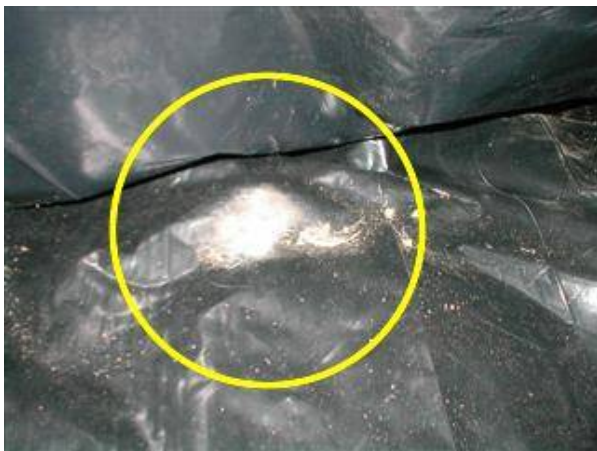
Evidence of rodent infestation was found in the form of dead rodents, damaged insulation in the crawl space. Consult with the property owner about this. A qualified person should make repairs to seal openings in the structure, set traps, and clean rodent waste as necessary. Recommend following guidelines in these Center for Disease Control articles:

Photo 53
Dead mouse between layers of vapor barrier in crawl space.

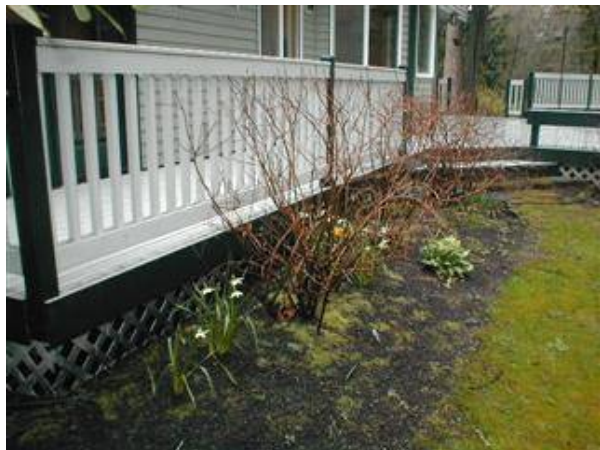
Photo 4

Most areas of the deck substructure were inaccessible due to limited space below, permanently installed

skirting. These areas couldn't be evaluated and are excluded from the inspection.

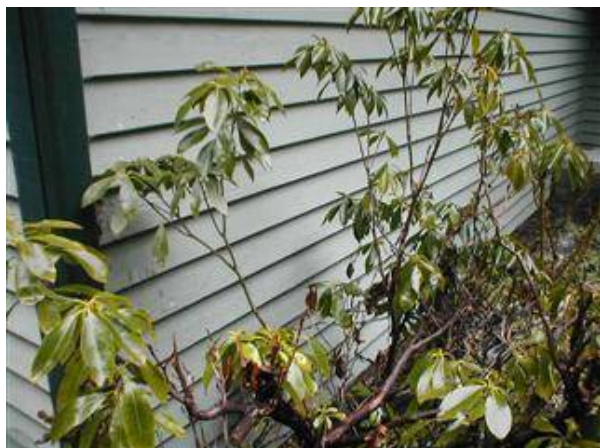
Photo 1

Vegetation such as trees, shrubs and/or vines was in contact with or close to the building exterior. Vegetation can serve as a pathway for wood-destroying insects and can retain moisture against the exterior after it rains. This is a conducive condition for wood-destroying organisms. Recommend pruning, moving or removing vegetation as necessary to maintain at least 6 inches of space between it and the building exterior. A 1-foot clearance is better.

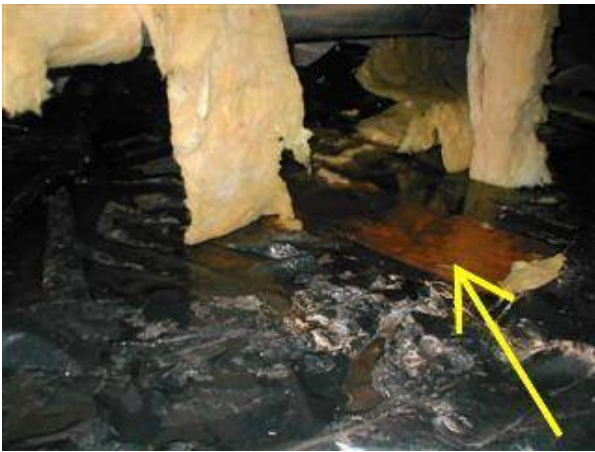
Standing water was found at one or more locations in the crawl space. Water from crawl spaces can evaporate and enter the structure above causing high levels of moisture in the structure. This is a conducive condition for wood-destroying organisms. While a minor amount of seasonal water is commonly found in crawl spaces, significant amounts should not be present.

Rain runoff is the most common cause of wet crawl spaces, but water can come from other sources such as groundwater or underground springs. Recommend that a qualified person correct any issues related to outside perimeter grading and/or roof drainage (see any other comments about this in this report). If standing water persists, then recommend that a qualified contractor who specializes in drainage issues evaluate and repair as necessary. Typically such repairs include:

Photo 54
Standing water in crawl space.

- Repairing, installing or improving underground footing and/or curtain drains
- Applying waterproof coatings to foundation walls
- Digging trenches in the crawl space to collect or divert water
- Installing sump pumps

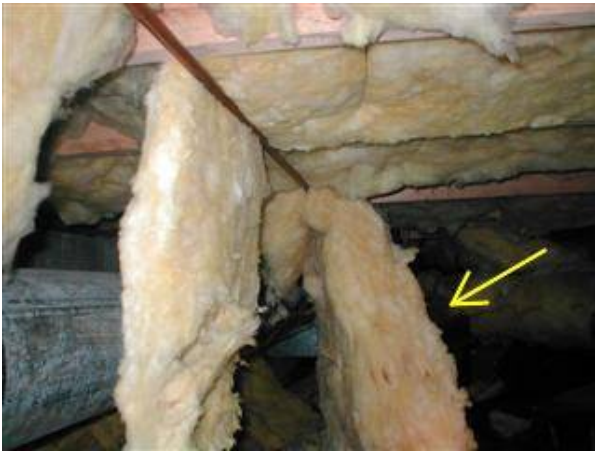
Some sections of under-floor insulation above the crawl space have fallen down, were damaged or deteriorated. This may result in reduced energy efficiency. Recommend that a qualified person install or replace insulation as necessary.

Photo 56
Fallen down under-floor insulation in crawl space.

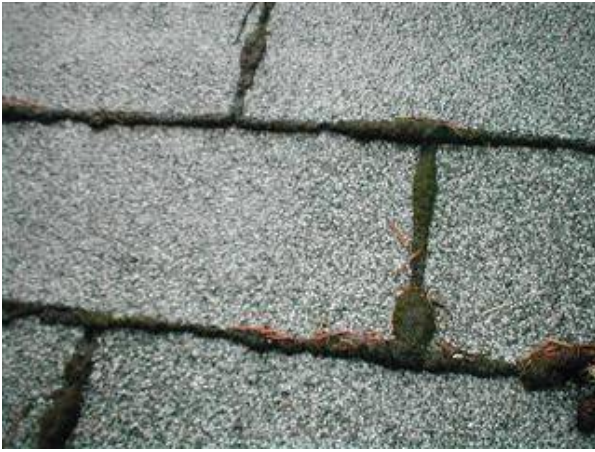
Photo 6

8) 🛠️ Moss was growing on the roof. As a result, shingles can lift or be damaged. Leaks can result and/or the roof surface can fail prematurely. Efforts should be made to kill the moss during its growing season (wet months). Typically, zinc or phosphate-based chemicals are used for this and must be applied periodically. For information on various moss treatment products and their pros and cons, visit:

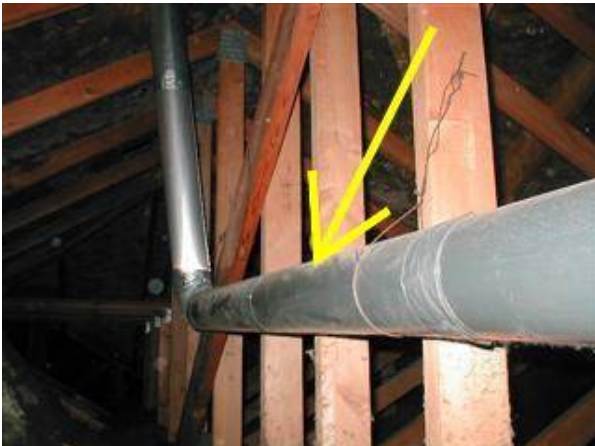
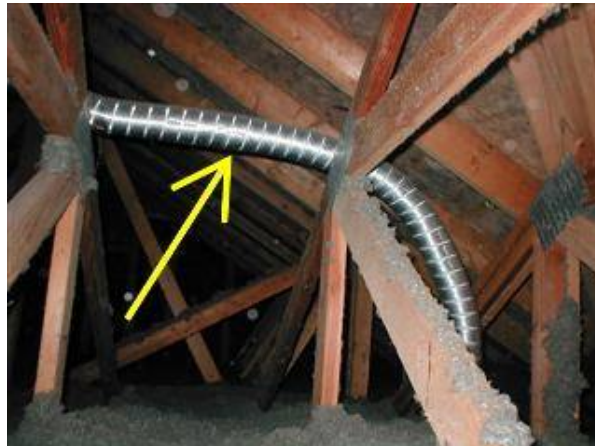
One or more exhaust ducts (e.g. bathroom fan, clothes dryer) in the attic were not insulated. This can result in moisture forming inside the duct or "sweating" on the outside of the duct depending on the surrounding air temperature and the exhaust air temperature. Recommend that a qualified person install insulation on exhaust ducts per standard building practices (typically R-4 rating), or replace uninsulated ducts with insulated ducts.

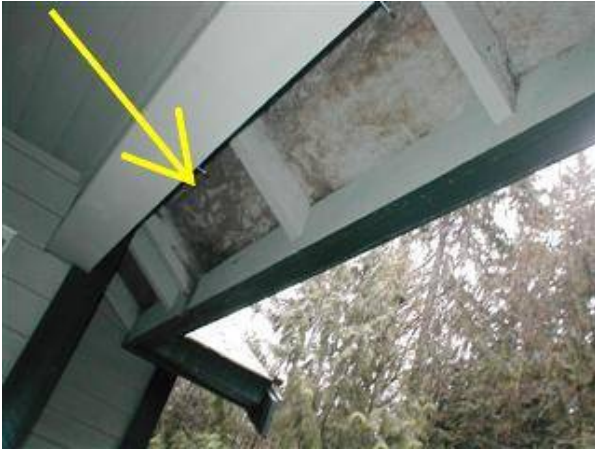
10) 🏠🔑 Oriented strand board (OSB) roof sheathing at some open soffits was dark in color. This may be due to high moisture levels from overflowing gutters. Recommend maintaining the roof drainage system and monitoring the roof sheathing. Soffit sheathing could be repainted for cosmetic reasons.

Photo 38
Dark colored roof sheathing over front porch.

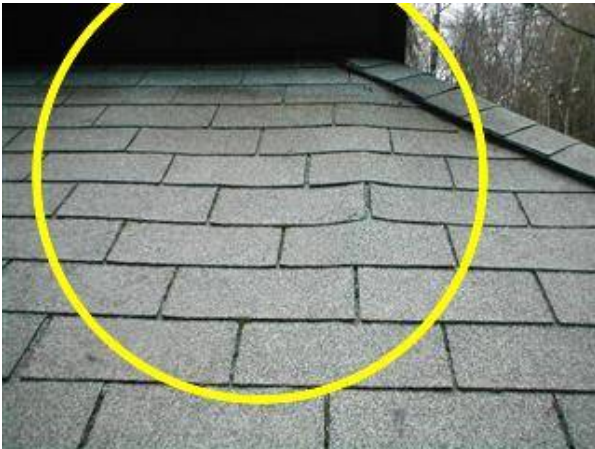
13) **i** A soft spot on the roof surface above the front door was found. This spot was at a location convenient for going up and down from a lower to a higher roof surface. It may have been caused by people jumping down on to the lower roof surface. Even though it was uneven, it appeared to be serviceable, with no repairs needed.

Photo 7
Uneven roof surface above front door.

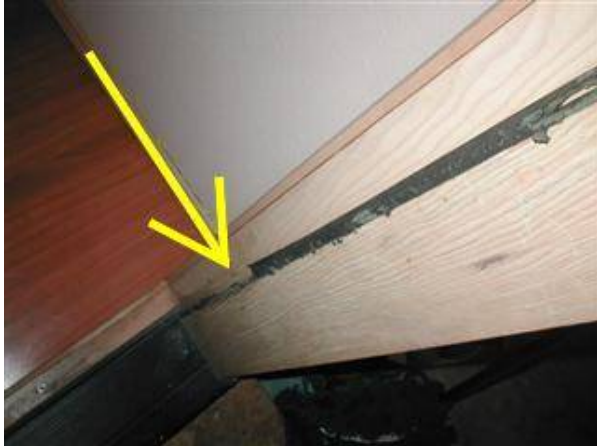
Photo 9

Weatherstripping around or at the base of the door between the garage and the house was damaged. House to garage doors are prevent fire and fumes from spreading from the garage to the house. Weatherstripping should form a seal around this door. This is a potential safety hazard. Recommend that a qualified person replace or install weatherstripping as necessary.

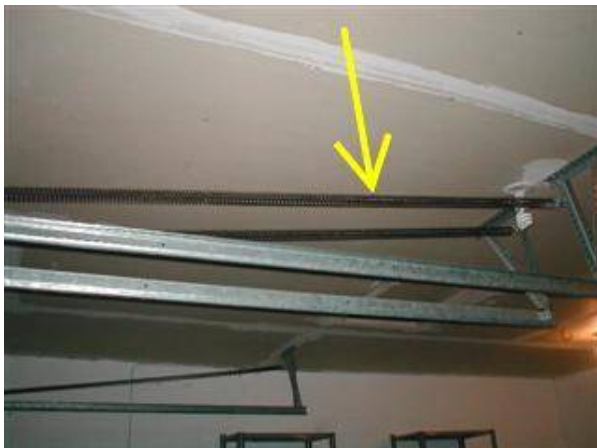
Photo 10

One or more extension springs supporting garage vehicle door springs had no safety containment cables installed. These cables prevent injury to people located nearby when springs eventually break. This is a potential safety hazard. Recommend that a qualified contractor install cables where missing per standard building practices. For more information, visit:

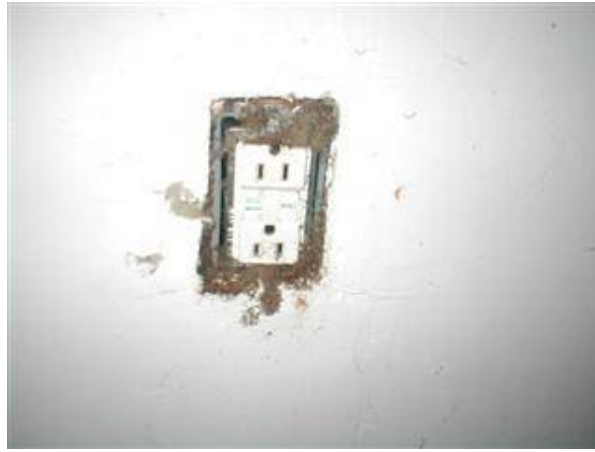
One or more cover plates for switches, receptacles (outlets) or junction boxes were missing or broken. These plates are intended to contain fire and prevent electric shock from occurring due to exposed wires. Recommend that a qualified person install cover plates where necessary.

Photo 12
Garage receptacle.

Photo 13
Garage receptacle.

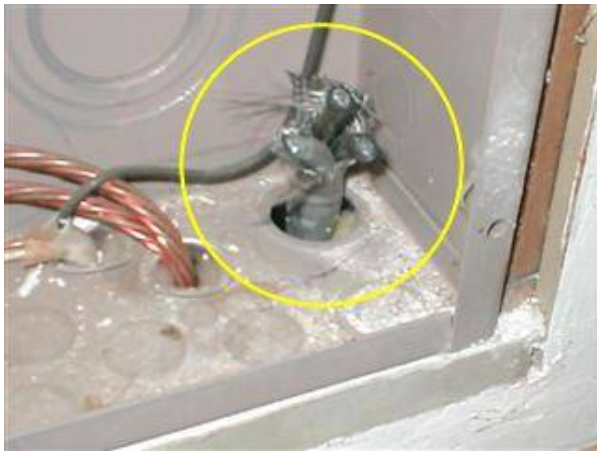
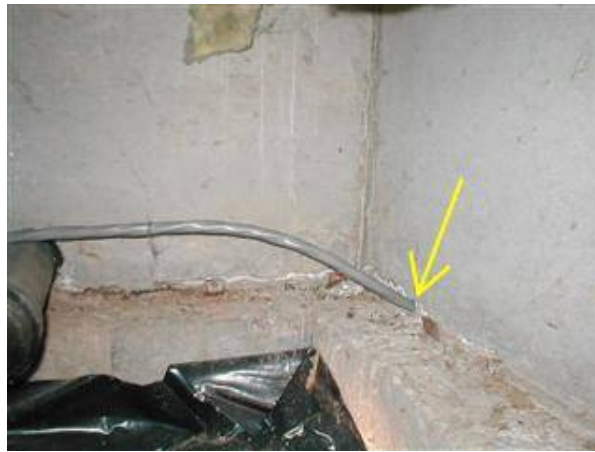
What appeared to be abandoned wiring was found in the main service panel and crawl space. Labeling on the panel cover indicated that wiring has been installed for a hot tub. Recommend that this wiring be removed and that the knockout hole in the main service panel cover have a cover installed.

Photo 14
Abandoned wiring with no bushing in main service panel.

Photo 48
Abandoned wiring (for hot tub?) in crawl space.

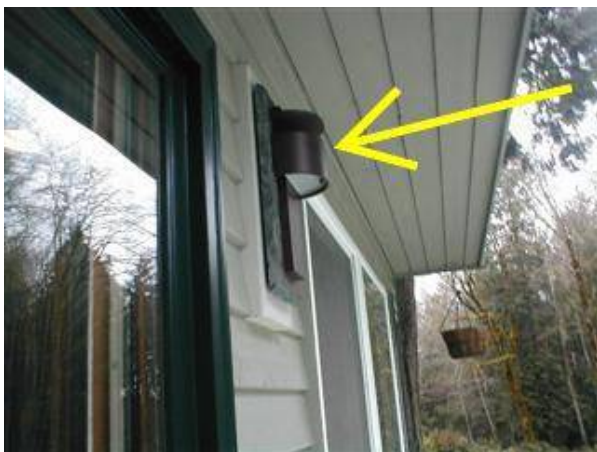
Photo 30

25) 🔍 One or more light fixtures were inoperable (didn't turn on when nearby switches were operated). Recommend further evaluation by replacing bulbs and/or consulting with the property owner. If replacing bulbs doesn't work and/or no other switch(es) can be found, then recommend that a qualified electrician evaluate and repair or replace light fixtures as necessary.

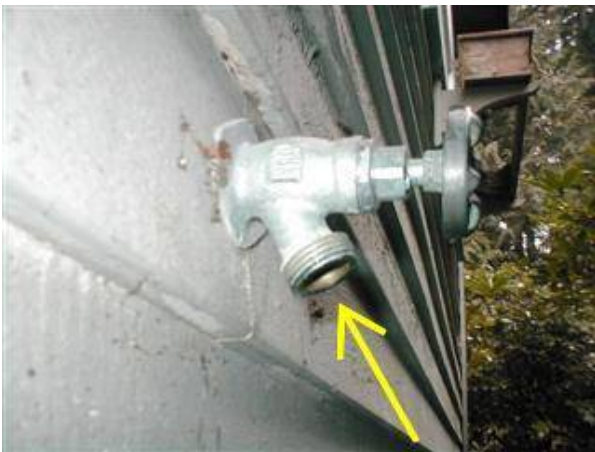
Photo 3

27) 🚰🔧 One or more hose bibs (outside faucets) were missing backflow prevention devices. These devices reduce the likelihood of gray water entering the potable water supply. Recommend installing backflow prevention devices on all hose bibs where missing. They are available at most home improvement stores and are easily installed. For more information, visit:

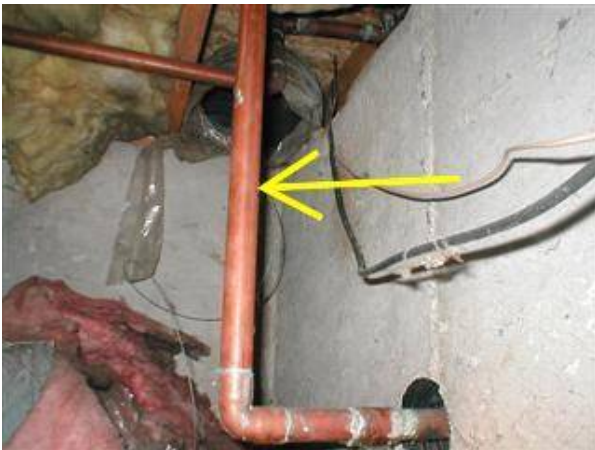
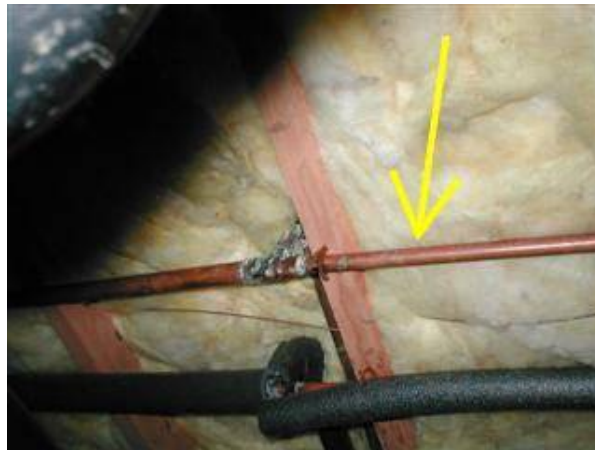
Water supply pipes in the crawl space were not insulated. Recommend insulating pipes per standard building practices to prevent them from freezing during cold weather, and for better energy efficiency with hot water supply pipes.

Photo 51
Main service water supply pipe in crawl space.

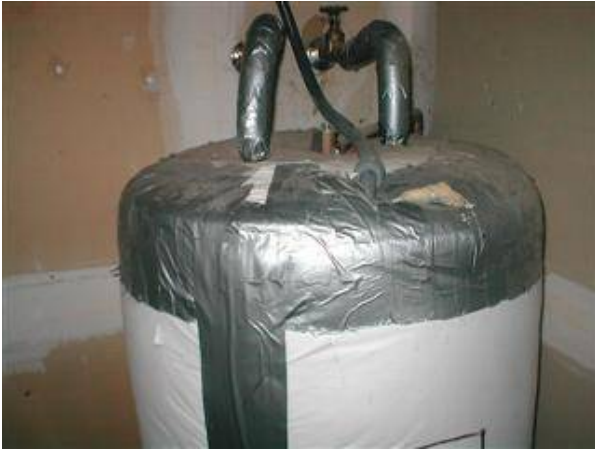
Photo 18

The water heater did not have earthquake straps or struts installed. This is a potential safety hazard in the event of an earthquake due to the risk of the water heater tipping over, gas lines breaking if it's gas-fired, or electric wiring being damaged if powered by electricity. Leaks can also occur in water-supply pipes. Recommend that a qualified person install earthquake straps or struts as necessary and per standard building practices.

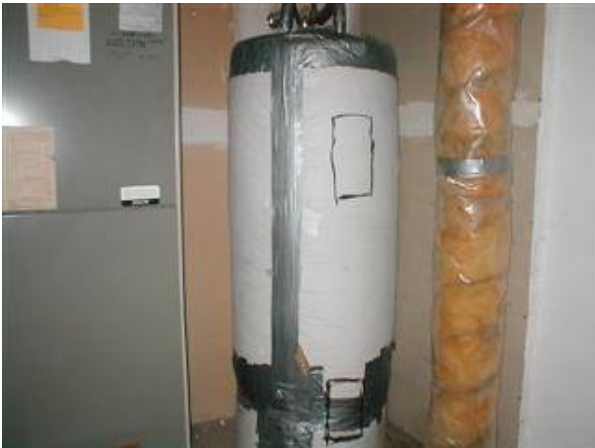
Photo 17

A permanently installed insulated jacket was installed on the water heater. It obscured the manufacturer's information label and/or most of the water heater. The inspector was unable to fully evaluate the water heater.

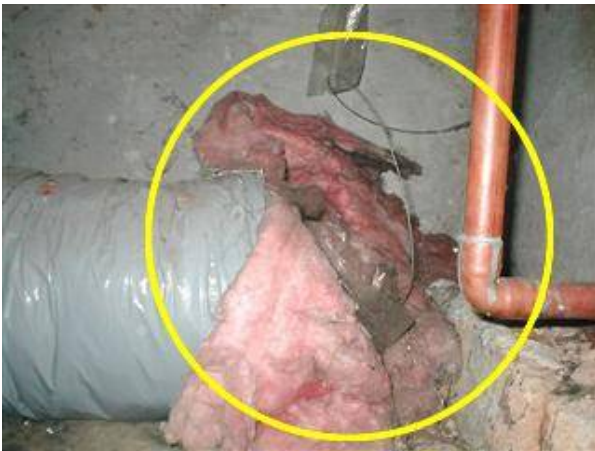
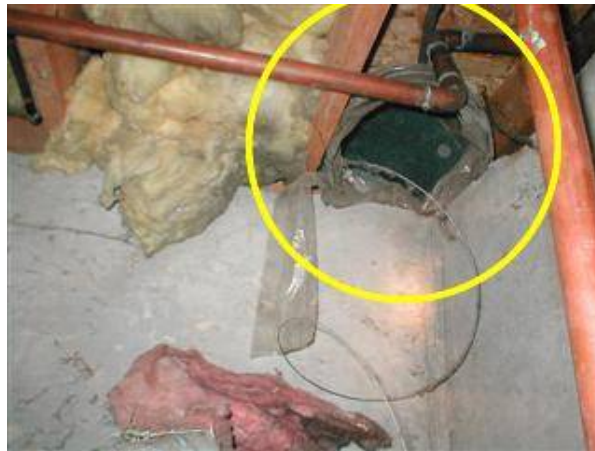
One or more heating or cooling ducts in an unconditioned space (e.g. crawl space, attic or basement) have come apart, or have significant gaps at junctions. This will result in reduced energy efficiency, and possibly increased moisture in surrounding spaces. A qualified contractor should make permanent repair as necessary. For example, by securely supporting ducts and installing approved tape or mastic at seams.

Photo 49
Broken duct in crawl space.

Photo 50
Other end of broken duct.

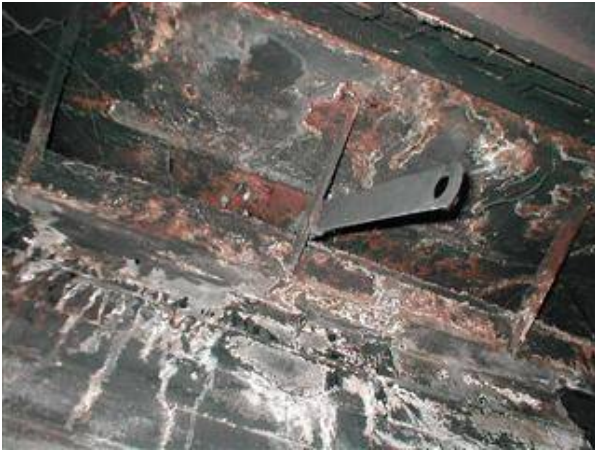
Photo 40
View up fireplace damper.

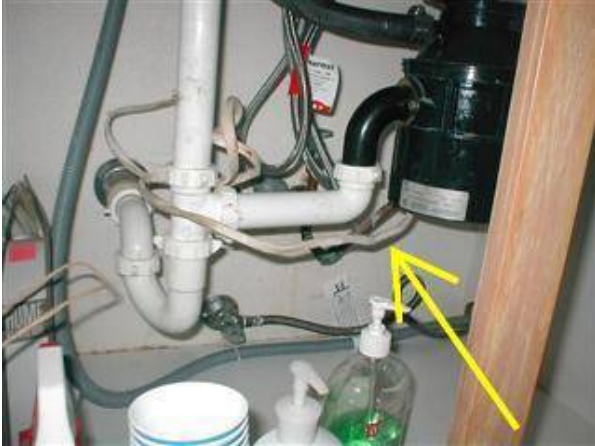
Photo 27

BX-armored conduit should be installed to protect wiring, or a flexible appliance cable should be installed. This is a potential shock hazard. Recommend that a qualified contractor repair per standard building practices.

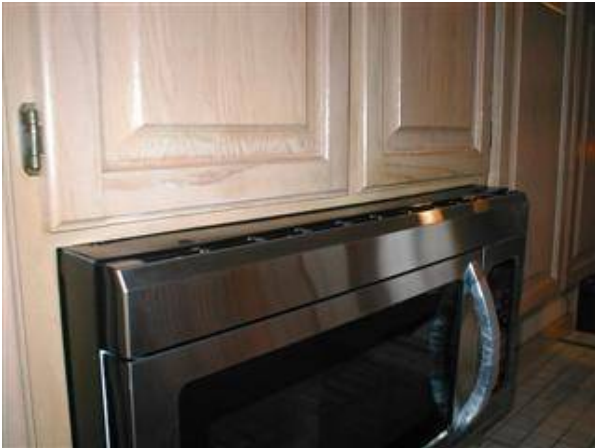
Photo 29

An exhaust hood was installed over the cook top or range, but the fan recirculated the exhaust air back into the kitchen. This may be due to no duct being installed, baffles at the front of the hood not being installed, or a problem with the duct. This can be a nuisance for odor and grease accumulation. Where a gas-fired range or cook top is installed, carbon monoxide and excessive levels of moisture can accumulate in living spaces. Recommend that a qualified contractor evaluate and repair as necessary so exhaust air is ducted outdoors.

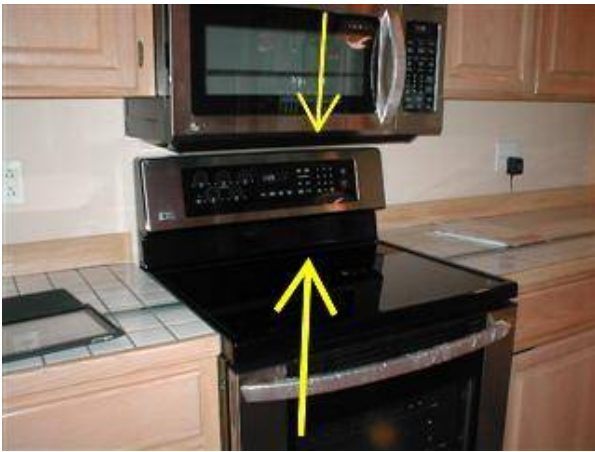
Photo 28

The clearance between the stove top and the base of the exhaust hood above was too low. While the recommended height varies per the hood manufacturer, standards usually call for a minimum of 24 inches of clearance. A low hood height can restrict visibility of the stove top. Recommend that a qualified contractor repair per standard building practices.

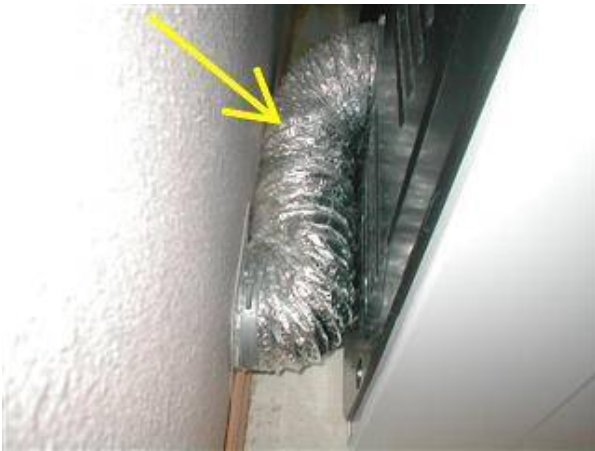
Photo 35

44) 🛠️ The clothes dryer was equipped with a vinyl or mylar, accordion-type, flexible exhaust duct. The U.S. Consumer Product Safety Commission considers these types of ducts to be unsafe, and a fire hazard. They can trap lint and are susceptible to kinks or crushing, which can greatly reduce the air flow and cause overheating. Recommend that such ducts be replaced with a rigid or corrugated semi-rigid metal duct, and by a qualified contractor if necessary. For more information, visit:
