# All Point Home Inspections

## Full General Home Inspection and Structural Pest Inspection WA State Dept. Agriculture ICN# 00000000

Property address: Anytown, USA

Inspection date: 3/29/2012

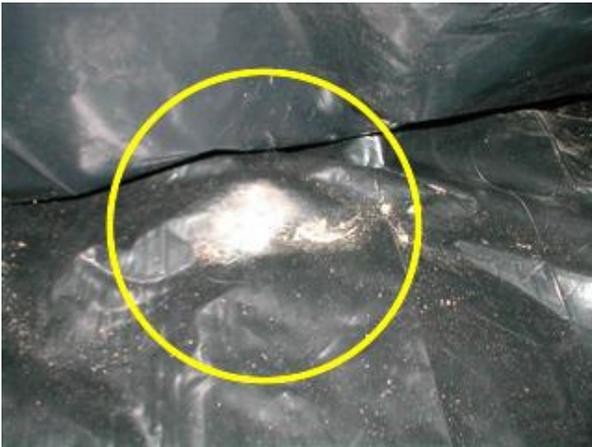
**Photo 53**

Evidence of rodent infestation was found in the form of dead rodents, damaged insulation in the crawl space. Consult with the property owner about this. A qualified person should make repairs to seal openings in the structure, set traps, and clean rodent waste as necessary. Recommend following guidelines in these Center for Disease Control articles:

Dead mouse between layers of vapor barrier in crawl space.

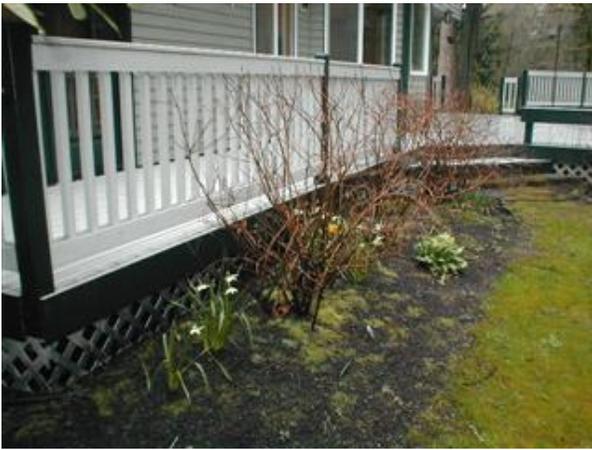
Photo 4

Most areas of the deck substructure were inaccessible due to limited space below, permanently installed skirting. These areas couldn't be evaluated and are excluded from the inspection.

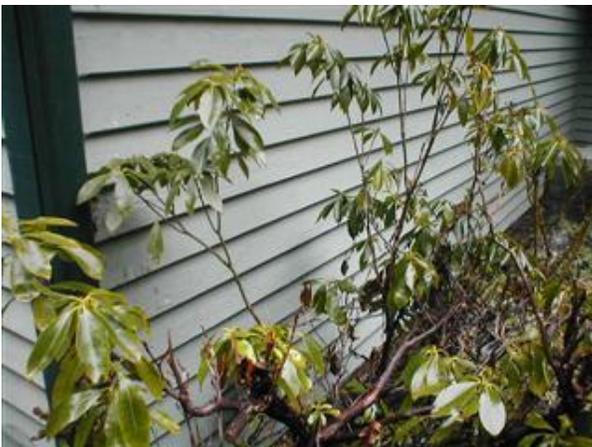
Photo 1

3) 🛠️💧 Vegetation such as trees, shrubs and/or vines was in contact with or close to the building exterior. Vegetation can serve as a pathway for wood-destroying insects and can retain moisture against the exterior after it rains. This is a conducive condition for wood-destroying organisms. Recommend pruning, moving or removing vegetation as necessary to maintain at least 6 inches of space between it and the building exterior. A 1-foot clearance is better.

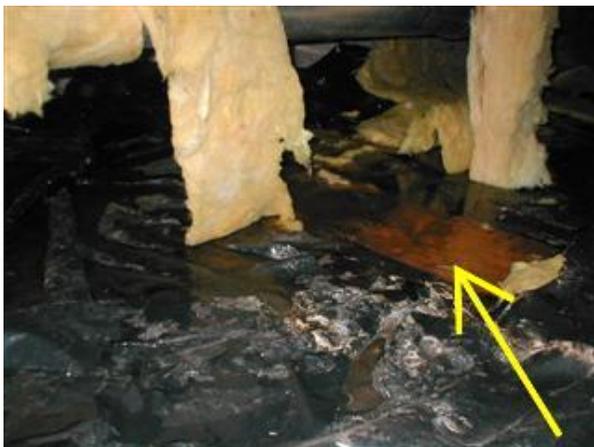
**Photo 54**

Standing water was found at one or more locations in the crawl space. Water from crawl spaces can evaporate and enter the structure above causing high levels of moisture in the structure. This is a conducive condition for wood-destroying organisms. While a minor amount of seasonal water is commonly found in crawl spaces, significant amounts should not be present.

Rain runoff is the most common cause of wet crawl spaces, but water can come from other sources such as groundwater or underground springs. Recommend that a qualified person correct any issues related to outside perimeter grading and/or roof drainage (see any other comments about this in this report). If standing water persists, then recommend that a qualified contractor who specializes in drainage issues evaluate and repair as necessary. Typically such repairs include:

Standing water in crawl space.

- Repairing, installing or improving underground footing and/or curtain drains
- Applying waterproof coatings to foundation walls
- Digging trenches in the crawl space to collect or divert water
- Installing sump pumps

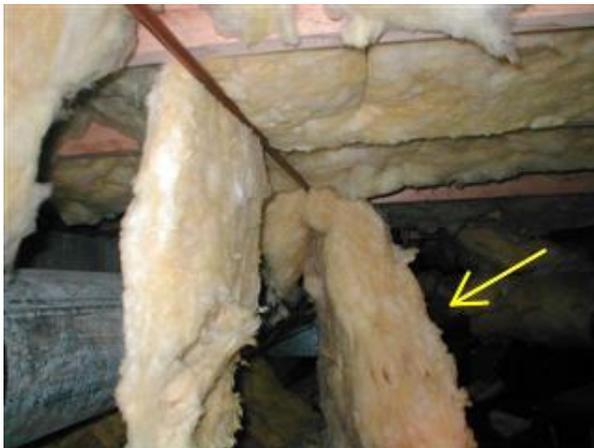
Some sections of under-floor insulation above the crawl space have fallen down, were damaged or deteriorated. This may result in reduced energy efficiency. Recommend that a qualified person install or replace insulation as necessary.

**Photo 56**  
Fallen down under-floor insulation in crawl space.

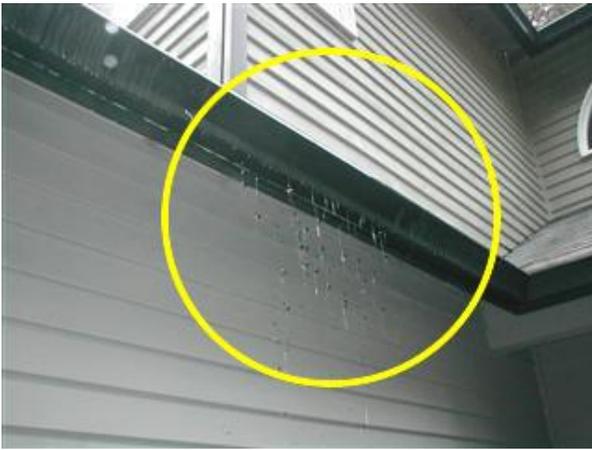
Significant amounts of debris have accumulated in one or more gutters. Gutters can overflow and cause water to come in contact with the building exterior or water can accumulate around the foundation. This is a conducive condition for wood-destroying organisms. Recommend cleaning gutters now and as necessary in the future.

**Photo 2**  
Overflowing gutters.

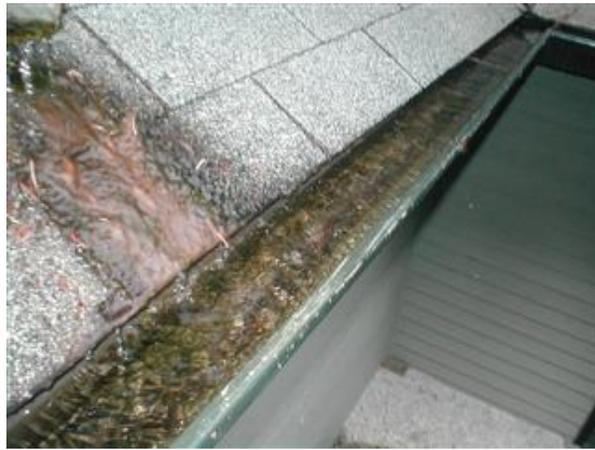
**Photo 5**  
Overflowing gutter.

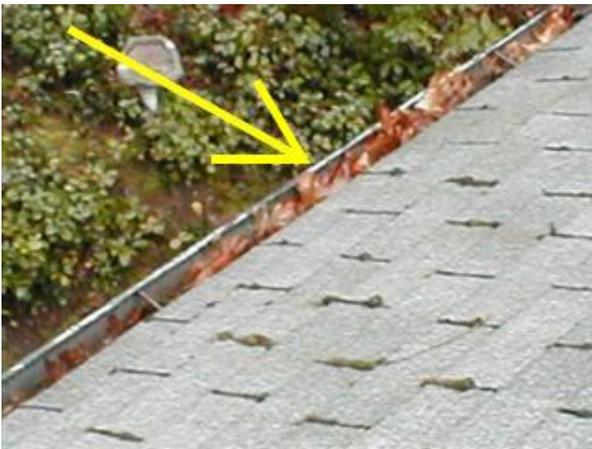
**Photo 8**  
Debris in gutters.

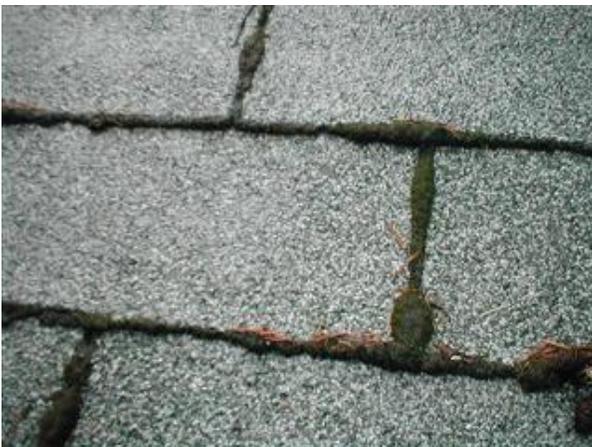
**Photo 6**

Moss was growing on the roof. As a result, shingles can lift or be damaged. Leaks can result and/or the roof surface can fail prematurely. Efforts should be made to kill the moss during its growing season (wet months). Typically, zinc or phosphate-based chemicals are used for this and must be applied periodically. For information on various moss treatment products and their pros and cons, visit: <http://www.google.com/search?q=moss+on+roof>

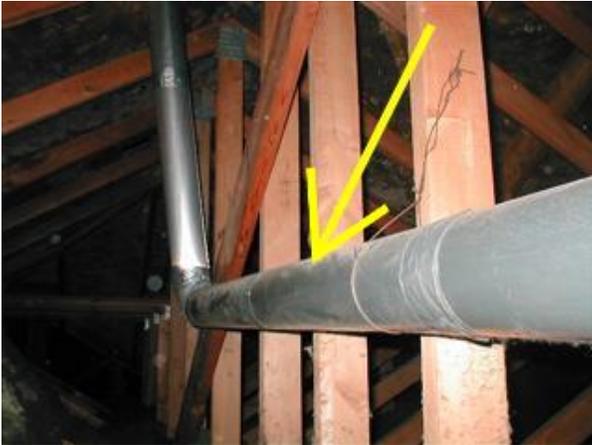
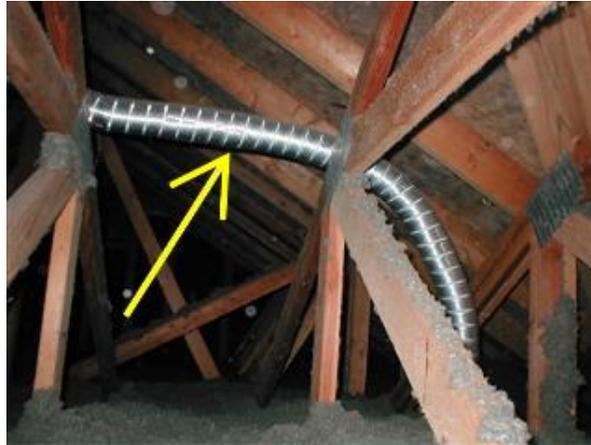
One or more exhaust ducts (e.g. bathroom fan, clothes dryer) in the attic were not insulated. This can result in moisture forming inside the duct or "sweating" on the outside of the duct depending on the surrounding air temperature and the exhaust air temperature. Recommend that a qualified person install insulation on exhaust ducts per standard building practices (typically R-4 rating), or replace uninsulated ducts with insulated ducts.

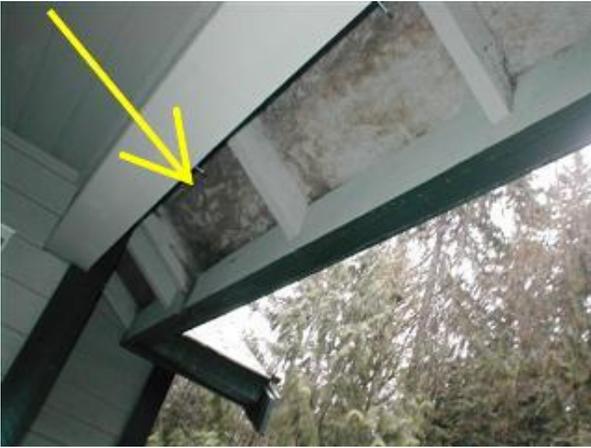
Oriented strand board (OSB) roof sheathing at some open soffits was dark in color. This may be due to high moisture levels from overflowing gutters. Recommend maintaining the roof drainage system and monitoring the roof sheathing. Soffit sheathing could be repainted for cosmetic reasons.

**Photo 38**  
Dark colored roof sheathing over front porch.

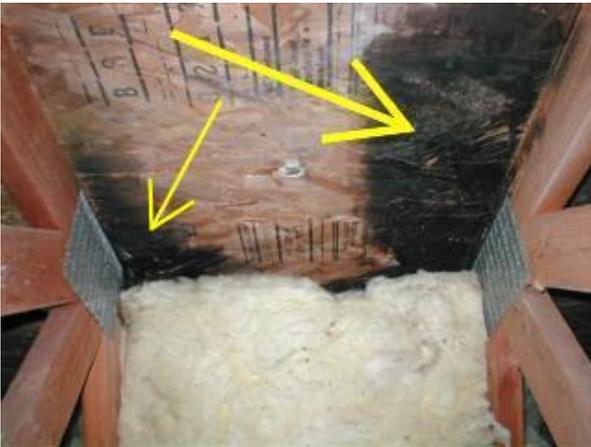
Oriented strand board (OSB) roof sheathing was dark in some areas inside the attic. This may be due to mold growth from substandard ventilation. Mold is not a wood destroying organism like fungal rot. The inspector probed dark areas of sheathing where accessible and found the OSB sheathing to be serviceable. However, recommend consulting with a qualified contractor to determine what repairs may be needed to prevent further deterioration. Note that standard building practices require one free square foot of ventilation for every 150 square feet of attic space, and that vents be evenly distributed between the lowest points of the roof structure and the highest points to promote air circulation. Additional venting may be needed.

**Photo 21**  
Blackened roof sheathing by skylight chase.

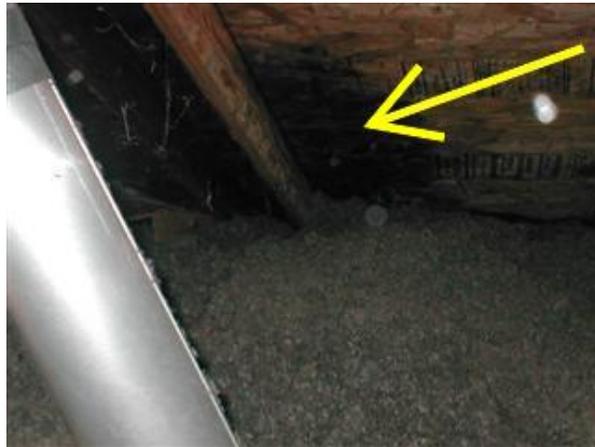
**Photo 22**  
Blackened sheathing by wooden chimney enclosure.

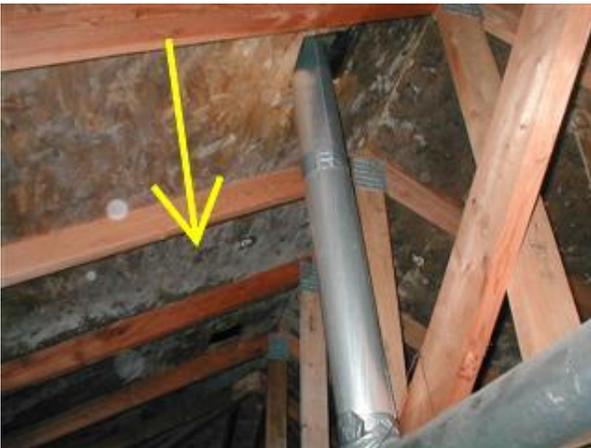
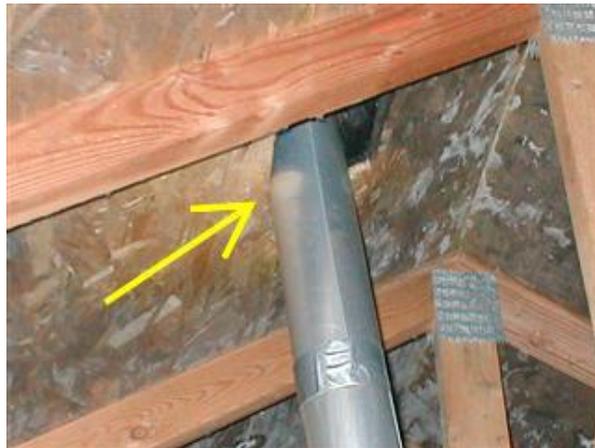
**Photo 23**

Discolored roof sheathing.

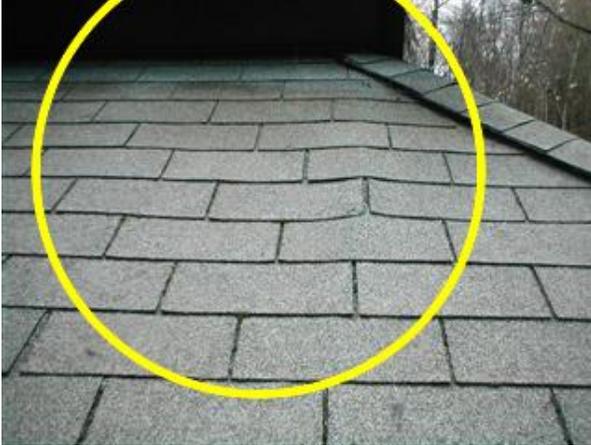
**Photo 7**

A soft spot on the roof surface above the front door was found. This spot was at a location convenient for going up and down from a lower to a higher roof surface. It may have been caused by people jumping down on to the lower roof surface. Even though it was uneven, it appeared to be serviceable, with no repairs needed.

Uneven roof surface above front door.

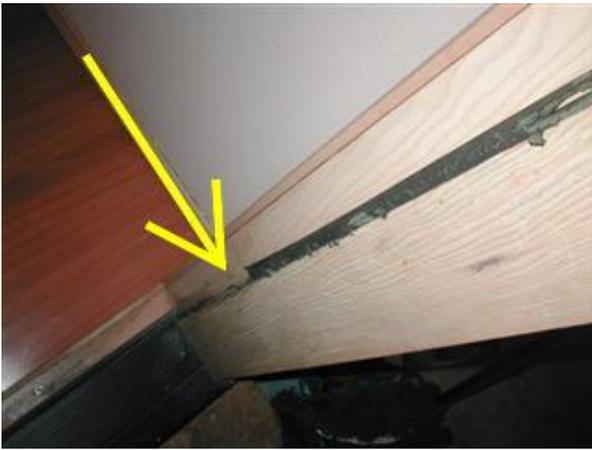
**Photo 9**

Weatherstripping around or at the base of the door between the garage and the house was damaged. House to garage doors are prevent fire and fumes from spreading from the garage to the house. Weatherstripping should form a seal around this door. This is a potential safety hazard. Recommend that a qualified person replace or install weatherstripping as necessary.

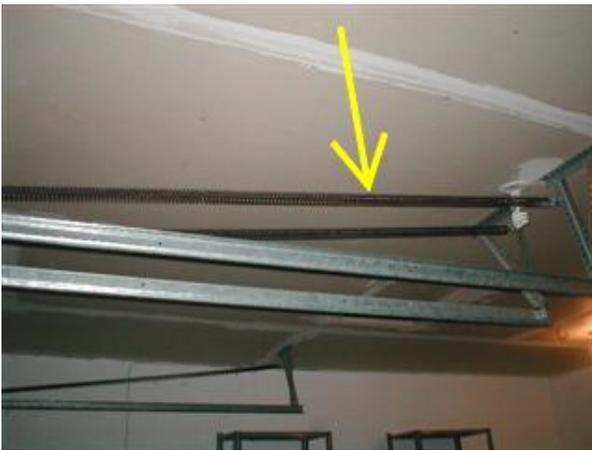
**Photo 10**

One or more extension springs supporting garage vehicle door springs had no safety containment cables installed. These cables prevent injury to people located nearby when springs eventually break. This is a potential safety hazard. Recommend that a qualified contractor install cables where missing per standard building practices. For more information, visit: <http://www.cpsc.gov/cpscpub/pubs/523.html>

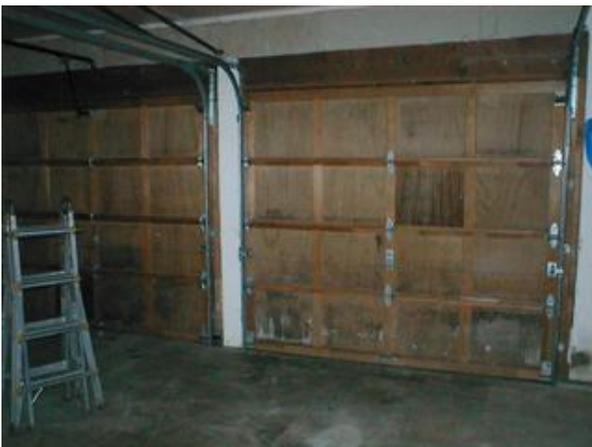
## Photo 11

One or more garage vehicle doors weren't balanced. The door(s) wouldn't stay in place when opened half-way, and fell to the ground instead. This is a potential safety hazard since the door(s) can fall when open and cause injury. A qualified contractor should repair as necessary. For more information on garage door safety issues, visit: <http://www.cpsc.gov/cpscpub/pubs/523.html>

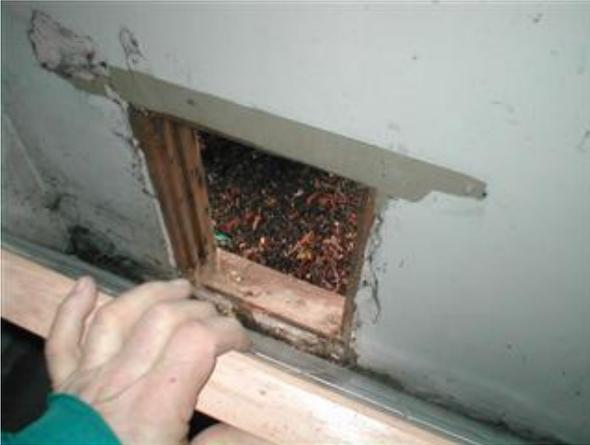
**Photo 15**

A large hole (for a pet door?) had been cut into the garage exterior wall. Recommend that a qualified contractor repair as necessary.

Hole in garage exterior wall (pet door?).

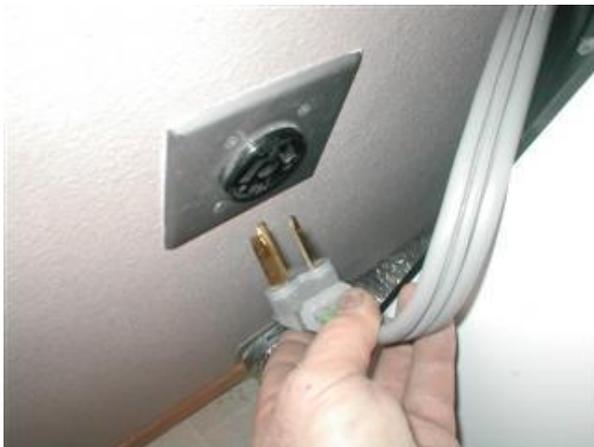
**Photo 34**

A 3-slot receptacle (outlet) was installed for the clothes dryer. Most modern clothes dryers use both 120 and 240 volts (120 for timers and motors, and 240 for heating elements) and either require or are more safely installed with a 4-slot receptacle. With 3-conductor wiring, the ground wire rather than a neutral wire is used to carry the return current back for the 120 volt leg. The clothes dryer's metal frame can become energized if the neutral wire becomes loose at the receptacle or panel. While 3-wire clothes dryer circuits were allowed prior to 1996 and are commonly found, they are considered unsafe due to the risk of shock. Recommend that a qualified electrician convert this to a 4-wire circuit. Note that this may require installing a new circuit wire from the panel to the clothes dryer location.

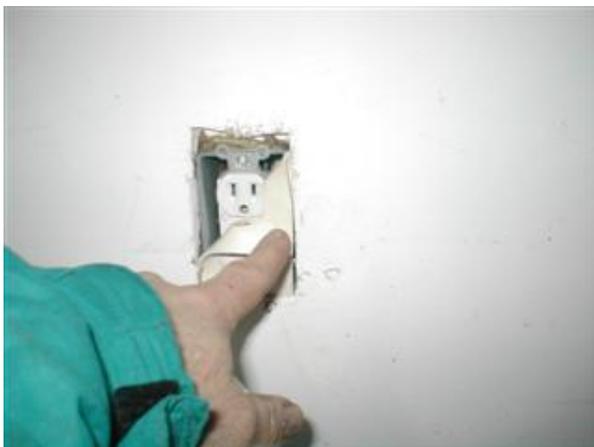
One or more cover plates for switches, receptacles (outlets) or junction boxes were missing or broken. These plates are intended to contain fire and prevent electric shock from occurring due to exposed wires. Recommend that a qualified person install cover plates where necessary.

**Photo 12**  
Garage receptacle.

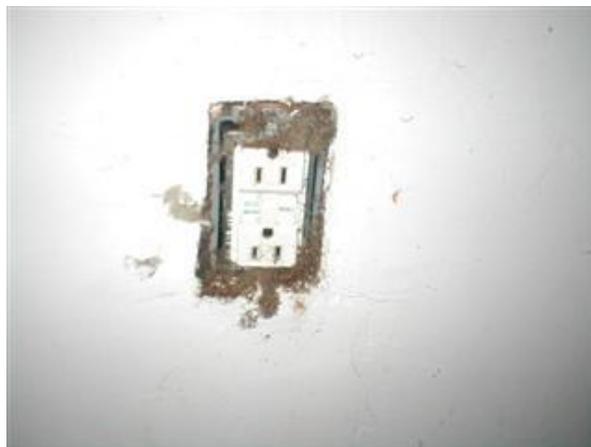
**Photo 13**  
Garage receptacle.

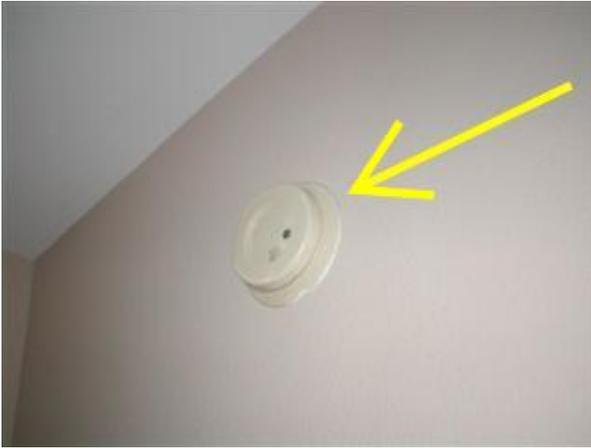
23) 🛠️ Based on the age of this structure and the appearance of existing smoke alarms, the alarms may have been installed more than 10 years ago. According to [National Fire Protection Association](http://www.nfpa.org), aging smoke alarms don't operate as efficiently and often are the source for nuisance alarms. Older smoke alarms are estimated to have a 30% probability of failure within the first 10 years. Newer smoke alarms do better, but should be replaced after 10 years. Unless you know that the smoke alarms are new, replacing them when moving into a new residence is also recommended by NFPA. For more information, visit: <http://www.google.com/search?q=old+smoke+alarms>

**Photo 19**  
Possible older smoke detector.

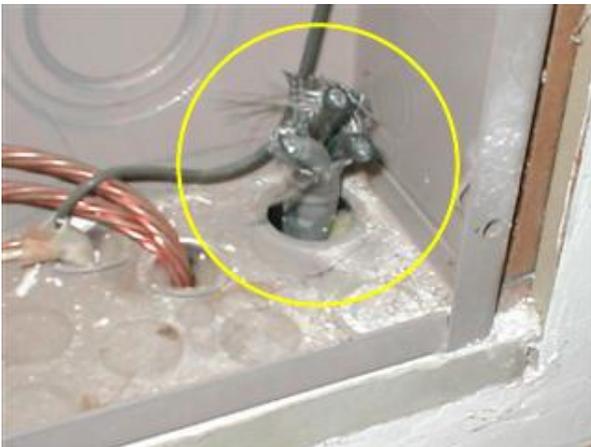
24) 🔧 What appeared to be abandoned wiring was found in the main service panel and crawl space. Labeling on the panel cover indicated that wiring has been installed for a hot tub. Recommend that this wiring be removed and that the knockout hole in the main service panel cover have a cover installed.

**Photo 14**  
Abandoned wiring with no bushing in main service panel.

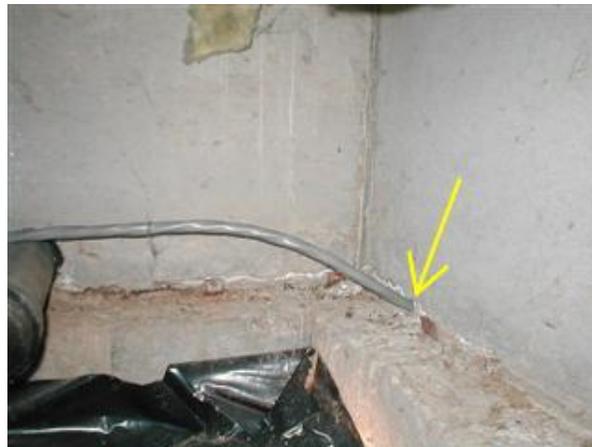
**Photo 48**  
Abandoned wiring (for hot tub?) in crawl space.

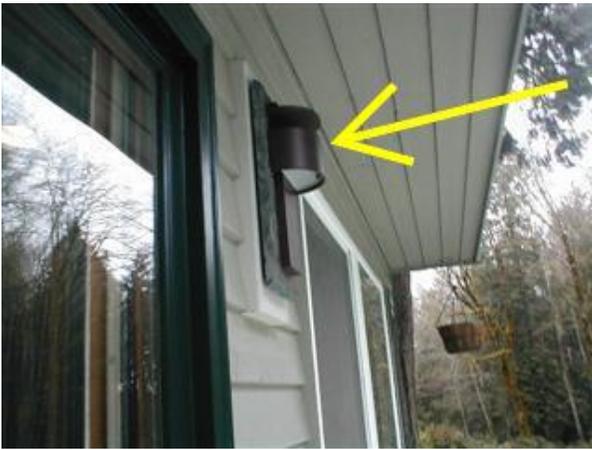
**Photo 30**

25) 🔍 One or more light fixtures were inoperable (didn't turn on when nearby switches were operated). Recommend further evaluation by replacing bulbs and/or consulting with the property owner. If replacing bulbs doesn't work and/or no other switch(es) can be found, then recommend that a qualified electrician evaluate and repair or replace light fixtures as necessary.

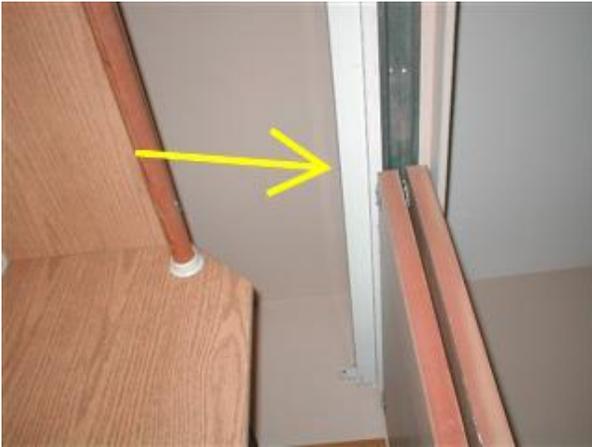
**Photo 41**

Bulbs in one or more light fixtures were missing, inoperable or broken. These light fixtures couldn't be fully evaluated. If replacement bulbs are inoperable, then recommend that a qualified electrician evaluate and repair or replace light fixtures as necessary.

Fluorescent light fixture in closet.

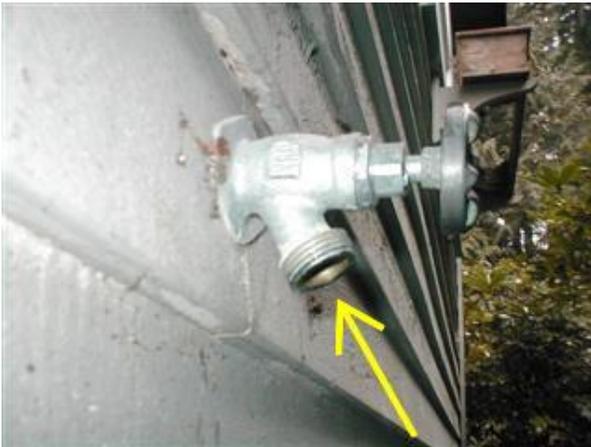
**Photo 3**

**27)** 🚰🔧 One or more hose bibs (outside faucets) were missing backflow prevention devices. These devices reduce the likelihood of gray water entering the potable water supply. Recommend installing backflow prevention devices on all hose bibs where missing. They are available at most home improvement stores and are easily installed. For more information, visit:

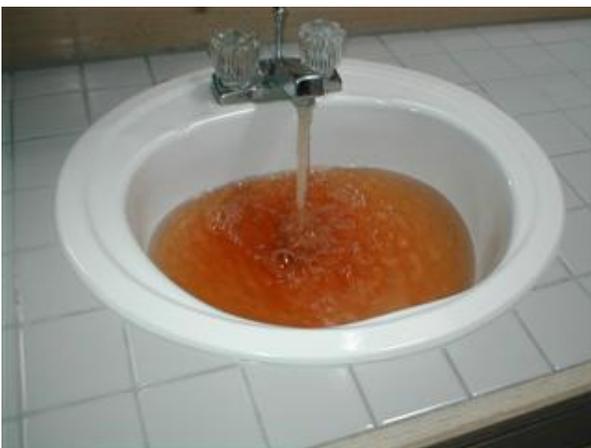
**Photo 43**

**28)** 🔧🔍 Water was discolored when bathtubs or sinks were filled, or when showers were operated. This can be caused by water stagnating in water supply pipes, rust accumulating in pipes or in the water heater, or sediment being present in the water supply. Recommend flushing the water supply piping and the water heater. If that fails to resolve the issue, then have a qualified plumber evaluate and repair as necessary.

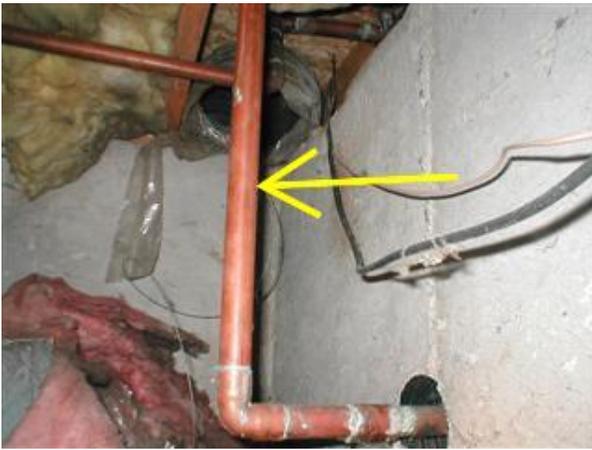
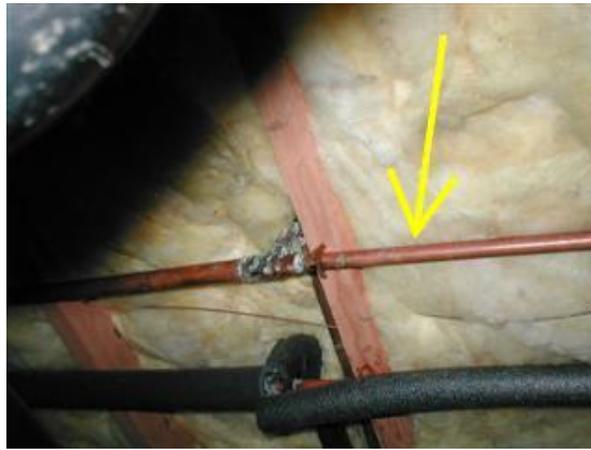
**29)** 🔧 Water supply pipes in the crawl space were not insulated. Recommend insulating pipes per standard building practices to prevent them from freezing during cold weather, and for better energy efficiency with hot water supply pipes.

**Photo 51**  
Main service water supply pipe in crawl space.

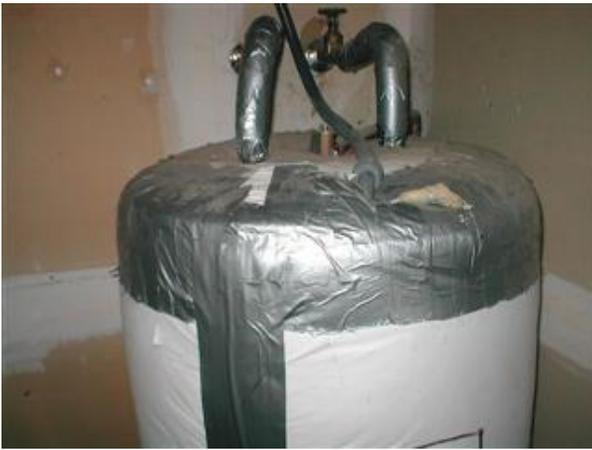
**Photo 18**

The water heater did not have earthquake straps or struts installed. This is a potential safety hazard in the event of an earthquake due to the risk of the water heater tipping over, gas lines breaking if it's gas-fired, or electric wiring being damaged if powered by electricity. Leaks can also occur in water-supply pipes. Recommend that a qualified person install earthquake straps or struts as necessary and per standard building practices.

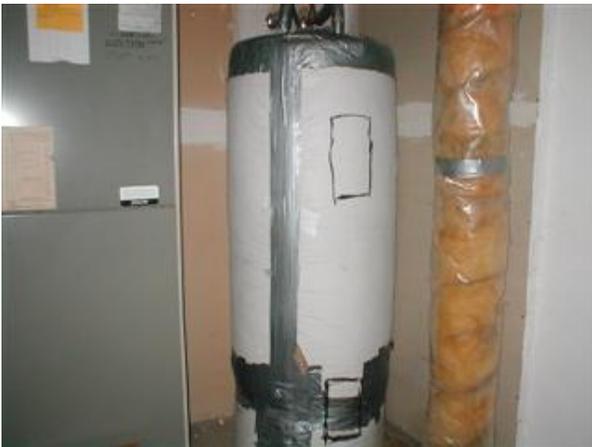
**Photo 17**

A permanently installed insulated jacket was installed on the water heater. It obscured the manufacturer's information label and/or most of the water heater. The inspector was unable to fully evaluate the water heater.

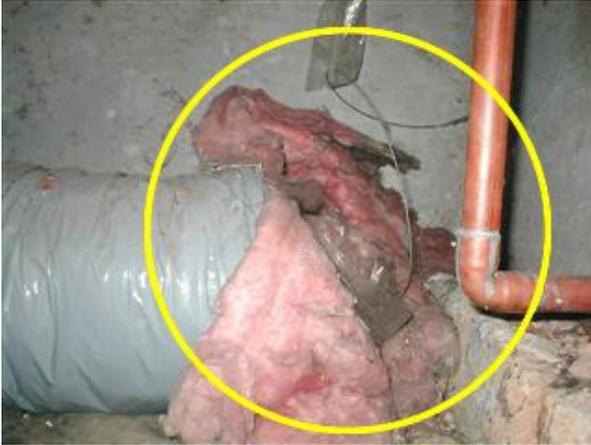
One or more heating or cooling ducts in an unconditioned space (e.g. crawl space, attic or basement) have come apart, or have significant gaps at junctions. This will result in reduced energy efficiency, and possibly increased moisture in surrounding spaces. A qualified contractor should make permanent repair as necessary. For example, by securely supporting ducts and installing approved tape or mastic at seams.

**Photo 49**  
Broken duct in crawl space.

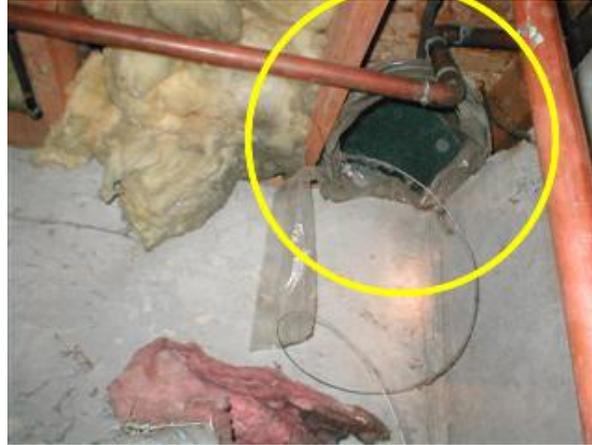
**Photo 50**  
Other end of broken duct.

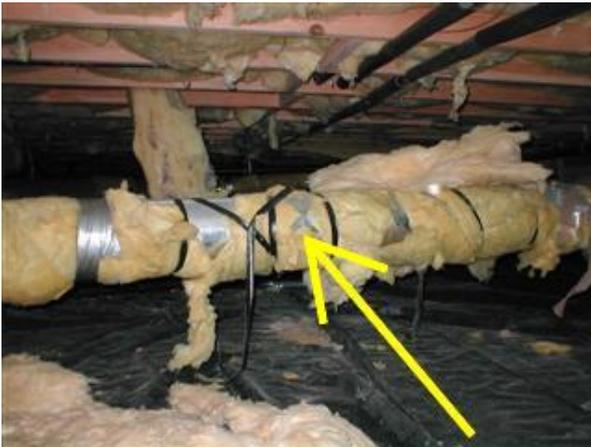
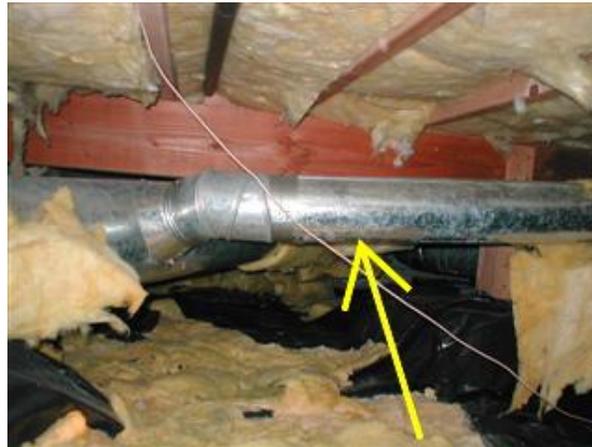
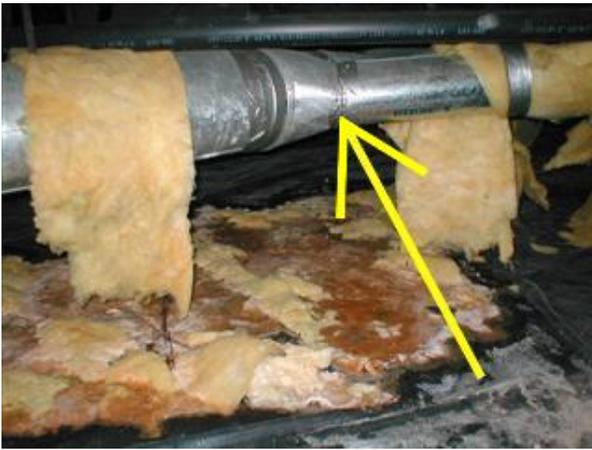
One or more heating or cooling ducts in an unconditioned space (e.g. crawl space, attic or basement) were not insulated, or the insulation was damaged or deteriorated. This can result in reduced energy efficiency, moisture inside heating ducts, and/or "sweating" on cooling ducts". Recommend that a qualified person repair as per standard building practices. For example, by wrapping ducts in insulation with an R-value of R-8.

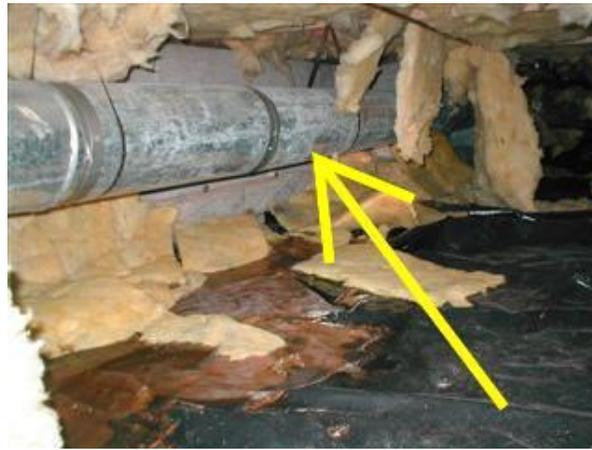
**Photo 55**

Ductwork insulation lying in water in crawl space.

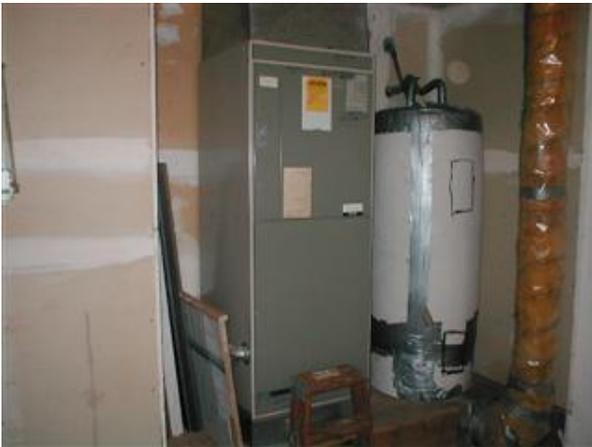
**Photo 16**

The last service date of this system appeared to be more than two years ago, or the inspector was unable to determine the last service date. The client should ask the property owner when it was last serviced. If unable to determine the last service date, or if this system was serviced more than two years ago, a qualified heating and cooling contractor should inspect, clean, and service this system, and make repairs if necessary. This servicing should be performed every few years in the future, or per the contractor's recommendations.

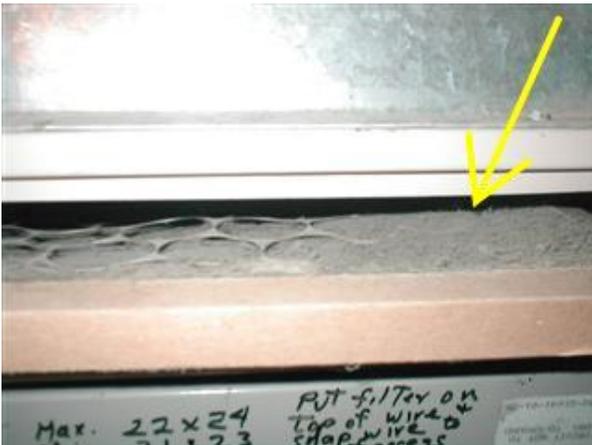
**Photo 44**

One or more air filters were dirty. A qualified person should replace filter(s) as necessary. Filters should be checked monthly and maintained as necessary in the future.

Dirty furnace filter.

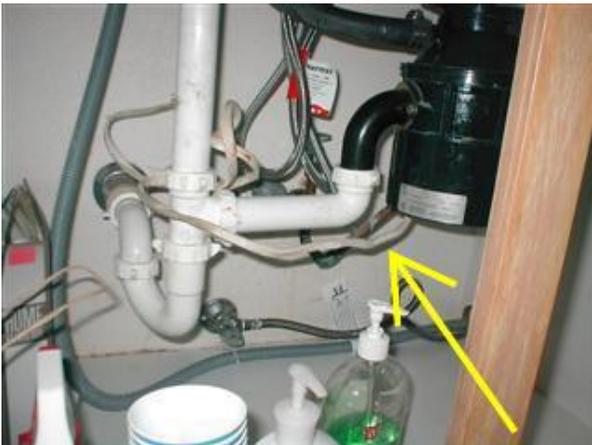
## Photo 27

** Electrical wiring for the under-sink food disposal was substandard. Non-metallic sheathed wiring was exposed and subject to damage. The wiring can be damaged by repeated bending or contact with sharp objects. BX-armored conduit should be installed to protect wiring, or a flexible appliance cable should be installed. This is a potential shock hazard. Recommend that a qualified contractor repair per standard building practices.

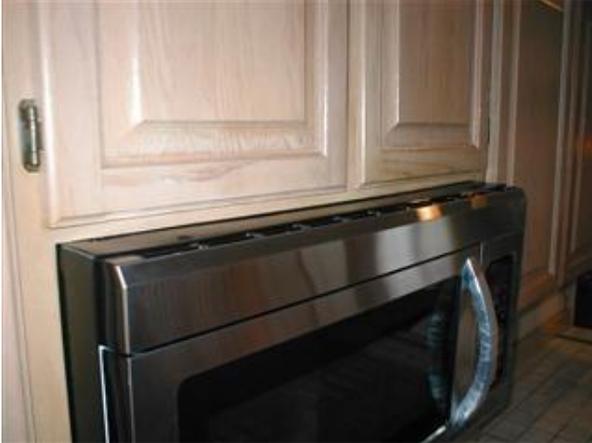
Photo 29

40) 🔧🔍 An exhaust hood was installed over the cook top or range, but the fan recirculated the exhaust air back into the kitchen. This may be due to no duct being installed, baffles at the front of the hood not being installed, or a problem with the duct. This can be a nuisance for odor and grease accumulation. Where a gas-fired range or cook top is installed, carbon monoxide and excessive levels of moisture can accumulate in living spaces. Recommend that a qualified contractor evaluate and repair as necessary so exhaust air is ducted outdoors.

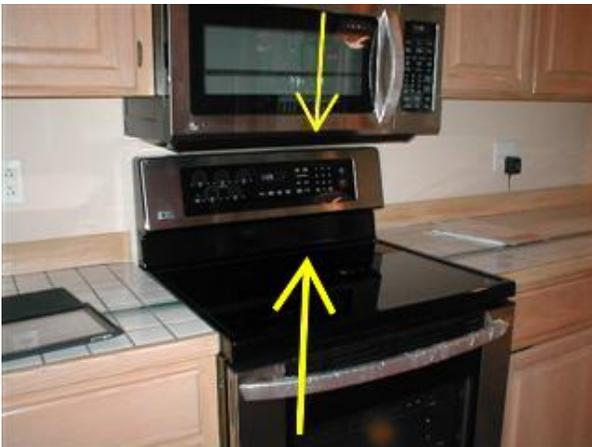
Photo 28

41) 🔧 The clearance between the stove top and the base of the exhaust hood above was too low. While the recommended height varies per the hood manufacturer, standards usually call for a minimum of 24 inches of clearance. A low hood height can restrict visibility of the stove top. Recommend that a qualified contractor repair per standard building practices.

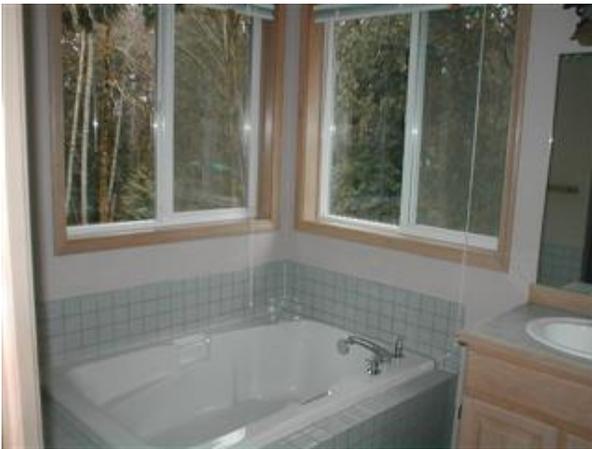
**Photo 20**

The inspector was unable to verify that the glass used in one or more windows by the bathtub at location(s) #C was approved safety glass. Glazing that is not approved safety glass located in areas subject to human impact is a potential safety hazard. Standard building practices require that approved safety glass be used in enclosures for bathtubs, showers, spas, saunas and steam rooms, and in windows where the bottom edge of the window is less than 60 inches above the drain inlet or standing surface. Wire-reinforced glass is not acceptable. Recommend that a qualified contractor evaluate and replace glass if necessary, and per standard building practices.

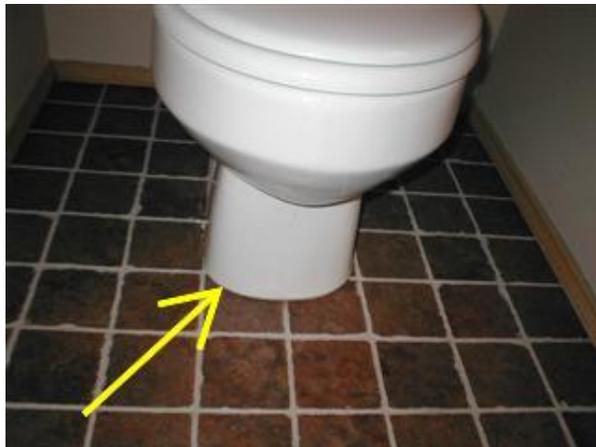
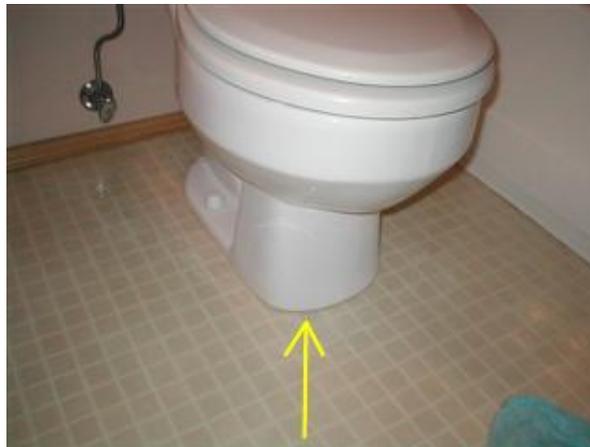
No caulk was installed around the base of the toilet at location(s) #A, B where fastened to the floor. Caulk should be applied approximately 3/4 of the way around the toilet base at the front for sanitary purposes and to prevent water intrusion. The back should be left uncaulked so water can escape if a leak ever occurs. Recommend that a qualified person caulk around the toilet base(s) per standard building practices.

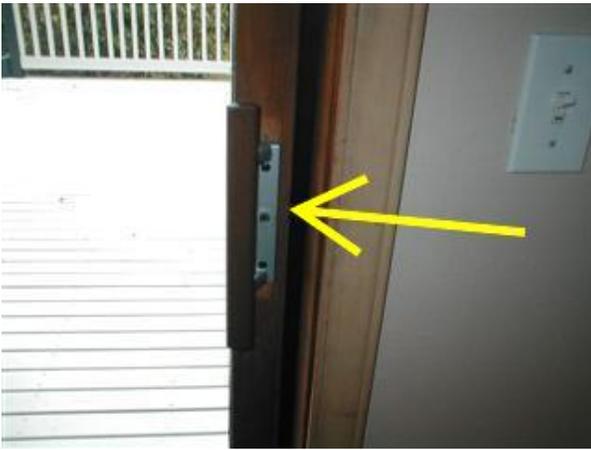
**Photo 31**

The lock mechanisms on one or more sliding glass doors were inoperable. A qualified person should repair as necessary.

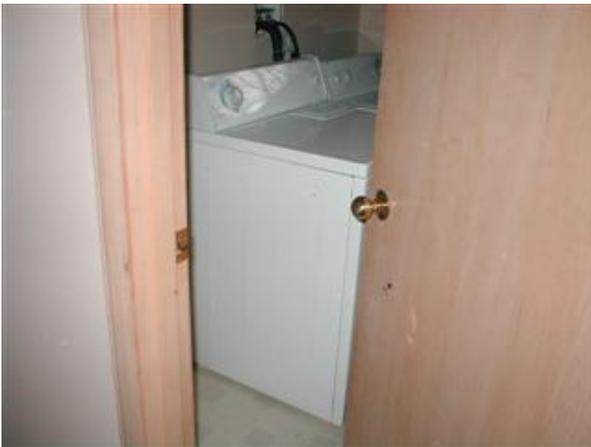
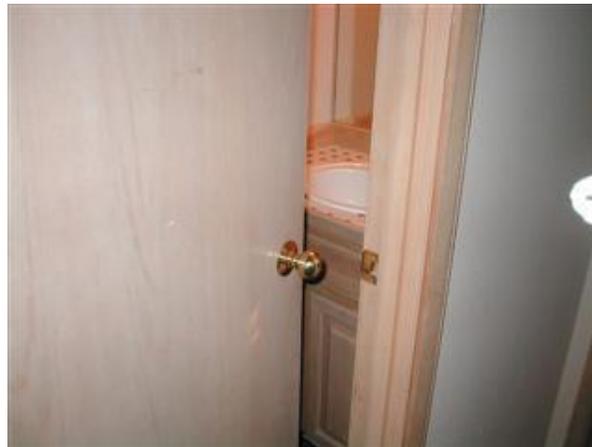
One or more interior doors wouldn't latch or were difficult to latch. Recommend that a qualified person repair as necessary. For example, by adjusting latch plates or locksets.
