Alltell Home Inspection

Home Inspection Report

Property address: **123 somewhere
Any where usa**

Inspection date: **02/01/2004**

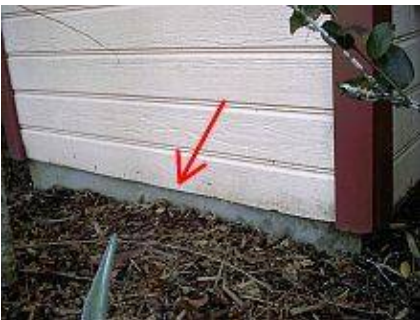
Photo 3

1) *Repair/Replace* - This property was clad with composition wood fiber siding. Many brands of this type of siding by different manufacturers are known to deteriorate or fail prematurely due to moisture penetration. Failure is typically visible in the form of swelling, cracking and delamination, especially at the bottom edges. This type of damage was found at several places.

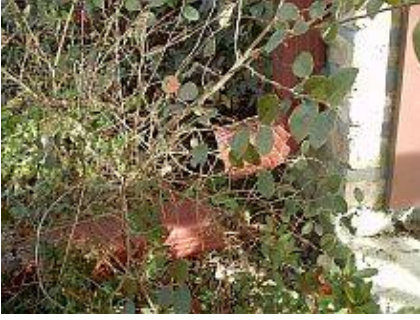
Photo 4

5) *Maintain* - Vegetation (trees, shrubs and vines) are in contact with the structure's exterior. This is a conducive condition for wood destroying insects and organisms. Vegetation can serve as a conduit for insects and may retain

moisture against the exterior after it rains. Recommend pruning or removing vegetation as necessary so there's at least a one foot gap between all vegetation and the structure's exterior.

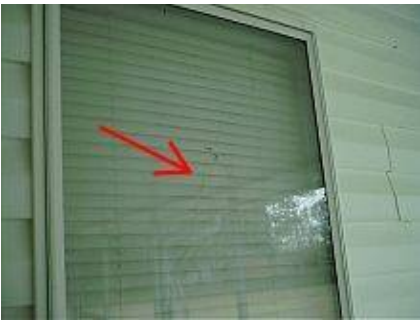
Photo 5

26) *Repair/Replace* - Window is cracked at the rear patio. Recommend replacing glass.

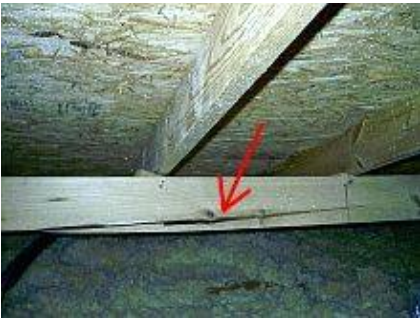
Photo 6

37) *Repair/Replace* - A cracked support purlin was found in the attic above the entrance stairs. Recommend contacting a licensed contractor for repairs.

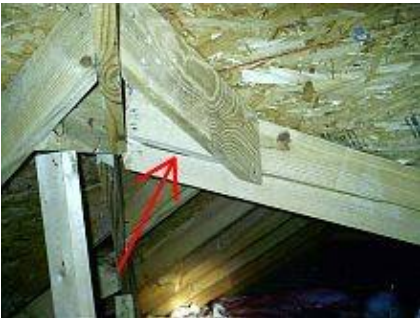
Photo 8

38) *Repair/Replace* - A cracked valley rafter was found at the right side of the attic. Additional wood should be added the sides of the rafter (sistered) to strengthen the cracked area. Recommend contacting a licensed contractor for repairs.

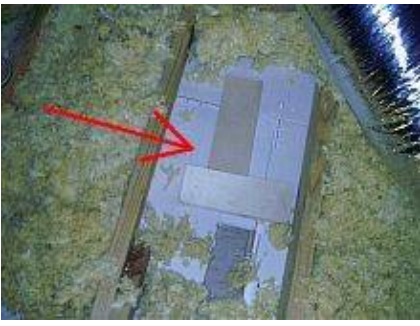
Photo 7

39) *Repair/Maintain* - Insulation is missing from the ceiling above the kitchen. Recommend installing insulation in this area to increase energy efficiency.
