# A.M.C. Home Inspections inc.

Property address: **6342 Kentstone Dr.**

Inspection date: **Tuesday, June 02, 2009**

Overview: There are numerous issues with this home. Roof decking is "mushy" all over. Numerous areas of trim on exterior of home have become rotted due to moisture and need to be replaced. Excessive cracking in the walls and ceilings. Windows are cheaply made and one has already been replaced, inspector feels like the windows will be problematic in the future. Overall, home has numerous problems with the potential of there being major repairs in the near future.

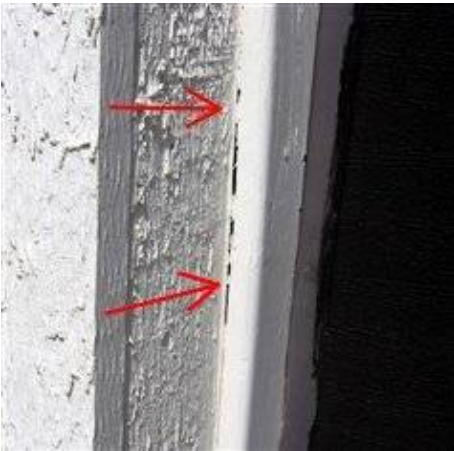
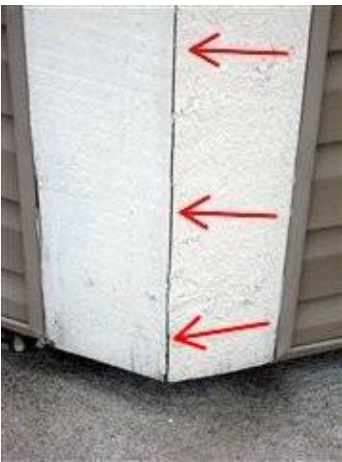
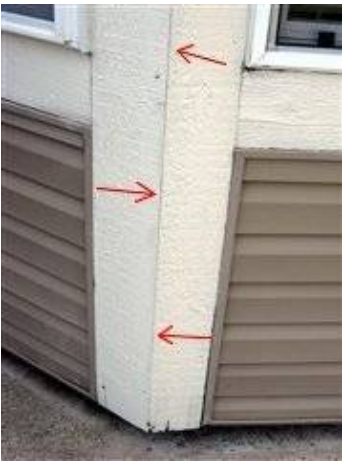
4) 🛠️🔪🔧 Caulk is missing or deteriorated in some areas. Recommend caulking where necessary.

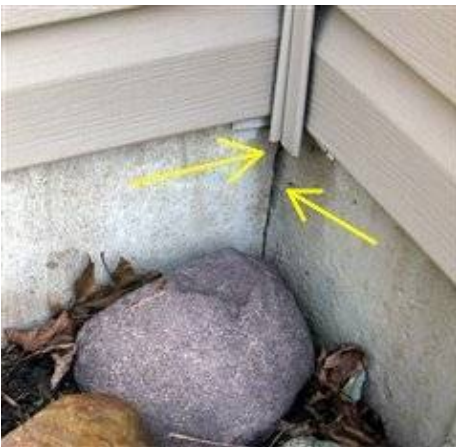
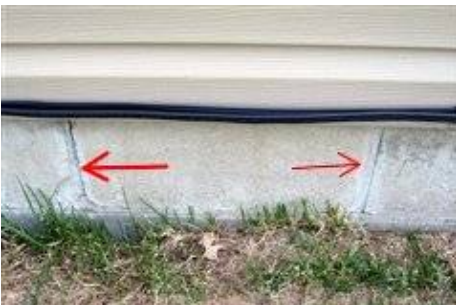
Moderate cracks (1/8" to 3/4") present in foundation. Recommend sealing cracks to prevent water infiltration. Numerous products exist to seal such cracks including:

- Hydraulic cement. Requires chiseling a channel in the crack to apply. See <http://www.quickrete.com/catalog/HydraulicWater-StopCement.html> for an example.
- Resilient caulks (easy to apply). See <http://www.quickrete.com/catalog/GrayConcreteRepair.html> for an example.
- Epoxy sealants (both a waterproof and structural repair). See <http://www.mountaingrout.com/> for examples of these products.

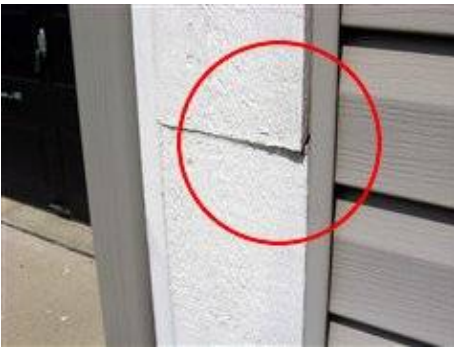
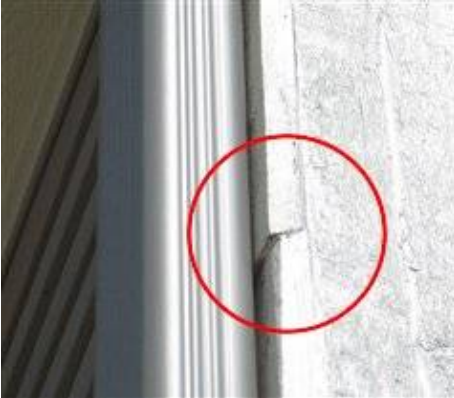
There are several pieces of wood trim that are starting to come apart from the house and need to be addressed. Recommend having qualified contractor evaluate and make the necessary repairs.

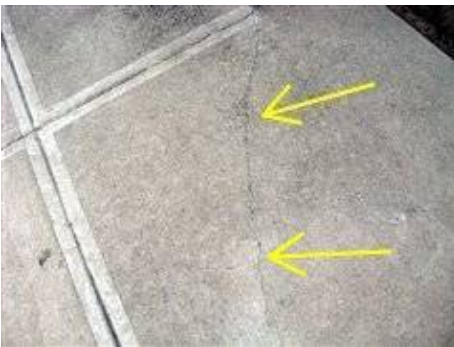
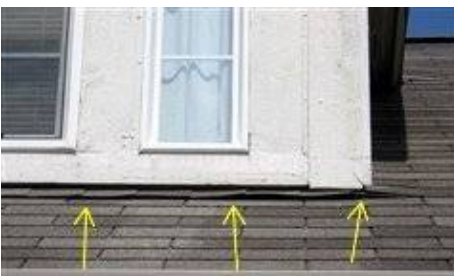
Shingles in the front of the house on the overhang appear to be curling up and needs to be replaced. Recommend having a qualified roofing contractor evaluate and make the necessary repairs.

Back patio concrete has cosmetic crack in the patio. It is only a cosmetic crack and does not require any action.

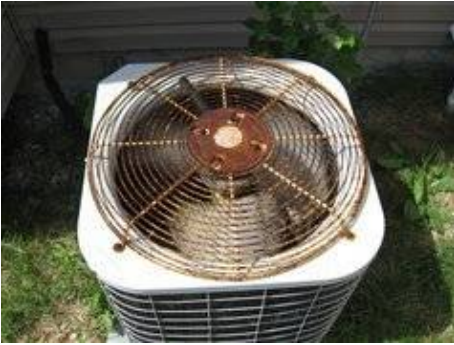
Photo 8

The grating for the ac unit outside appears to be very rusty which leads inspector to believe that there is a significant amount of water dumping on the unit. Inspector recommends having qualified HVAC technician evaluate and make the necessary recommendations and repairs.

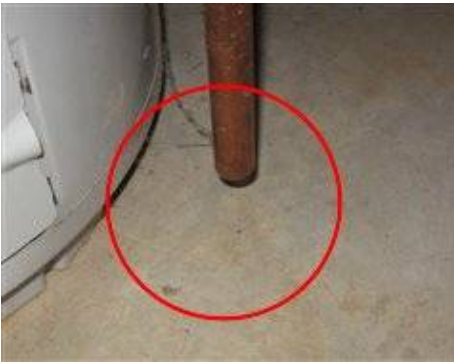
Photo 55

The drain line to the water heater's temperature-pressure relief valve is routed directly down over the cement floor with no drain underneath which poses a problem of flooding in an incident that the relief valve is used.

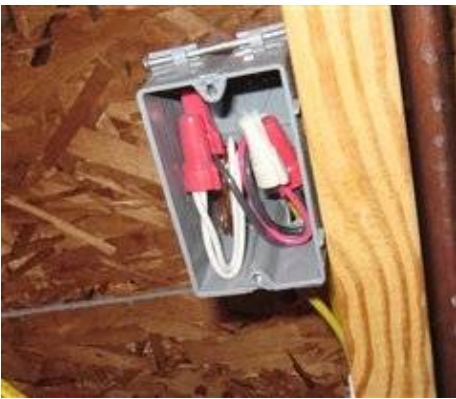
Photo 54

Cover plate(s) are missing from one or more electric junction boxes. They are intended to contain fire and prevent electric shock from exposed wires. This is a safety hazard and poses a risk of both fire and shock. Recommend installing cover plates over junction boxes where missing.

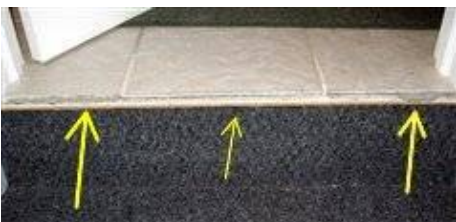
Photo 51

The top step going down to the basement needs a piece of trim to cover the exposed and unfinished tile/pad/wood floor.

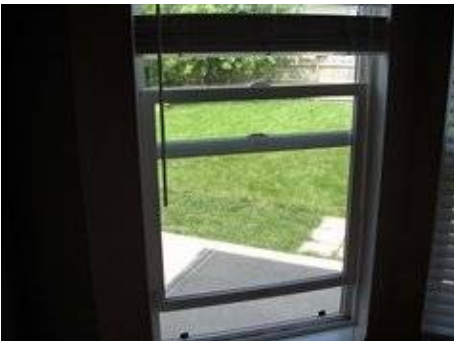
Photo 29

All of the windows in the home are inferior quality. Inspector noted that it felt like the windows were going to fall out of the home when testing each one to open vertically and also when testing to see if they would open towards him to clean. One window has already had to be replaced.

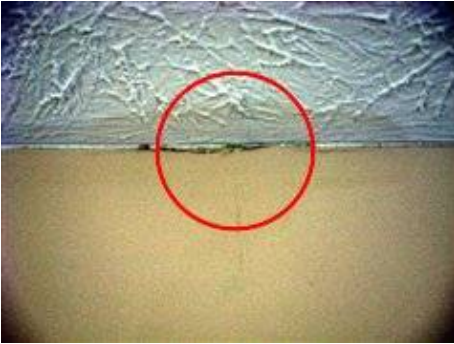
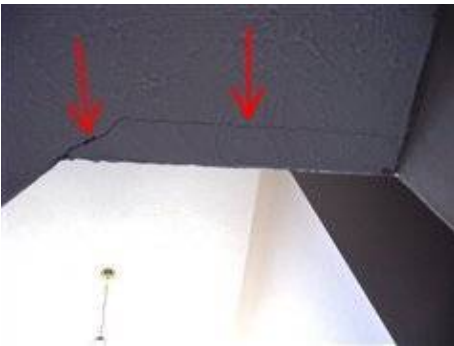
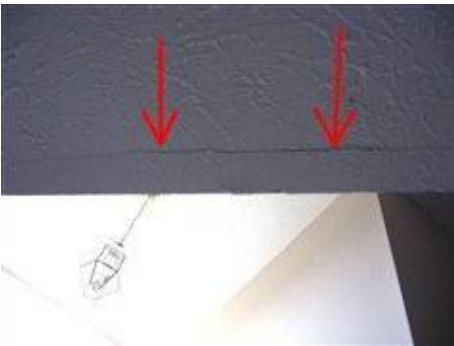
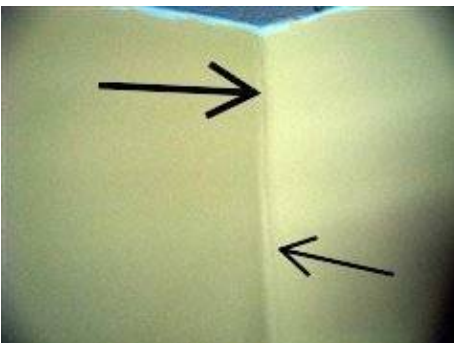
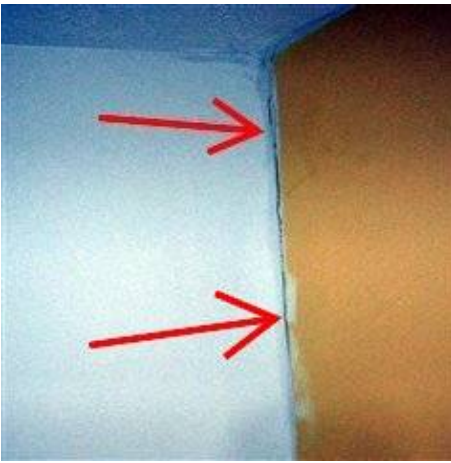
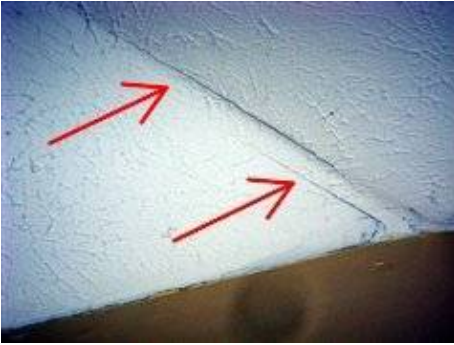
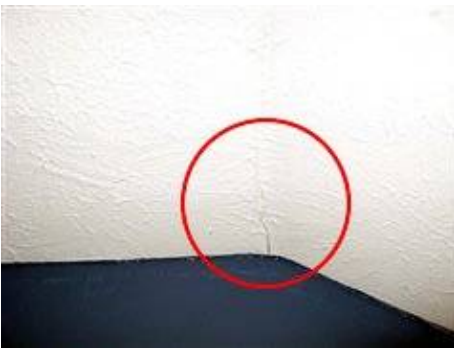
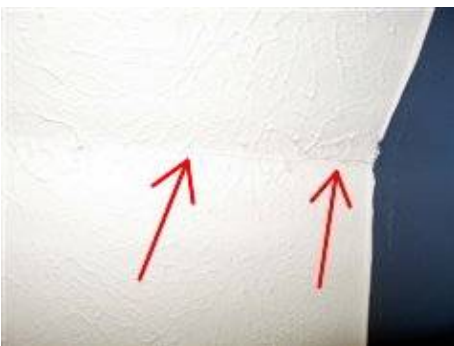
Minor cracks found in ceiling. These are only a cosmetic concern. No action is recommended. Inspector notes that cracking is excessive.

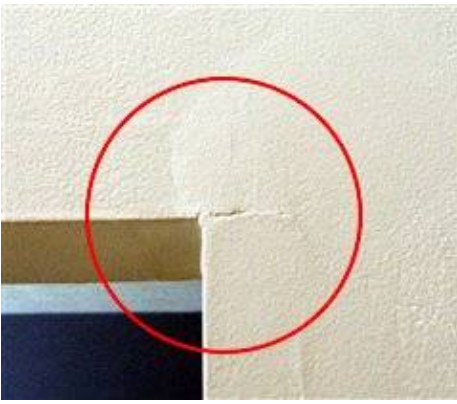
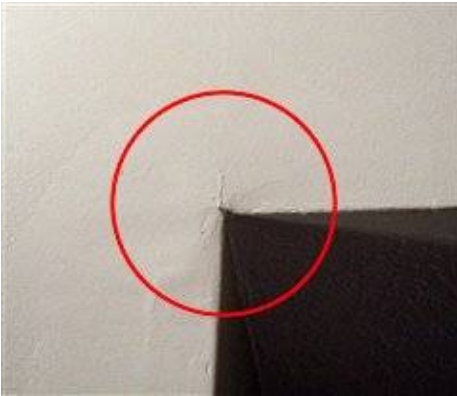
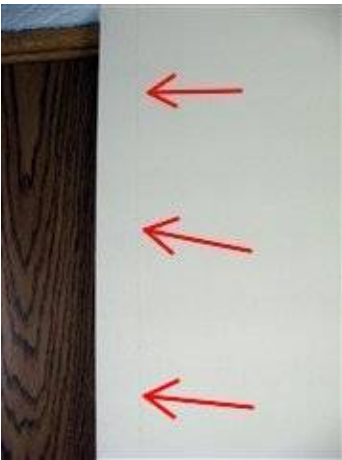
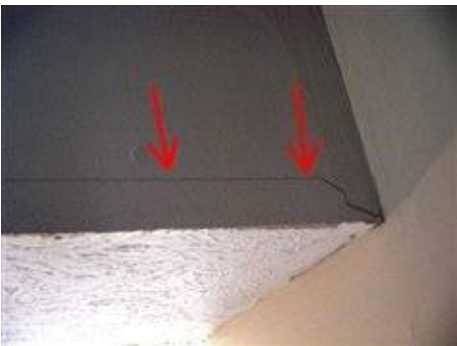
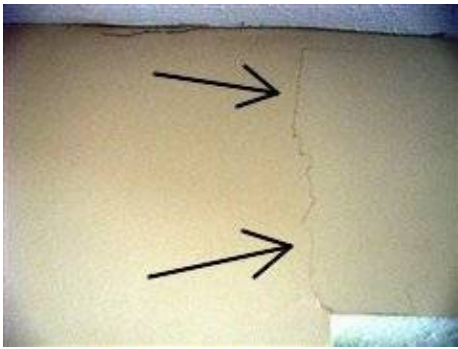
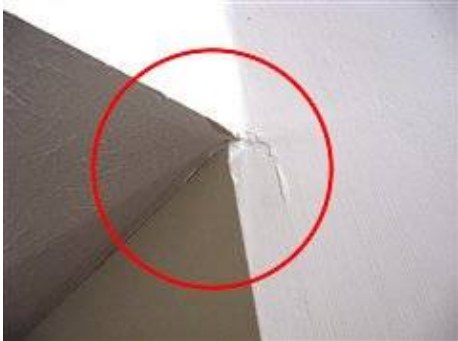
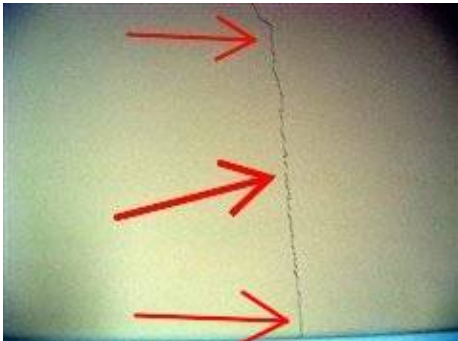
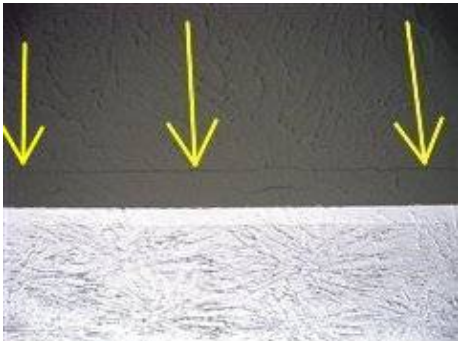
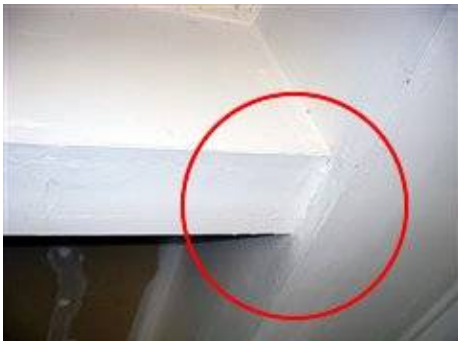
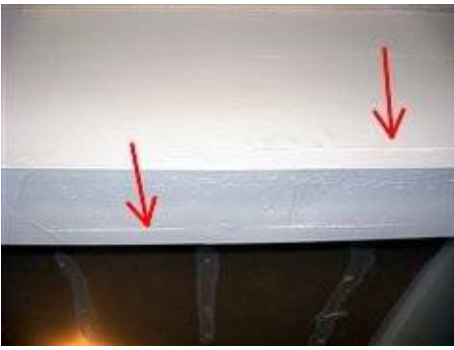
Minor cracks found in walls. These are only a cosmetic concern. No action is recommended. Inspector notes that cracking is excessive in nature.

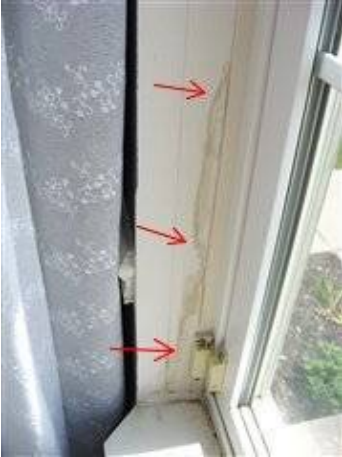
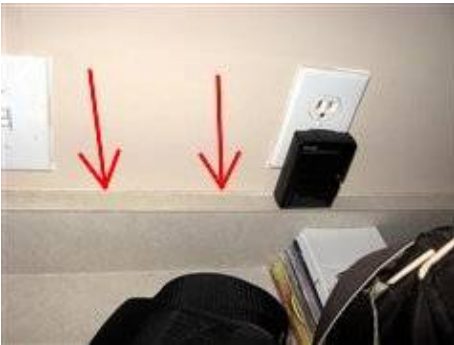
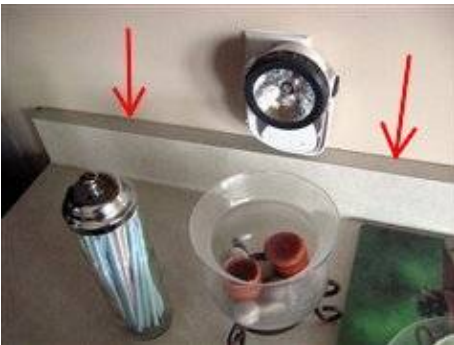
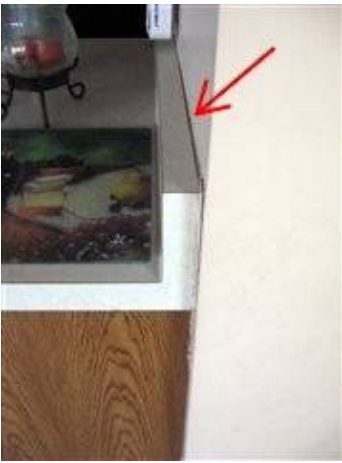
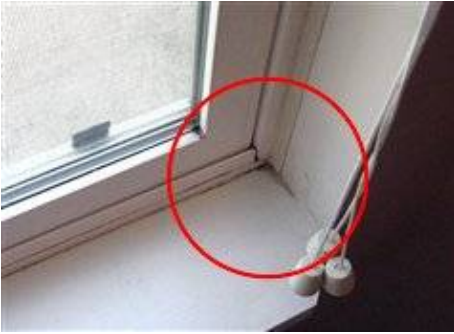
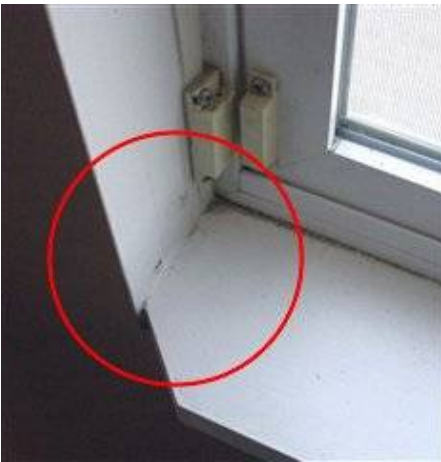
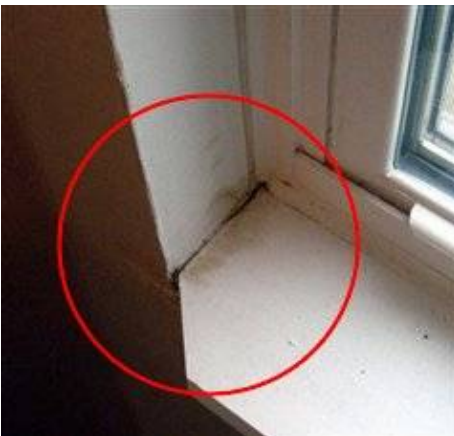
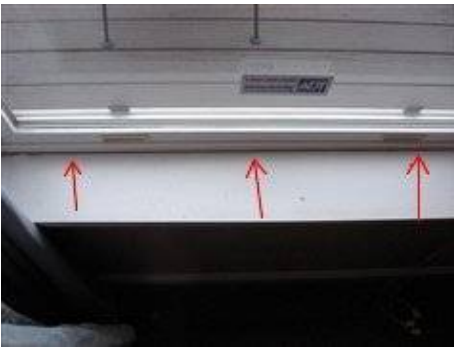
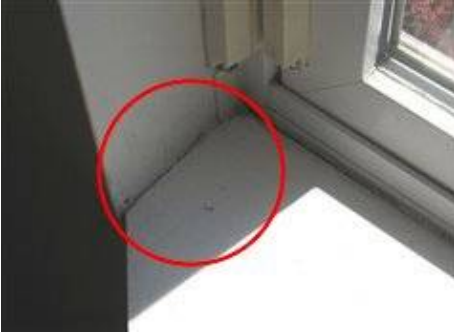
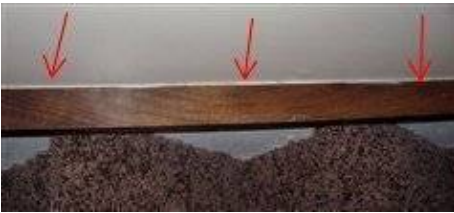
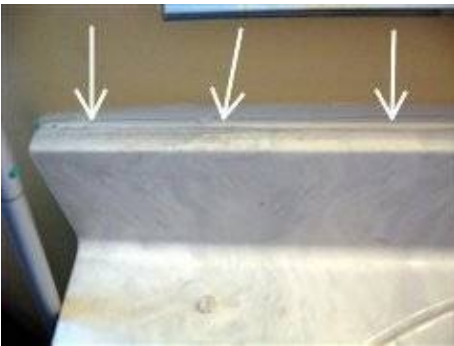
There is numerous caulking that needs to be done throughout the home. Recommend caulking where needed.

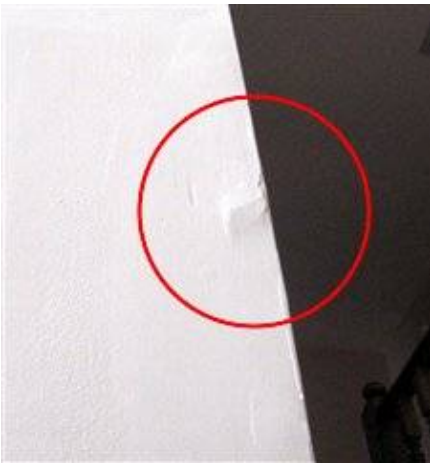
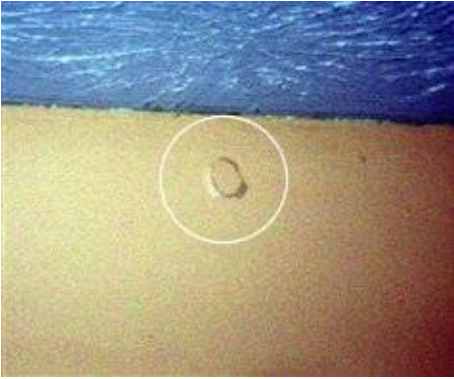
34) There are nail pops throughout the home, these are of a cosmetic nature only. On both walls leading down to the basement, it is very evident that the screws or nails that were used to install are coming out and will ALL be popping through the paint sooner than later.

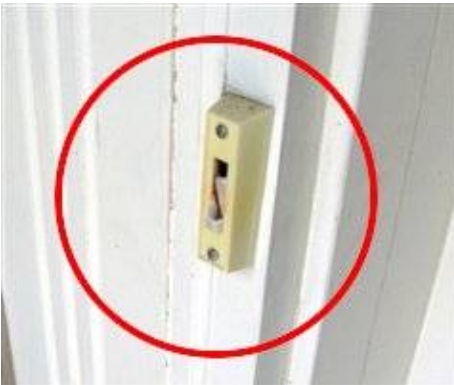
Photo 23

35) Doorbell is button is damaged and needs to be replaced.
