## Standard Home Inspection Report

Client(s): **Sample Report**

Property address: **Westinspect**

Inspection date: **2010**

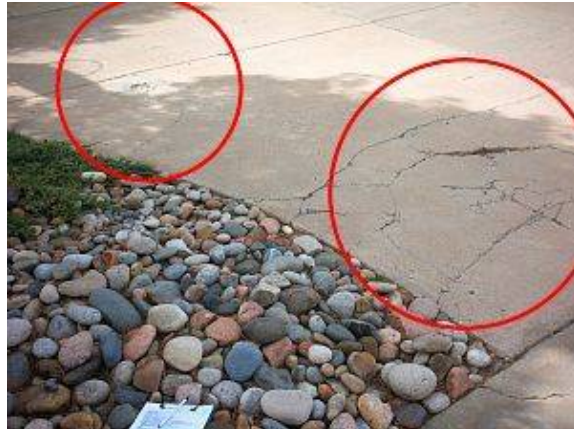
The driveway had significant cracks and/or deterioration in the southeast corner. Recommend repairing or replacing this section of driveway. Other minor cracks were noted, and many had been repaired with caulk. Recommend repairing all minor cracks with concrete caulk or similar product. [See photo 2](#)

Photo 2  
driveway deterioration

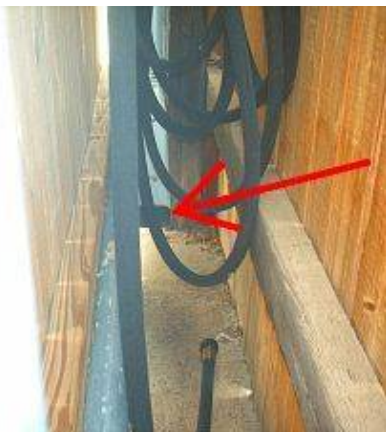
The downspout extension at the southeast corner of the house was ineffective, due to being located between two confining fence sections. This will prevent water from flowing freely away from the house, and can result in water accumulating around the structure's foundation. Accumulated water is a conducive condition to wood destroying insects and organisms, and may also cause the foundation to settle and possibly fail over time. Repairs should be made as necessary, such as installing or repositioning splash blocks, or installing and/or repairing tie-ins to underground drain lines, so rain water is carried at least several feet away from the structure to soil that slopes down and away from the structure. [See photo 3](#)

Photo 3  
downspout between two fence sections

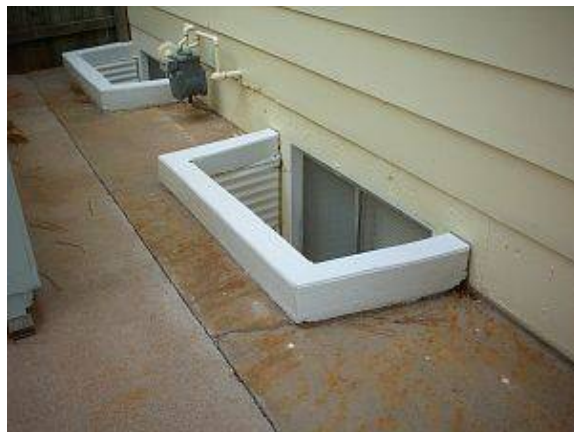
Three window wells below ground level did not have covers. This can allow water to penetrate to the foundation or basement. Recommend installing window well covers on all window wells. If window is located at a room that will be used as a bedroom, then also recommend installing hinges and a standard window well ladder, so that the window well can be used as a fire escape. [See photo 4](#)

Photo 4  
window wells

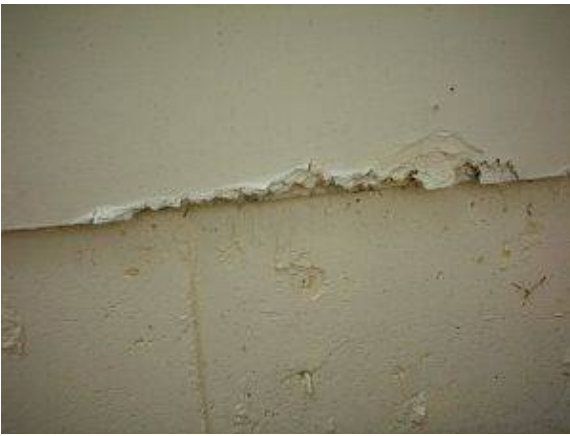
This home was clad with composition wood fiber siding. Some areas of siding on this structure showed symptoms of swelling, cracking, or delamination, but it appeared that the siding had not deteriorated to the point of needing replacement. Some manufacturers (Louisiana Pacific) recommend a repair process for this siding where affected areas are sealed with "Permanizer Plus", a flexible primer made by Pittsburgh Paint, followed by two coats of 100% acrylic latex paint. This sealant must be applied to the bottom edges using a brush. The face of the siding can be sprayed. The "Permanizer Plus" sealer isn't required for edges that aren't swollen, cracked or deteriorated, but the acrylic latex should still be brushed on these edges. At a minimum, recommend having a qualified contractor seal and repaint as described above, or by other methods specified by the siding's manufacturer. [See photo 5](#)

Photo 5  
deterioration at lower edge of siding

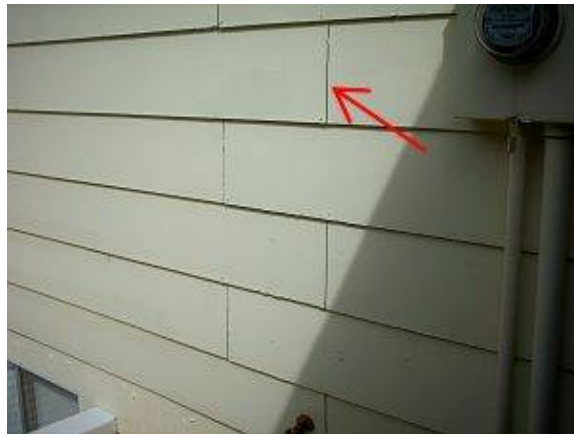
Random gaps were found between sections of siding. Gaps should be sealed or caulked as necessary to prevent moisture intrusion and entry by vermin. [See photo 6](#)

Photo 6  
gaps between siding pieces

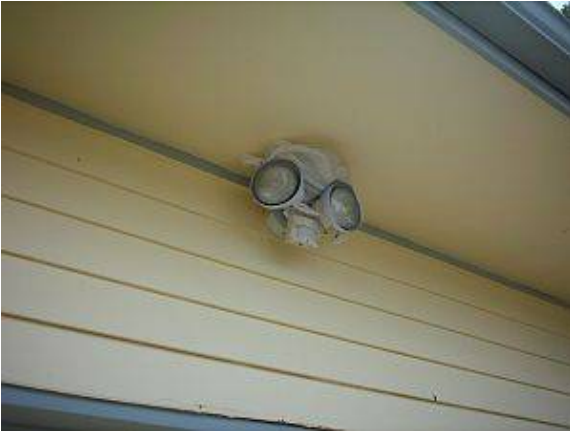
A plastic bag was wrapped around the driveway light. The seller reported that the bag keeps barn swallows from nesting in that fixture. [See photo 7](#)

Photo 7  
plastic wrap at driveway light

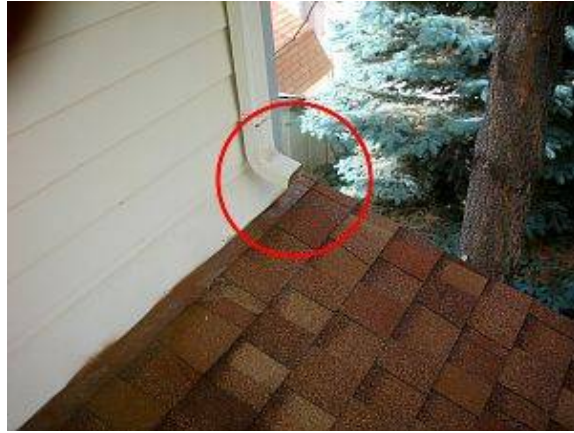
One downspout terminated above roof surfaces rather than being routed to gutters below or to the ground

level. This is very common, but it can reduce the life of roof surface materials below due to large amounts of water frequently flowing over the roof surface. Granules typically are washed off of composition shingles as a result, and leaks may occur. Recommend considering having a qualified contractor install extensions as necessary so downspouts don't terminate above roof surfaces. [See photo 8](#)

Photo 8  
downspout above roof

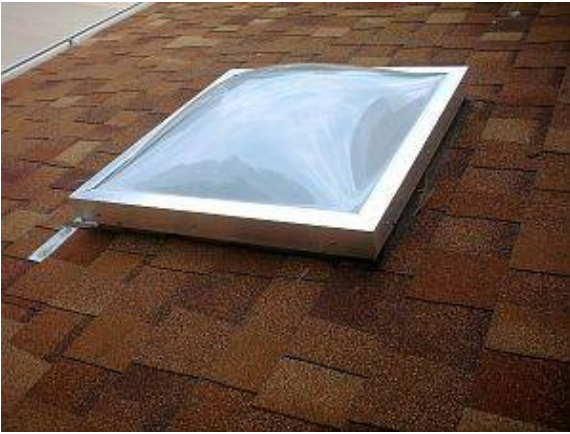
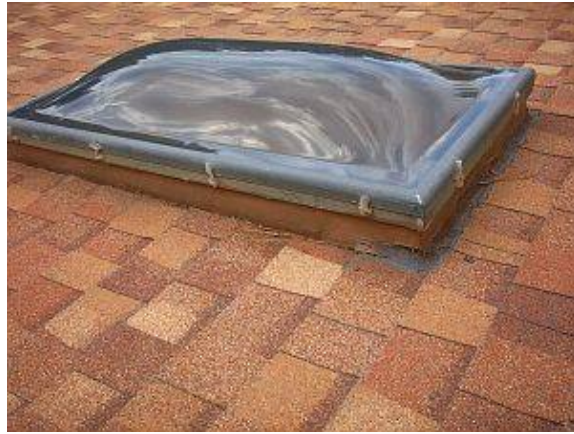
Recommend resealing around all four skylights with roofing caulk, as a standard precaution to avoid water intrusion. See line 25 below. [See photo 9](#) [See photo 10](#)

25) 🔧 The skylight in the small front bathroom (near the front entry) showed evidence of past leaking. Paint was bubbled and soft in two small areas, and a thicker layer of caulk was noted around the interior edges of the skylight. Recommend sealing around the exterior of this skylight. See line 9 above. Recommend occasional monitoring to make sure skylight does not leak during heavy rain or snow.

Photo 9  
front skylight

Photo 10  
back skylight

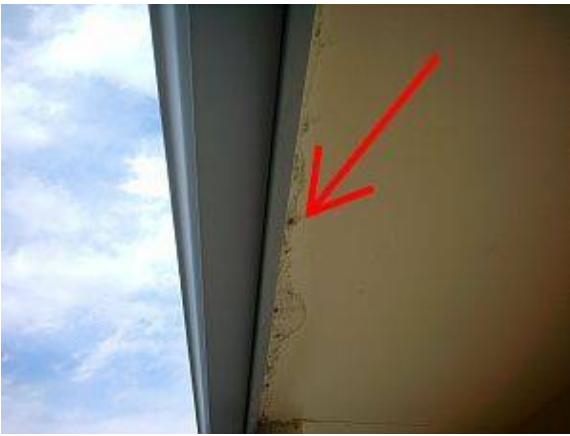
A small area of deterioration was found on the soffit of the upper level on the west side. This appeared to be from a previous roof leak, and was not a current concern. The current roof had no leak evidence at the time of this inspection. No action is recommended at this time. [See photo 11](#)

Photo 11  
minor deterioration of soffit on back side

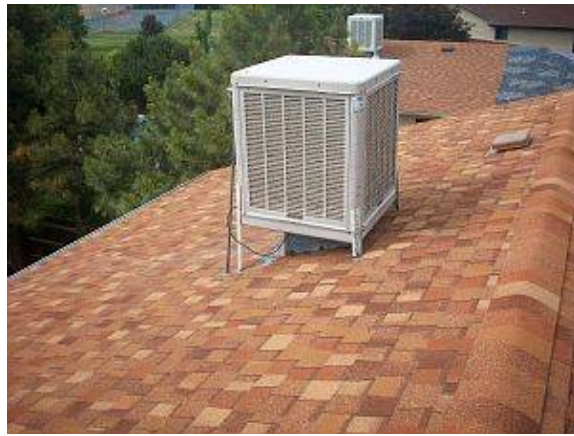
No concerns were found with the heating and cooling systems at the time of this inspection. [See photo 12](#)

Photo 12  
rooftop evaporative cooler

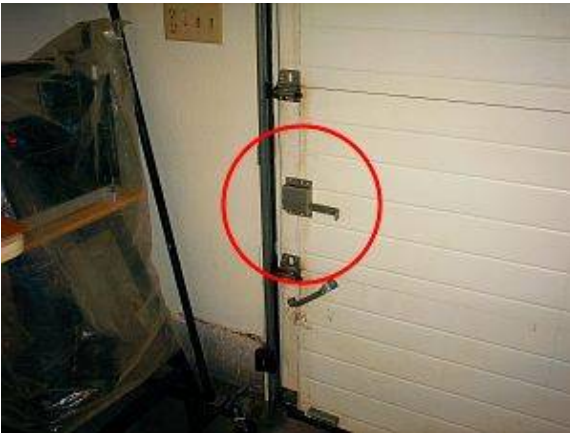
The vehicle door had an electric opener installed, and the manual lock mechanism on the door had not been disabled. Damage or injury may occur if the vehicle door opener is operated with the manual lock engaged. A qualified contractor should disable or remove the lock mechanism. For more information on garage door safety issues, visit: <http://www.cpsc.gov/cpsc/pub/pubs/523.html> or <http://www.ohdstl.com/safety.html> [See photo 13](#)

Photo 13  
lock not disabled on garage door
