Property Inspection Report

Property address: **123 your st.**

Inspection date: **3/31/2010**

Report number: 03312010

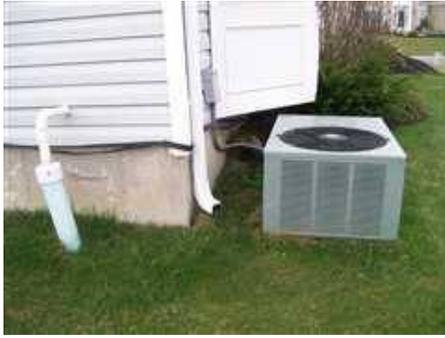
Photo 10

One or more downspouts have no extensions, or have extensions that are ineffective. This can result in water accumulating around the structure's foundation, or in basements and crawl spaces if they exist. Accumulated water is a conducive condition to wood destroying insects and organisms, and may also cause the foundation to settle and possibly fail over time. Repairs should be made as necessary, such as installing or repositioning splash blocks, or

installing and/or repairing tie-ins to underground drain lines, so rain water is carried at least several feet away from the structure to soil that slopes down and away from the structure.

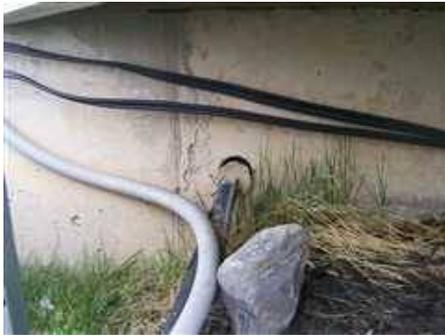
Photo 9

4) 🛠️ Gaps exist at one or more openings around the exterior, such as those where outside faucets, refrigerant lines, and/or gas supply pipes penetrate the exterior. Gaps should be sealed as necessary to prevent moisture intrusion and entry by vermin.

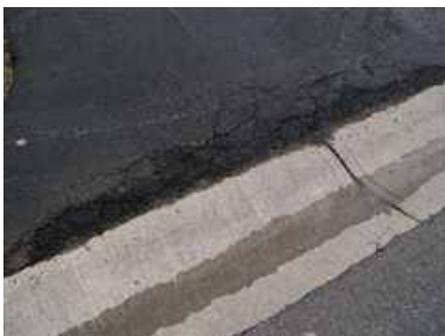
Photo 13

6) ⓘ Minor cracks were found in the driveway. However they don't appear to be a structural concern and no trip hazards were found. No immediate action is recommended, but the client(s) may wish to have repairs made or have cracked sections replaced for aesthetic reasons.

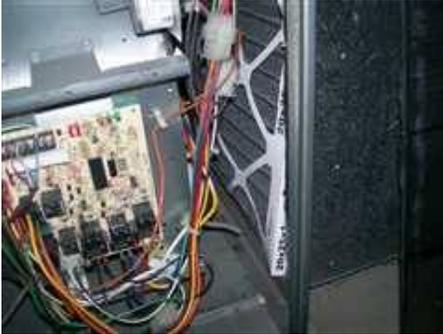
Photo 8

The air handler's filter(s) are damaged and/or deteriorated and should be replaced.

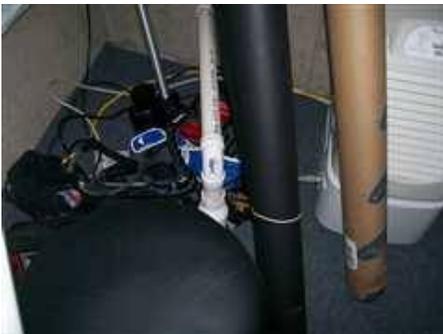
Photo 7

The inspector was unable to test the sump pump for one or more reasons (no source of water, appeared unsafe, no power, etc.). The sump pump was not fully evaluated. THE SUMP PUMP WAS NOT READILY ACCESSIBLE

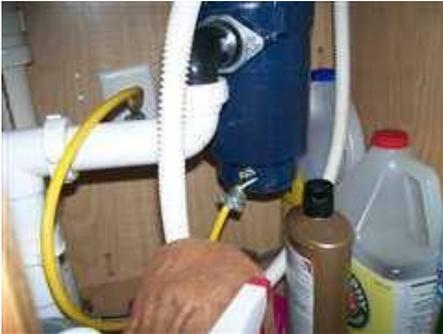
Photo 2

Substandard wiring was found for the under-sink food disposal. Unprotected solid-strand, non-metallic sheathed (Romex) wiring is used. The insulation can be damaged by objects coming in contact with it and/or it being repeatedly moved. This is a safety hazard due to the risk of shock and fire. Armored (BX) cable, or a flexible appliance cord with a plug end and electric outlet should be used. A qualified electrician should evaluate and repair as necessary.

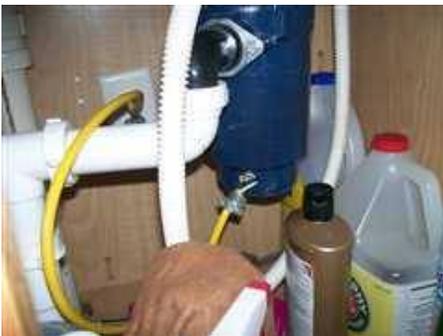
Photo 2

The dishwasher drain line is not configured with a "high loop" or "air gap". A high loop is created by routing the drain line up to the bottom surface of the counter top above, and securely fastening it to that surface. It is meant to prevent water from siphoning out of the dishwasher, and to prevent water from the sink drain or food disposal from entering the dishwasher. Some dishwashers have a built-in high loop where one is not required to be configured in the drain line. The clients should try to determine if a high loop is required for this brand and model of dishwasher (review installation instructions, etc.). If one is required, or it cannot be determined if one is not required, then a qualified contractor should install a high loop as per standard building practices.

Also, no "air gap" is installed. Air gaps are another device meant to prevent water from the sink drain or food disposal from entering the dishwasher. These are required in some municipalities for new construction and when remodeling. The client(s) should consult with a qualified contractor to determine if an air gap should be installed.

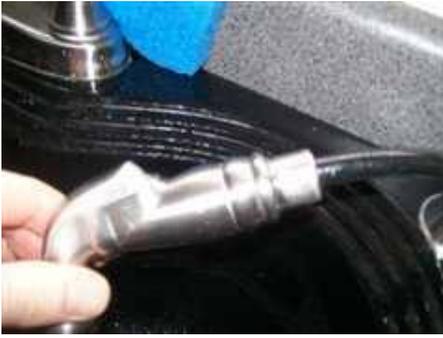
Photo 3

The sink sprayer at the kitchen sink is inoperable or defective. It should be replaced, and by a qualified plumber if necessary.

THERE IS A SLIGHT LEAK AT THE SPRAYER HOSE /HANDLE CONNECTION

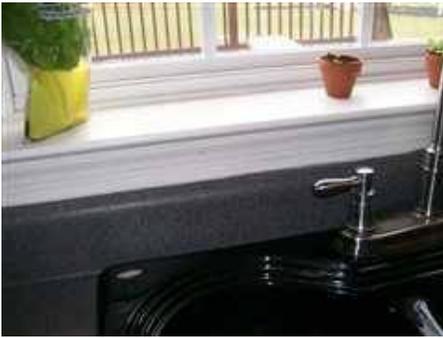
Photo 1

18) 🛠️ Water damage was found in the WINDOW TRIM above the sinks. A qualified contractor should evaluate and make repairs as necessary.

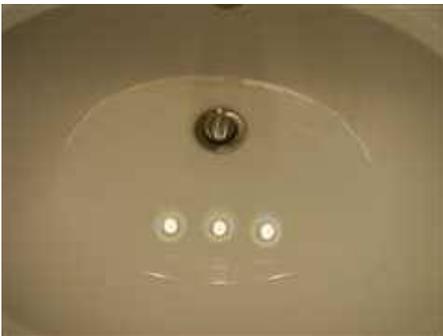
Photo 4

19) 🛠️ One or more sinks are clogged or drain slowly. Drain(s) should be cleared as necessary, and by a qualified plumber if necessary.

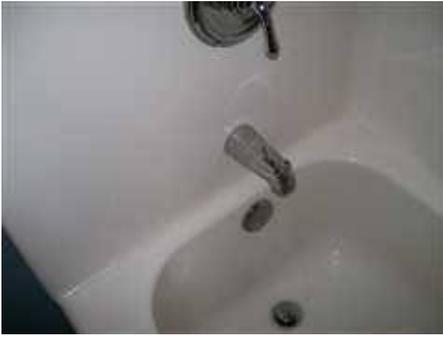
Photo 5

20) 🛠️✅📍 the tub spout in the bathroom needs to be sealed against the tub wall to prevent water damage to the lower floor ceilings

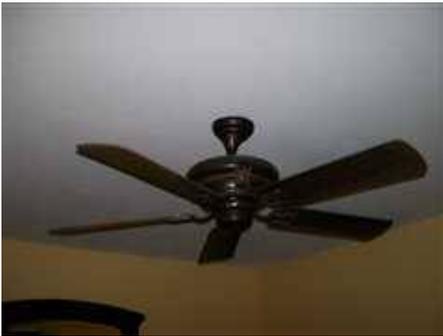
Photo 6

One or more ceiling fans wobbles excessively during operation. This is a potential safety hazard and may be caused by one or more of the following:

- Loose screws
- Loose blade(s)
- A loose connection between the rod and the fan body
- A loose connection between the fan body and the electric box above
- Misaligned blades
- Bent or warped blades
- Unbalanced blades

Recommend having a qualified contractor evaluate and repair as necessary. For more information, visit:
