Home Inspection Report

Property address: **5555 E. 5th St.
Anytown, USA**

Inspection date: **May 30th 2005**

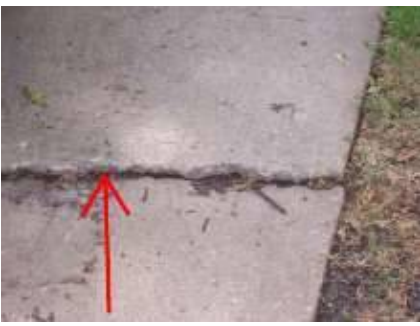
Photo 12

3) *Safety, Repair/Replace, Evaluate* - One or more trip hazards were found in the driveway due to cracks, settlement and/or heaving. Recommend having a qualified contractor evaluate and repair or replace driveway sections as necessary to eliminate trip hazards.

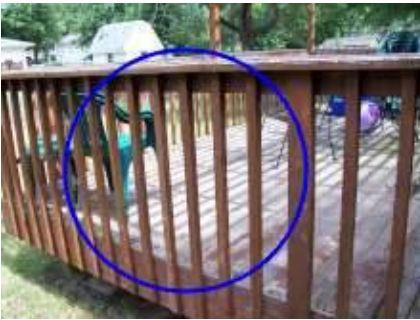
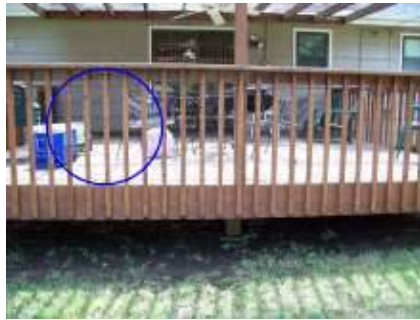
6) *Safety, Repair/Replace* - Gaps larger than four inches were found in one or more guardrails. This is a safety hazard, especially for small children. A qualified contractor should make modifications as necessary so gaps in guardrails do not exceed four inches. For example, installing additional balusters or railing components.

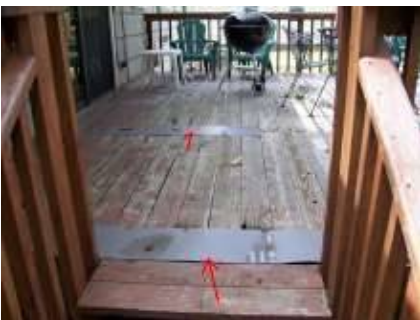
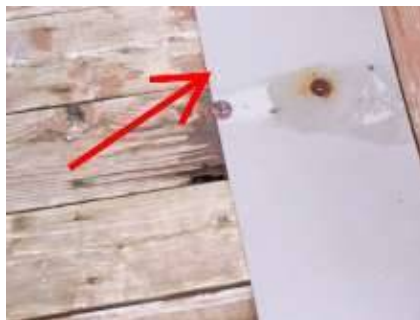
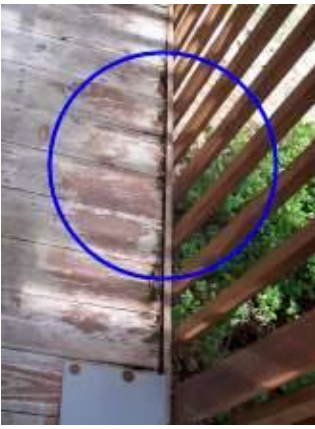
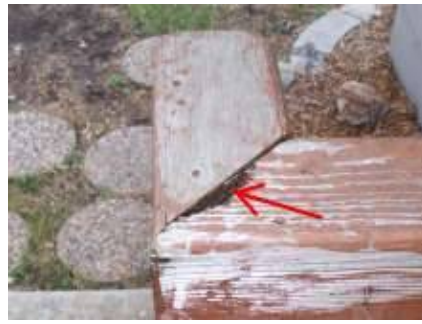
7) *Safety, Repair/Replace* - - The deck flooring and the hand rail has several rotted boards, some covered with metal strips. A qualified contractor should evaluate and repair as necessary.

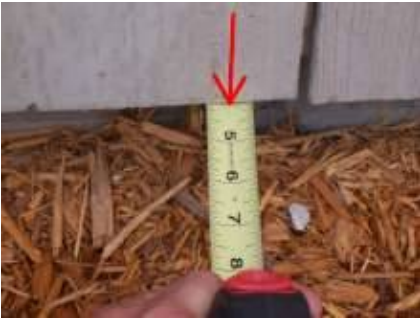
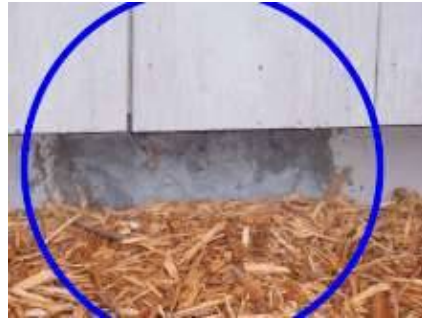
8) *Major Defect, Repair/Replace, Evaluate* - The middle section of the south wall hangs over the foundation wall approximately four inches. You can also see where the steel support beam has broken through the concrete before the anchors were put in place, then patched the hole with concrete patch. This was caused from the foundation wall bowing inward. A qualified contractor should evaluate and repair as necessary.

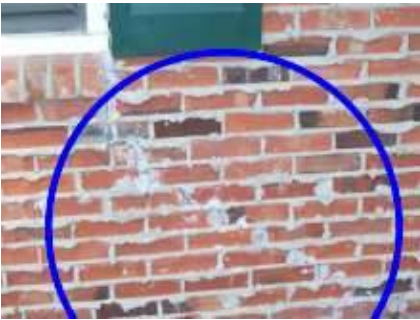
Photo 11

9) *Repair/Replace, Evaluate* - Minor cracks were found in one or more sections of brick veneer. A qualified contractor should evaluate and make repairs as necessary, such as repointing mortar to prevent water intrusion and further deterioration in the future.

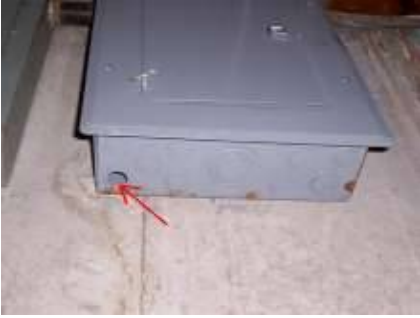
Photo 18

19) *Safety, Minor Defect* - One or more knockouts have been removed inside the main service panel where no wires and bushings are installed, and no cover(s) have been installed to seal the hole(s). This is a safety hazard due to the risk of fire. A qualified electrician should install knockout covers where missing.

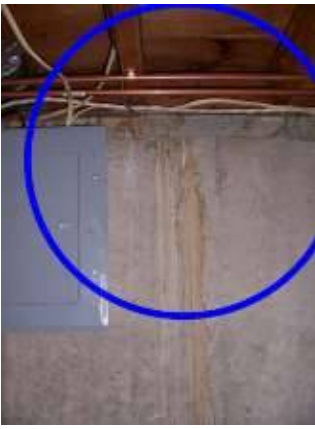
Photo 17

28) *Repair/Maintain* - Water stains on the rim joist, sub-floor and foundation wall - Water entering under the sliding glass door threshold.

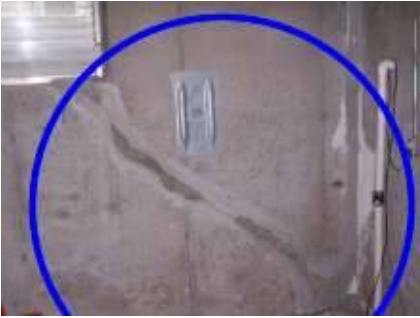
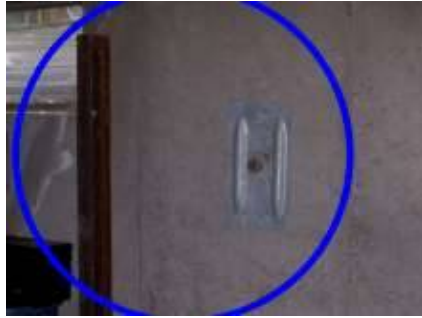
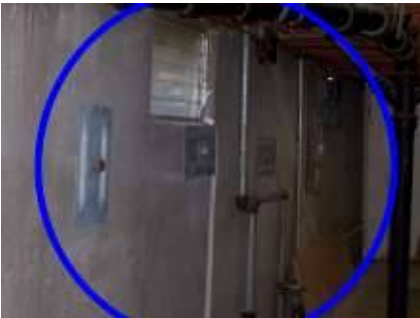
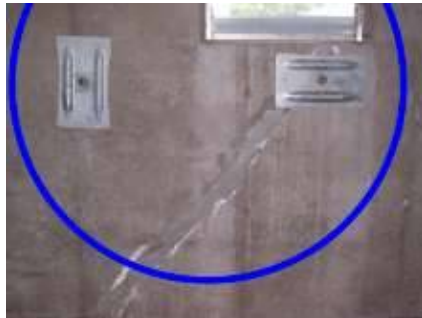
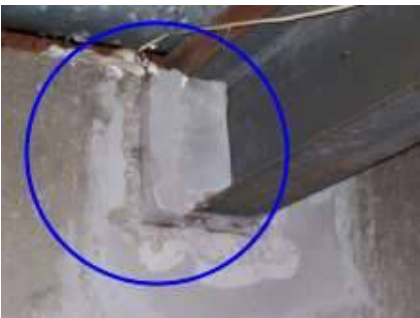
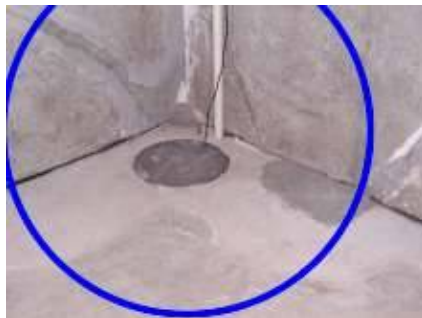
29) *Evaluate, Comment* - The east, south and west foundation walls have wall stabilizers and steel piers installed. The floor perimeter has been cut and a perforated drainage line installed and drains into a newly installed sump pit. Buyers should ask sellers if there is a transferable warranty on the foundation work.
