# BC Warner Inspections

## Sample Pre-Listing Home Inspection Report

Property address: **1 Great House For Sale Drive  
Sample City, USA**

Inspection date: **June 14, 2006**

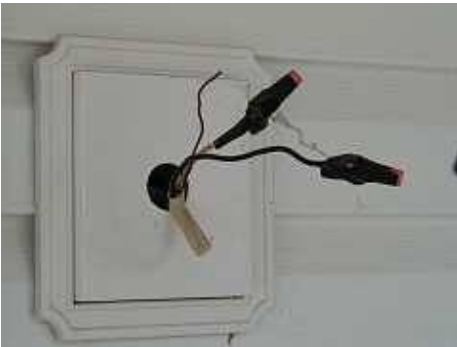
Photo 11

Exposed wiring due to splices not being contained in junction box or fixture. Recommend having a qualified electrician evaluate and install junction boxes with cover plates or fixtures where needed to contain wiring splices.

Concern has been repaired per report recommendations. Receipts and/or invoices for repair are available from seller by request.

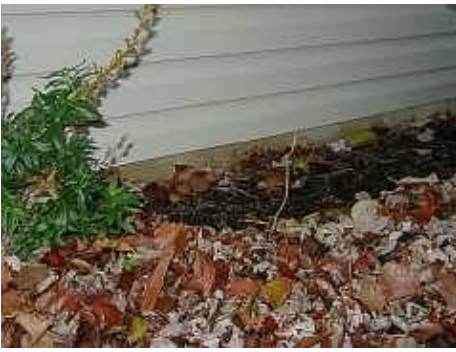
Photo 18

Soil is in contact with or less than 6" from siding and/or trim. This is a conducive condition for wood destroying insects and organisms. Recommend grading soil as necessary so there's at least 6" of space between the siding and trim and the soil below.

Issue has been corrected per report recommendations. Recommend periodic maintenance of these areas in order to prevent issue or concern from reoccurring.

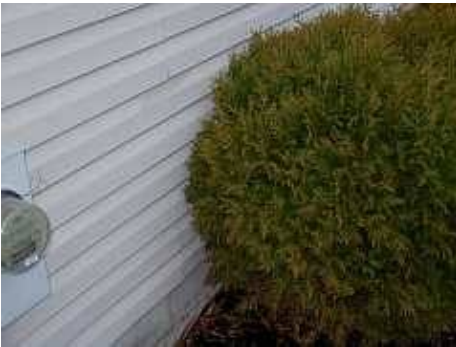
Photo 17

Shrub(s) in contact with siding. Recommend pruning or moving shrub(s) so there's at least a one foot gap between shrub(s) and siding. This gap should exist to allow siding and trim materials to dry quickly after it rains, and to eliminate pathways to the structure for wood destroying insects.

Issue has been corrected per report recommendations. Recommend periodic maintenance of these areas in order to prevent issue or concern from reoccurring.

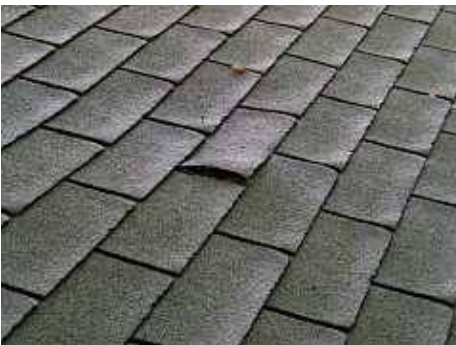
Photo 4

Roof covering appears to be at or beyond the end of its serviceable life. These conditions indicate that random failures may or have already occurred. The potential for damage to interior surfaces and structures is great. Due to the poor condition, this roof may require the additional expense of installing or replacing sheathing, such as plywood or oriented strand board (OSB).

Recommend qualified roofing contractor evaluate and replace.

Repairs have not been completed. Estimates for repair are available from seller by request.

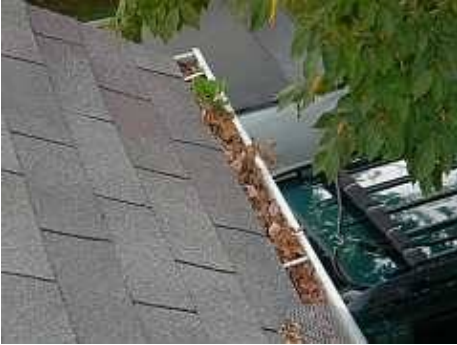
Photo 9

7) 🪛 Significant amounts of debris have accumulated in one or more gutters. This is a conducive condition for wood destroying insects since gutters may overflow and cause water to come in contact with the roof structure or make water accumulate around the foundation. Recommend cleaning gutters now and as necessary in the future.

Issue has been corrected per report recommendations. Recommend periodic maintenance of these areas in order to prevent issue or concern from reoccurring.

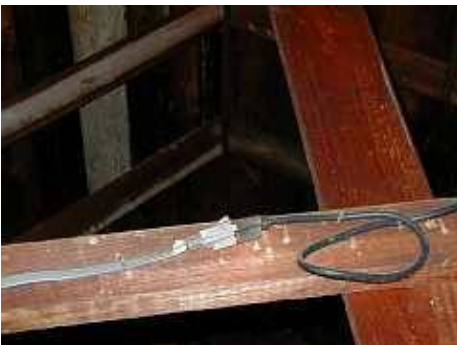
Photo 8

9) 🛠️🔍 Extension cord(s) are used as permanent wiring with the electric garage door opener(s). This is an unsafe practice. Recommend having a qualified electrical contractor evaluate and repair as necessary so no extension cords are needed. Possible solutions include:

- Replacing the cord on the opener with a longer cord
- Moving the existing outlet closer to the opener
- Installing an additional grounded outlet closer to the opener

Concern has been repaired per report recommendations. Receipts and/or invoices for repair are available from seller by request.

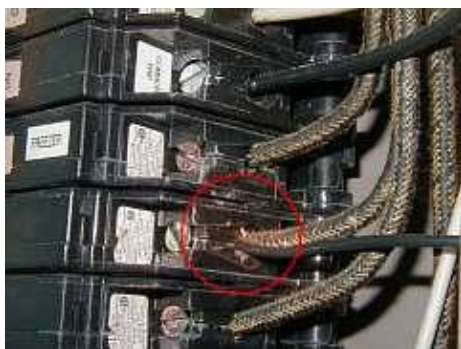
Photo 10

One or more circuit breakers are "double tapped", where 2 or more wires are clamped in a circuit breaker terminal, and the circuit breaker is only designed for 1 wire. This is a safety hazard since wires may come loose and cause arcing, sparking and fires. Recommend having a qualified electrician evaluate and repair.

Concern has been repaired per report recommendations. Receipts and/or invoices for repair are available from seller by request.

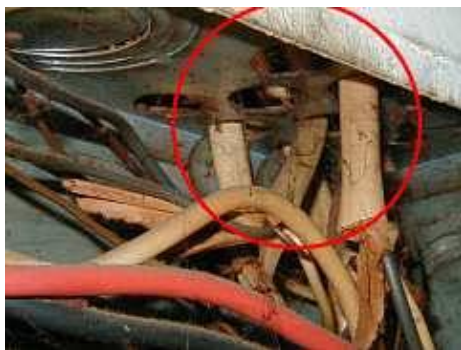
Photo 5

One or more bushings are missing from where wires enter main panel through holes. This is a safety hazard since the wiring insulation can be cut or abraded on the metal edge of the hole. Recommend having a qualified electrician evaluate and repair as necessary.

Concern has been repaired per report recommendations. Receipts and/or invoices for repair are available from seller by request.

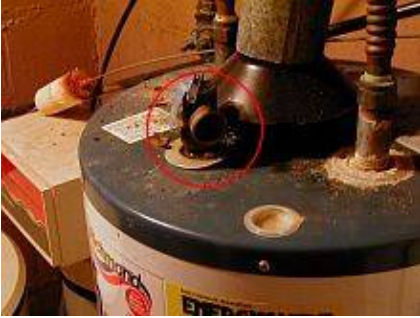
Photo 1

Temperature-pressure relief valve drain line is missing. Recommend having a qualified plumber install a drain line extending to within 6" from the floor, or routed so as to drain outside.

Concern has been repaired per report recommendations. Receipts and/or invoices for repair are available from seller by request.

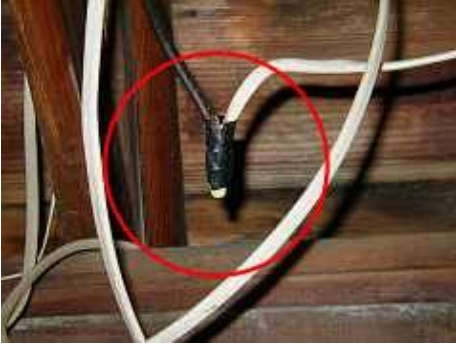
Photo 12

Exposed wiring due to splices not being contained in junction box. Recommend having a qualified electrician evaluate and install junction boxes with cover plates where needed to contain wiring splices.

Concern has been repaired, corrected, or addressed per report recommendations. Receipts and/or invoices for repair or service are available from seller by request.

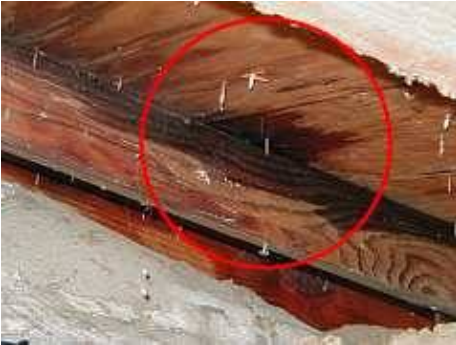
Photo 19

Water stains visible in roof sheathing and framing members. Sheathing and framing material are wet, apparently from an active leak in the roof. Recommend qualified roofing contractor repair or replace roof. Damage and staining may continue into interior ceiling and wall sections.

Concern has been repaired, corrected, or addressed per report recommendations. Receipts and/or invoices for repair or service are available from seller by request.

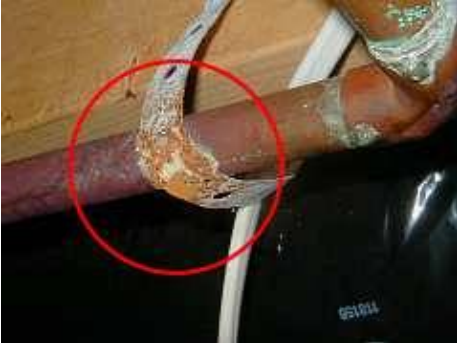
Photo 7

Steel hangers are used to support copper water supply pipes. This contact between dissimilar metals causes corrosion. Recommend having a qualified plumbing contractor evaluate water supply pipes where these hangers have been used, and repair or replace pipes if necessary. Recommend replacing steel hangers with appropriate hangers that won't cause corrosion.

Concern has been repaired, corrected, or addressed per report recommendations. Receipts and/or invoices for repair or service are available from seller by request.

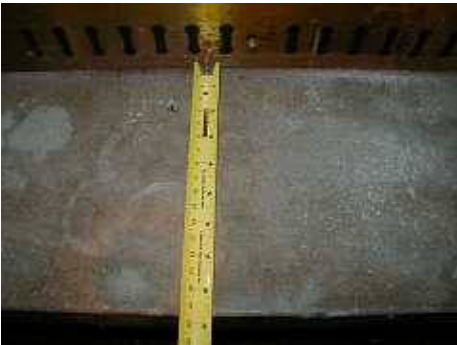
Photo 20

Fireplace hearth is less than 18" deep. This is a fire hazard. Recommend installing a non-combustible hearth pad or extending hearth to at least 18" deep.

Repairs have not been completed or performed. Estimates for repair are available from seller by request.

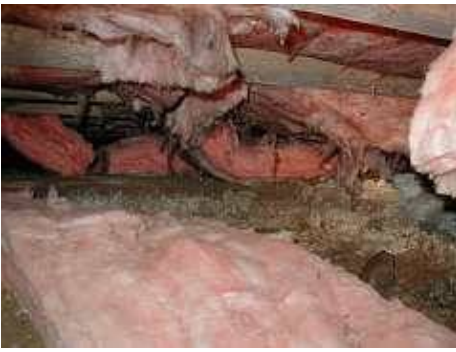
Photo 3

Some insulation in the crawlspace has fallen down. Recommend reinstalling or replacing this insulation.

Concern has been repaired, corrected, or addressed per report recommendations. Receipts and/or invoices for repair or service are available from seller by request.

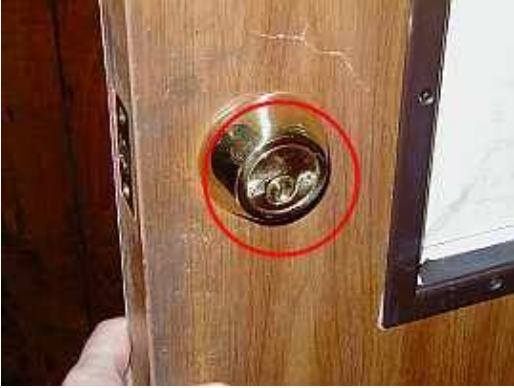
Photo 2

A deadbolt is installed on door where a key is required to open it from both sides. This can be a safety hazard since the door can't be opened if the deadbolt is locked and the key isn't available. Recommend replacing this deadbolt with one that doesn't require a key from both sides.

Concern has been repaired, corrected, or addressed per report recommendations. Receipts and/or invoices for repair or service are available from seller by request.

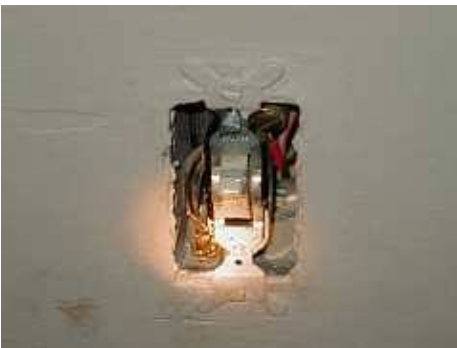
Photo 14

Cover plate(s) are missing from one or more electric switch boxes. They are intended to contain fire and prevent electric shock from exposed wires. This is a safety hazard and poses a risk of both fire and shock. Recommend installing cover plates over switch boxes where missing.

Concern has been repaired, corrected, or addressed per report recommendations. Receipts and/or invoices for repair or service are available from seller by request.

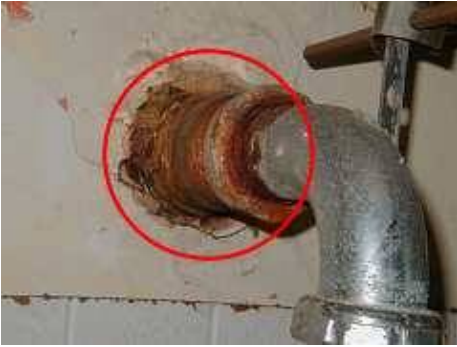
Photo 13

Leak at drain under sink. Recommend repairing leak.

Concern has been repaired, corrected, or addressed per report recommendations. Receipts and/or invoices for repair or service are available from seller by request.

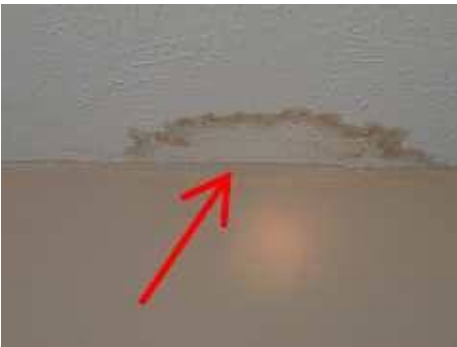
Photo 15

Water stains visible in ceiling. Ceiling material is wet, apparently from an active leak in the roof. Recommend repairing roof leak. Recommend removing wet wallboard or plaster and replacing with new after area has dried thoroughly.

Concern has been repaired, corrected, or addressed per report recommendations. Receipts and/or invoices for repair or service are available from seller by request.

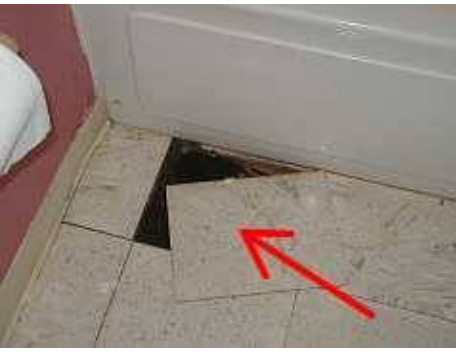
Photo 16

Vinyl floor tiles are installed in some rooms that are "wet areas" (kitchen, bathrooms, laundry room, etc.). This is a poor choice of floor material since water can seep through the cracks and infiltrate the wooden subfloor beneath. Recommend replacing vinyl floor tiles with a waterproof floor such as sheet vinyl where necessary.

Concern has been repaired, corrected, or addressed per report recommendations. Receipts and/or invoices for repair or service are available from seller by request.
