All Point Home Inspections

Full General Home Inspection and Structural Pest Inspection WA State Dept. Agriculture ICN# 00000000

Property address: **Anytown, USA**

Inspection date: **3/29/2012**

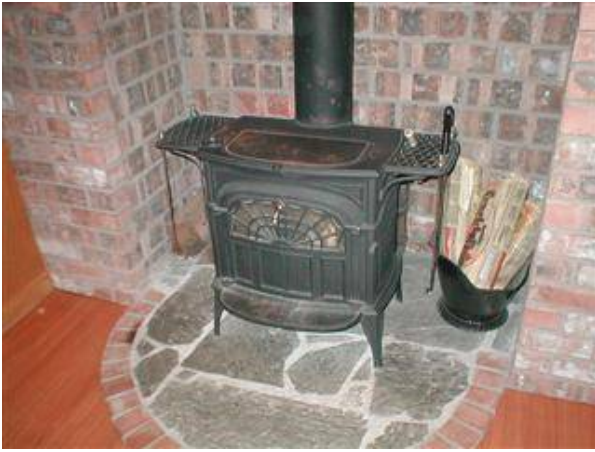
Photo 32

One or more wood-burning fireplaces or stoves were found at the property. When such devices are used, they should be professionally inspected and cleaned annually to prevent creosote build-up and to determine if repairs are needed. The National Fire Protection Association states that a "Level 2" chimney inspection should be performed with every sale or transfer of property with a wood-burning device. Recommend consulting with the property owner about recent and past servicing and repairs to all wood-burning devices and chimneys or flues at this property. Recommend that a qualified specialist evaluate all wood-burning devices and chimneys, and clean and repair as necessary. Note that if a wood stove insert is installed, it may need to be removed for such an evaluation. For more information, search for "chimney inspection" at:
