# All Point Home Inspections

## Full General Home Inspection and Structural Pest Inspection WA State Dept. Agriculture ICN# 00000000

Property address: Anytown, USA

Inspection date: 3/29/2012

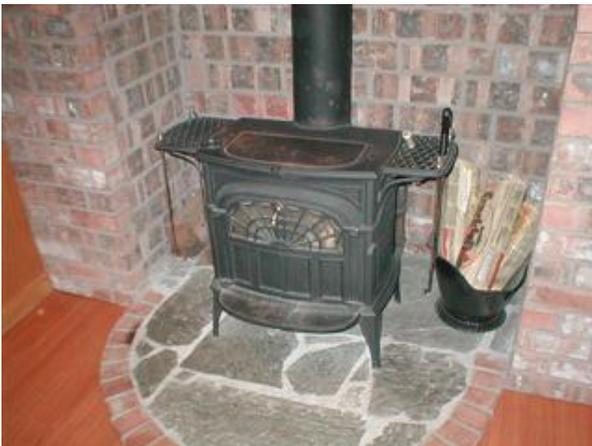
**Photo 32**

One or more wood-burning fireplaces or stoves were found at the property. When such devices are used, they should be professionally inspected and cleaned annually to prevent creosote build-up and to determine if repairs are needed. The National Fire Protection Association states that a "Level 2" chimney inspection should be performed with every sale or transfer of property with a wood-burning device. Recommend consulting with the property owner about recent and past servicing and repairs to all wood-burning devices and chimneys or flues at this property. Recommend that a qualified specialist evaluate all wood-burning devices and chimneys, and clean and repair as necessary. Note that if a wood stove insert is installed, it may need to be removed for such an evaluation. For more information, search for "chimney inspection" at:

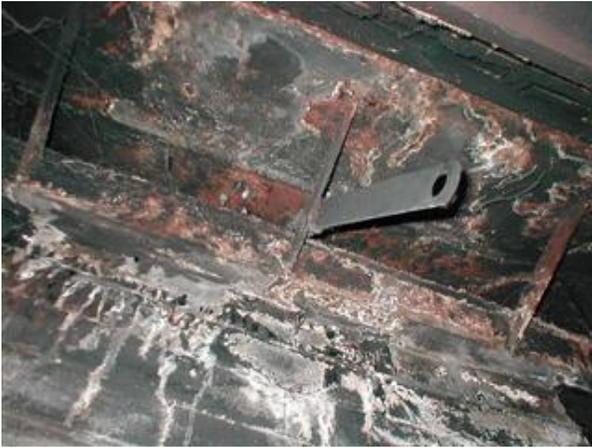
**Photo 40**

View up fireplace damper.

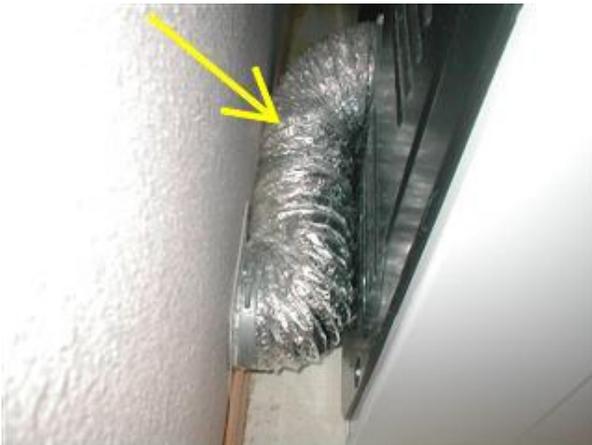
## Photo 35

The clothes dryer was equipped with a vinyl or mylar, accordion-type, flexible exhaust duct. The U.S. Consumer Product Safety Commission considers these types of ducts to be unsafe, and a fire hazard. They can trap lint and are susceptible to kinks or crushing, which can greatly reduce the air flow and cause overheating. Recommend that such ducts be replaced with a rigid or corrugated semi-rigid metal duct, and by a qualified contractor if necessary. For more information, visit:
