The finish line

A Forest Products Laboratory finishing factsheet

The Ins and Outs of Caulking

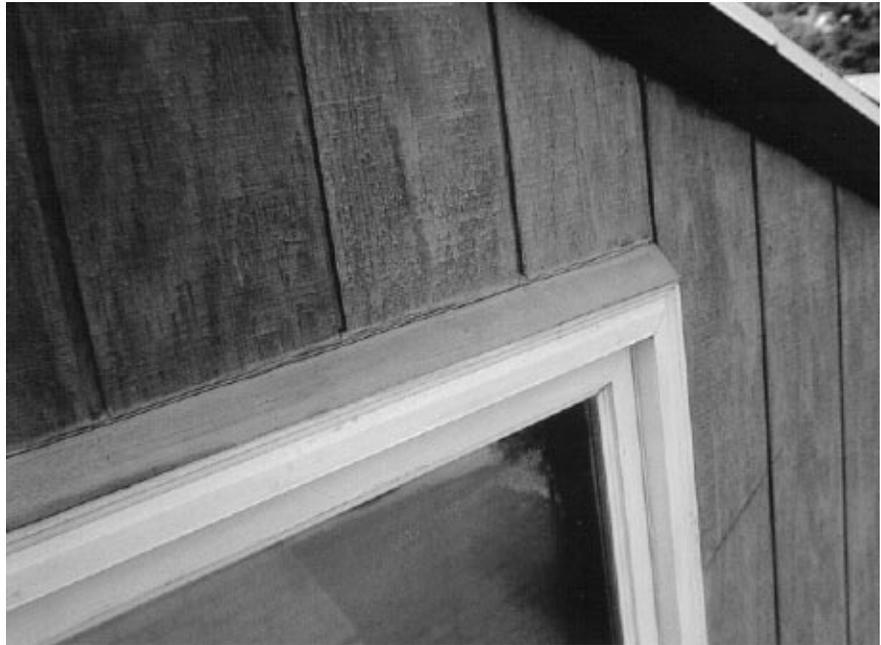
Figure 1—Site-fabricated sloped drip cap above window with pine brick molding installed over plywood panel siding. Seal at top of drip cap is urethane caulk. Seal has remained functional, but it is beginning to show surface cracking. Drip cap and caulk seal were installed in September 1983; photo was taken in June 1997.

before the window and door units are installed; that is, fenestration units are installed over the siding. When this is the case, metal flashing cannot be used at window and door heads. Water management in this situation depends on the use of sloped drip caps and high quality caulk joints (Fig. 1). An advantage of this type of window installation is that “draining” windows are less likely to be installed improperly than when siding is installed after windows are in place. Providing for window drainage outside the panel face is fairly easy, although it may still be possible to block drainage paths if caulk is used carelessly.
